IN-SERVICE REMEDIATION OF A RAILWAY EMBANKMENT TO PREVENT SETTLEMENT

ABSTRACT. After optimization of the railway geometry for higher speed, a continuous settlement of the track occurred. Improvement of the embankment body was needed; however, a complete traffic interruption was not allowed. The reconstruction work has been done using the methods of special ground engineering such as vibro-stone columns and driven ductile piles.

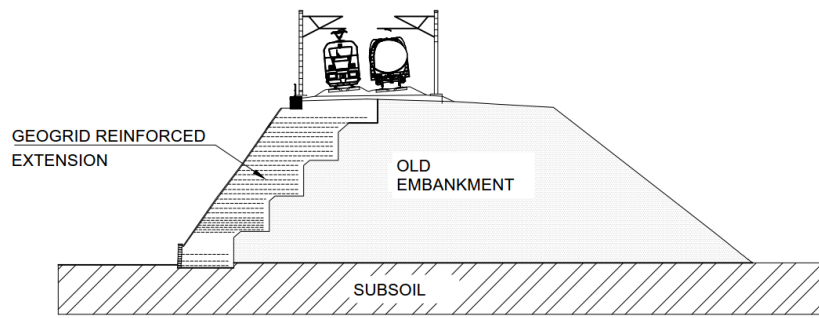
FIGURE 1. Existing condition – extension with geogrids.

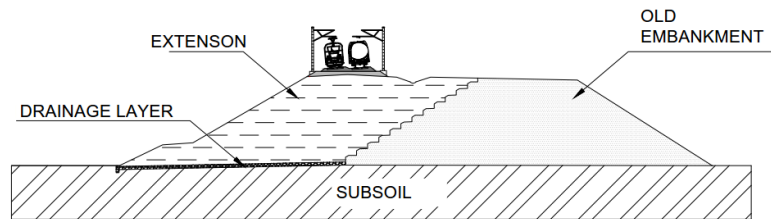
FIGURE 2. Existing condition – unreinforced embankment.

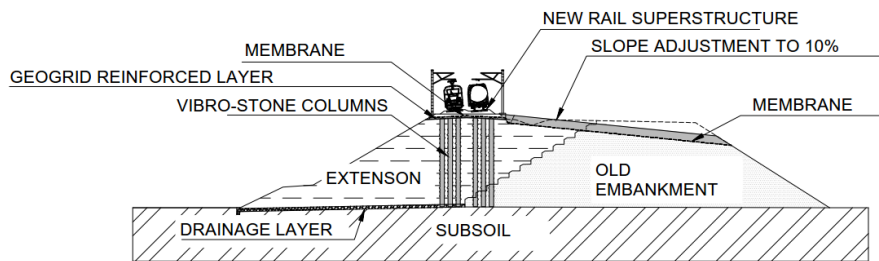
FIGURE 3. Concept for improvement of the non-reinforced embankment.

Vibro-stone columns installed to the earth structure would drain the body, solving the problem associated with the high water content. When installing the vibro-stone columns, the gravel is pushed to the sides and it would also compact the existing material around them [2].

The watertight membrane installed around all the area of the embankment top would provide a permanent barrier to the rainwater (see Figure 3).

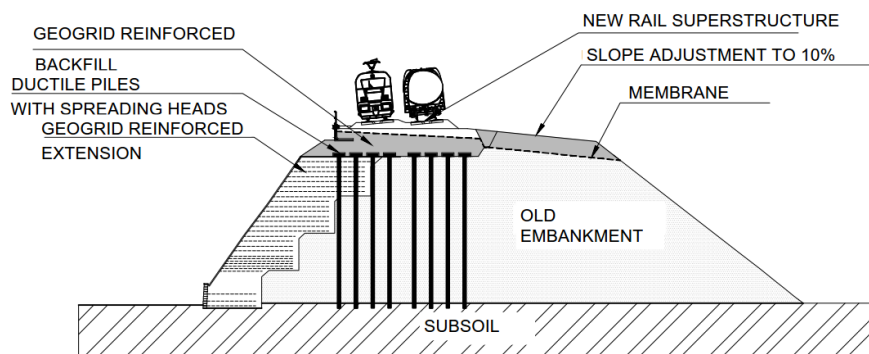
FIGURE 4. Concept for improvement of reinforced embankment.

At the part where the embankment extension was reinforced with geogrids the vibro-stone columns would not be possible to use. Reinforced geogrids would obstruct the technology of the columns installation. If the columns crossed the geogrids, its anchor length would break and the stability of the steep slope could be also broken. These are the reasons why the improvement of the bridge transition zone and its close parts were designed with driven ductile piles with precast reinforced concrete heads. Ductile piles have been installed in the regular triangle grid, around 2 m under the subgrade. On the piles concrete spreading heads have been placed and the construction has been covered using gravel with geogrids (see Figure 4).

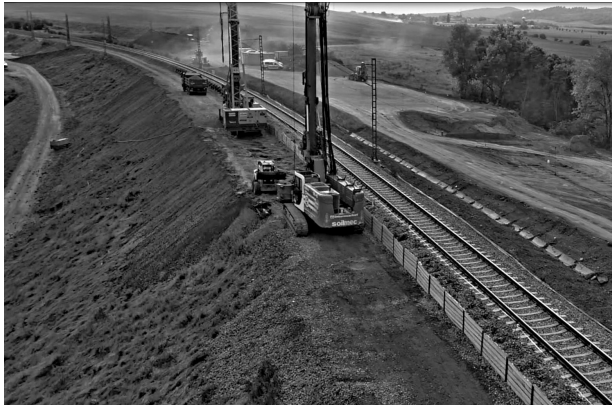
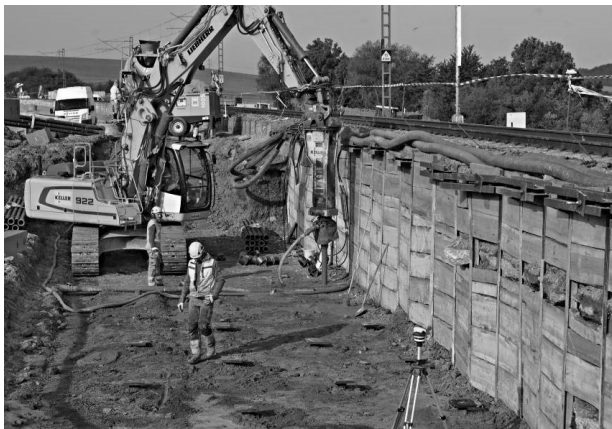
FIGURE 5. Stone columns procedure under the track no. 1. (top) and procedure of the Ductile piles under the track no. 1 (bottom).

After the removal of superstructure and ballast, a space with the width of 5.5 m was formed for the installation of the stone columns. The workspace was bounded by the track in service from one side and the embankment slope from the other side. It was very difficult to plan the work procedure. The area close to the machine for the stone columns production was very narrow and it was not able to pass by with other forms of mechanization. Due to the length of the columns (15 m), it was necessary to do a pilot borehole with a CFA drilling machine (see Figure 5).

After all stone columns were fixed, the excavation at the transition zone could be done. The installation of the ductile piles followed. At the same time repair to the insulation of the bridge abutment was made. Finally, the watertight geo-membrane, the sub-ballast and ballast were laid. The superstructure was laid to

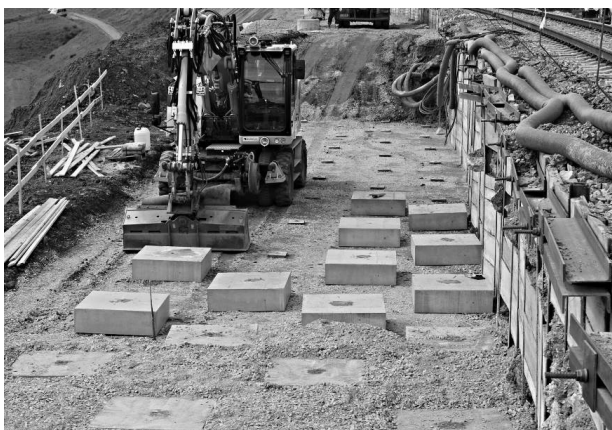
FIGURE 6. Procedure of the spreading heads under the track No. 1.

the original geometry with zero super-elevation (see Figure 6).

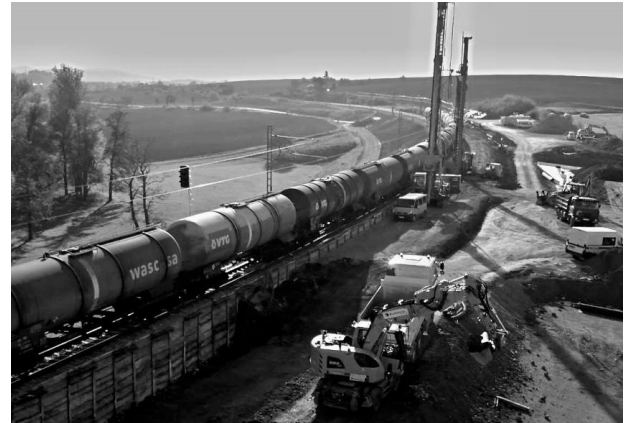
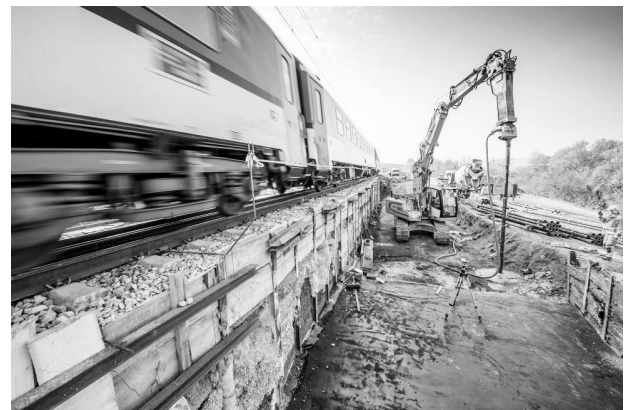
FIGURE 7. Vibro-stone columns and excavation for ductile piles under the track no. 2 (top) and ductile piles hammering under the track no. 2 (bottom).

As the track No. 1 was brought into service, the superstructure of the track No. 2 was removed. The procedure was repeated. The vibro-stone columns were fixed. The bridge transition zone was excavated for the ductile pile installation. The bridge abutment insulation was repaired as well. Work on the crown of the old embankment was finishing at the same time. After the stone columns and the ductile piles

installation, the backfill of the transition zone was done. This was laid and connected to the membrane under track No. 1 and the membrane on the crown of the old embankment. Finally, the track superstructure was laid and both tracks were adjusted to its final geometry.

The service was restored in both tracks and the final work was performed away from the track in service (see Figure 7).

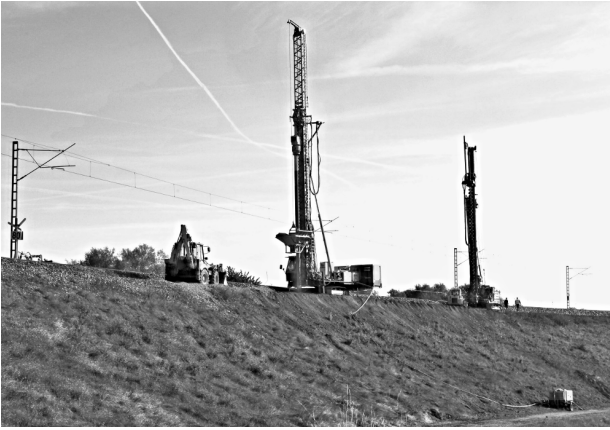
FIGURE 8. Vibro-stone columns installation under the track no. 1.

Vibro-stone columns have been designed in 700 mm diameter, placed in triangular raster with 1500 mm distance. The drainage layer on the base of the embankment had to be reached by the columns in order to achieve the best drainage effect. The maximum column length was 15 m.

In order to achieve the maximum length of the columns and to speed up the works, it was decided to install the columns into the pilot bore diameter of 500 mm. Under each track, 402 pieces of vibro-stone columns were fixed, a total of 804 pieces. In the first stage under track No. 1 there were 5,400 meters of columns installed in 19 days. In the second stage under track No. 2, 5,900 meters of columns were completed in the same period (see Figure 8).
