A HEADRACE TUNNEL RECONSTRUCTION IN TURKEY

ABSTRACT. The operation of a hydro power project in North Turkey started in 2015, included the 12 km long headrace tunnel. An 8 km long lower tunnel section was excavated by double shield TBM technology with 8.7 m ID. Due to problems with the mechanised excavation, a 4 km long upper tunnel section was excavated conventionally by the Drill and Blast method with single shell lining generated from fibre reinforced sprayed concrete and rock bolts. Significant operational problems were observed in September 2016. The flooded tunnel was investigated by underwater Remotely Operated Vehicle which indicated significant collapses. Operation of the power station had to be stopped and water from a supply dam at the headrace tunnel inlet had to be discharged to enable dewatering and inspection of the tunnel. Consequent investigation revealed three major collapses and a considerable variety of other damages in the D&B section of the tunnel. Repair and strengthening of the tunnel was completed in October 2017.

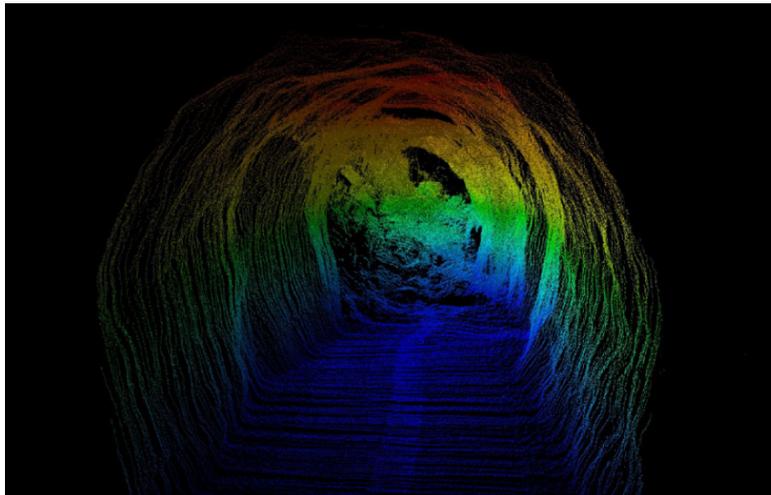
Significant problems were observed in the power station in September 2016 (lower water pressure, muddy colour of water, stones in water), and thus its operation had to be stopped. The flooded tunnel was inspected by underwater Remotely Operated Vehicle (ROV) allowing 3D scanning (Figure 2). The inspection revealed three different and bigger failures in the tunnel at approximately 0+210, 0+590 and 3+280 (chainage starts at the intake portal). The collapse 1 at 3+280 was the largest, as it obstructed about three quarters of the tunnel profile and did not allow further inspection of the remaining section of D&B tunnel from 3+280 to 4+000 since there was a significant risk that the ROV cable would be trapped in the collapse. The tunnel and upper dam had to be dewatered afterwards, and this procedure took about one month (Figure 1).

FIGURE 2. Record from scanning of collapsed area by ROV.

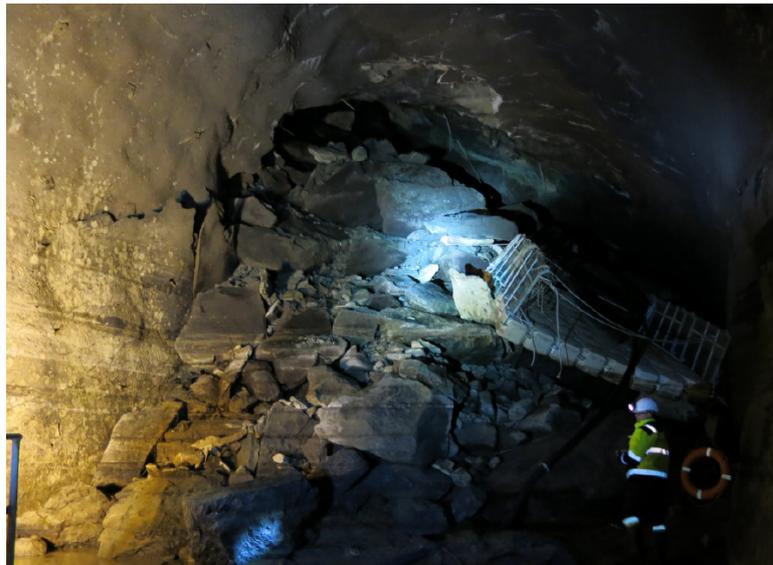
The collapse 1 area (about a 30 m long tunnel section) starting at km 3+280 (Figure 3) was additionally filled by sand and access to the collapse cavern sealed by foam. For ventilation and access behind the collapse, a 30 m long pipe of 1.2 m diameter was placed on the top of the blockage before closing the tunnel profile. Also a pipe for water pumping through the collapse 1 was installed prior to its filling. Then the lower part of the cavern generated by the collapse 1 was filled with concrete from the tunnel. Filling of the rest of the cavern was done through boreholes drilled from the surface.

FIGURE 3. The collapse 1 after water pumping completion.

Tunnel lining strengthening in front of the collapse 1 area was realised prior to start of re-excavation. This was needed to generate a safe working area to minimize the risk for the working crews. A systematic rockbolting using 6 m long galvanised SN bolts was done from 3+240 to 3+270. Additional support using steel meshes, lattice girders and shotcrete was installed as from km 3+265 to km 3+270. Then conventional

excavation of top heading with 1 m advances through the collapse 1 was carried out. Applied support included sprayed concrete, steel meshes, lattice girders, 6 m long galvanised rockbolts SN or IBO, umbrellas from 8 m long IBO 51 bolts, etc. Probe drilling with a length up to 15 m was conducted every 6 m. All voids encountered by drilling were filled by cement grout. Material removal from the bench area started afterwards. Excavation was initially ongoing on the right side from the downstream view, then bench excavation on the left side started. The original tunnel lining in the bench area was not damaged, thus material removal and installation of support was straightforward. Only very low deformations below 20 mm were recorded during re-excavation due to successful filling by concrete and grout.

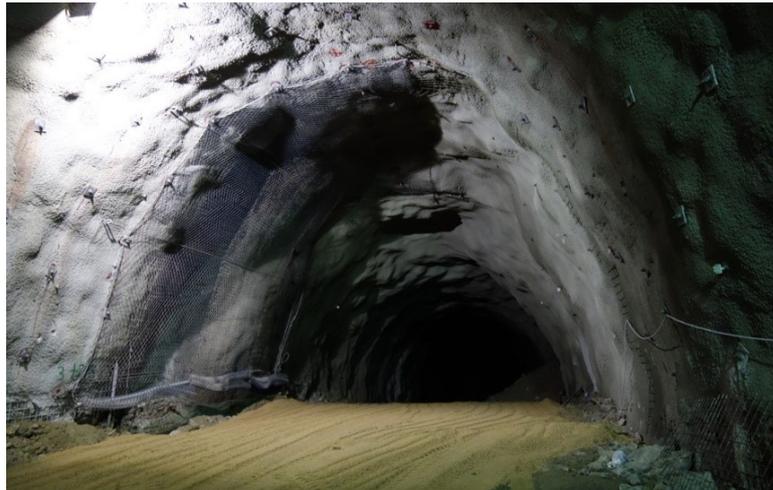
Breakthrough to the collapse 1 allowed access to the collapse 2. However, the area between the collapses 1 and 2 was flooded, and had to be dewatered. After water pumping completion, access could be cleaned up and the collapse 2 could be investigated. Investigation revealed about a 34 m high and a 5 m wide cavern with the shape of a square vertical chimney. The cavern mouth was situated on the left shoulder at km 3+885. Strengthening of area ahead of the collapse 2 started afterwards, with shotcrete spraying and rockbolting being realised. Removal of collapsed material followed. Then initial support was partly installed, but working was slow due to safety concerns (risk of falling stones from the cavern). A decision was taken to cover the cavern by the high-tensile steel mesh MINAX 80/3 (Figure 4). After initial support and permanent rockbolting up to 3+880, the first meshes and 13 lattice girders were installed over the cavity opening from 3+878 to 3+890. The area was sprayed by shotcrete and plastic pipes were installed

FIGURE 4. The collapse 2 mouth protection by the high-tensile steel mesh.

through the lining to allow concrete pouring into the cavern. Pumping of the self-levelling concrete C35 into the cavern started after tunnel lining under the collapse 2 (including permanent rockbolting, second meshes covered by shotcrete, and also the left side propping). The pumping was slower in the beginning; speed was increased once the concrete level reached 2 m above the tunnel crown. The pipes for concrete pouring and air release were extended 3-times during concreting using a telescopic piping arrangement, and finally pipes reached the cavern roof. About 50 m³ of concrete was pumped per day. Then, grouting of voids and open spaces behind the lining was carried out. The collapse 2 cavern filling was completed in July 2017, involving a pumping of about 800 m³ of concrete in total.

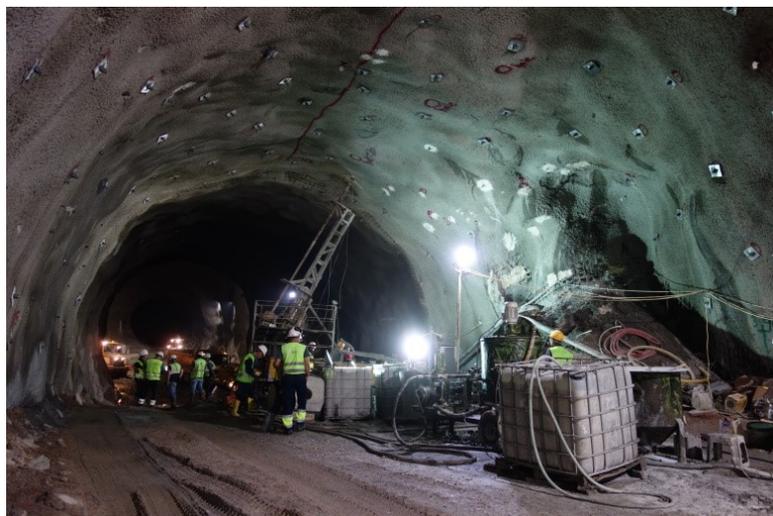
Installation of the high-tensile steel mesh MINAX 80/3 over the collapse 2 before its filling allowed safe access to the collapse 3. A narrow mouth of the collapse 3 was situated to the right side wall at km 3+905, and as the mouth was blocked by a bigger block of rock, it did not allow sight and survey of the cavern behind it. After strengthening of the area, probe drilling performed by a standard tunnel boomer started, with the length of drills varied from 6 to 9 m. Generally loose material was encountered by probe holes, but no big cavern was detected. Drilling machine for longer drills was also utilised, and the purpose of longer drills was to locate a cavern in higher areas. Probe hole 20 drilled from 3+912 reached a length 32 m, and as it encountered a loose material, it was used for grouting (Figure 5) with a packer 9 m deep. During grouting leakage in the cavern mouth area was observed which confirmed the connection of loose areas. After the probe hole 20 blockage, it was re-drilled by the probe hole 21. Grouting was finalized by probe hole 22 which was crossing the probe hole 21 in a diagonal way. When a leakage from the hole 21 was observed during grout pumping into the hole 22, it was confirmed that the whole possible cavern was reasonably filled. Some additional systematic 6 m long drilling and grouting was performed afterwards. In total over 300 m³ of grout was pumped into the collapse 3 area.

FIGURE 5. Grouting of the collapse 3, its mouth situated behind a barrel with grout.

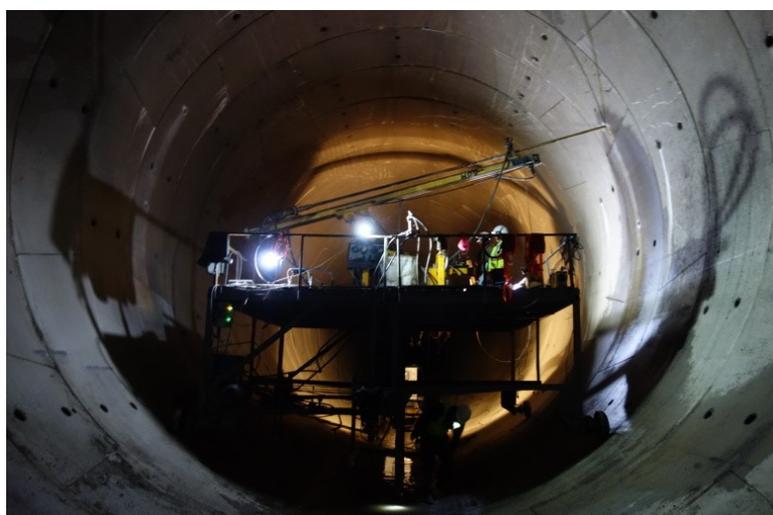
FIGURE 6. Core drilling in the TBM tunnel.

Repair of the tunnel section excavated by double-shield with segmental lining was significantly affected by a limited access. Access for people to this section was originally allowed by a small opening in the steel tube in the area of the power station. The second access was allowed by a surge shaft situated close to the power station. Preparatory work to get an access through the shaft started in April 2017 – installation of crane with basket, arrangement of safety measures, etc. Access from the intake portal was affected by collapses and activities in the D&B tunnel, with a barrier separating the segmental tunnel and the dismantling chamber in D&B tunnel being removed in July 2017. However, a good access was ensured after completion of the bench excavation in the collapse 2 and 3 areas. Work in the segmental tunnel section started with core drilling in May 2017 using access through the surge shaft (Figure 6). Only problematic sections were investigated by core drilling. 5 m long cores were taken from 5 locations in each profile (9:00, 10:30, 12:00, 1:30, 3:00). Pressure water tests were realised in drills after removal of cores. Trial grouting in the segmental tunnel section started in June 2017. It was executed on 18 rings (27 metres). Grouting continued afterwards on other problematic sections, with a total of 6 sections being grouted. Trial grouting was done through 5 drills in each profile (9:00, 10:30, 12:00, 1:30, 3:00), then the number of drills in each profile was reduced to 3 (11:00, 12:00, 1:00) and then only to 1 (12:00). Repair of damaged segments was done in September 2017. The worst section of segmental lining (about 11 rings) included cracked segments with exposed reinforcement. Problematic segments had to be repaired (removal of loose concrete, cleaning of area, covering by appropriate material). Steel ribs (galvanized HEB 260 profiles) were installed to the section. Also permanent rockbolting and grouting was completed.
