FATIGUE FRACTURE OF THE LOGICA CEMENTED STEM – CLINICAL AND MECHANICAL ANALYSIS

Marian Melisik^{1,2}, Peter Palcek³, Libor Necas¹, Martin Zofcak⁴, Michal Al-Khoury¹,
Maros Hrubina^{1,2}

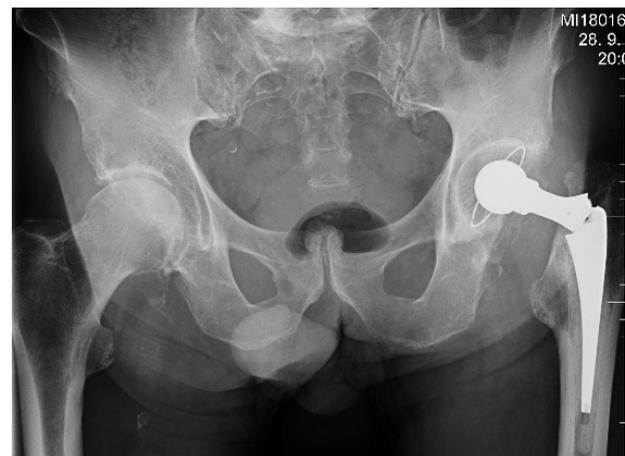
Radiographs confirmed the fractures in all instances (Fig. 1).

Fig. 1: The anteroposterior X-ray of 79-year-old patient with broken cemented stem Logica 8 years after the implantation.

All fractured stems were the smallest available sizes (0 or 01) and were paired with XXL or XL heads. During revision surgery, a modular revision stem was implanted in four cases following endofemoral cement removal. In

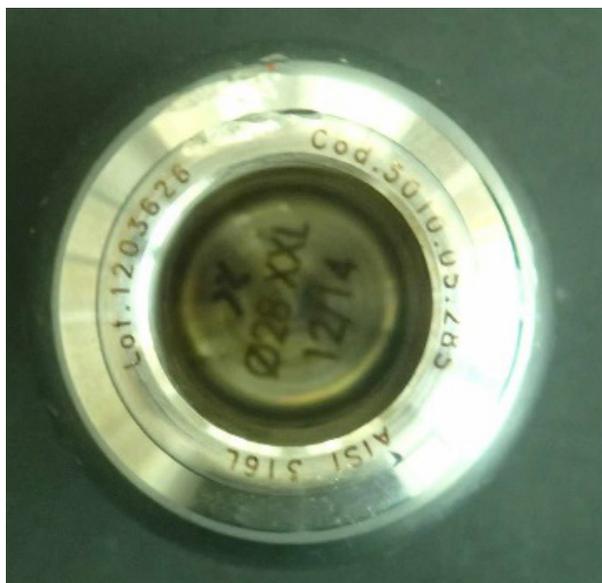
two cases, a "cement-in-cement" technique with a new stem of the same size was performed to minimize operative time in elderly, polymorbid patients. The recurrence of fractures exclusively in the smallest stem sizes combined with long-neck heads (XL, XXL) suggests a potential correlation between slender implant geometry, increased offset, and elevated mechanical stress (Fig. 2).

Fig. 2: The endoprosthesis head with visible XXL label.

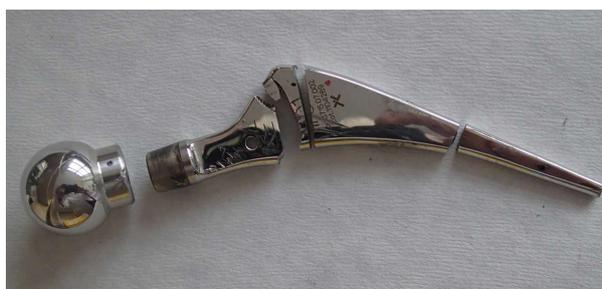
Macroscopic evaluation revealed that fracture initiation occurred in the thread region, subsequently propagating through the entire cross-section (Fig. 3–5).

Fig. 3: Fractured Logica stem, explanted component.

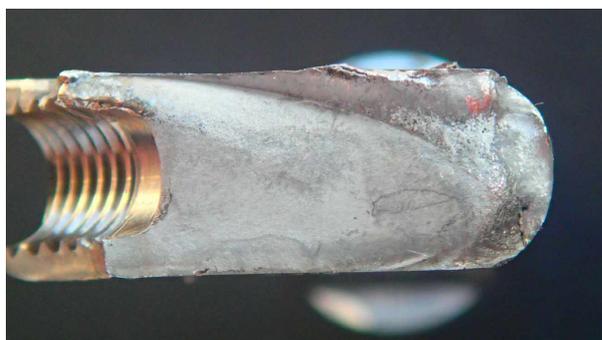
Fig. 4: Fracture surface morphology of the proximal (upper) part of the broken femoral stem.

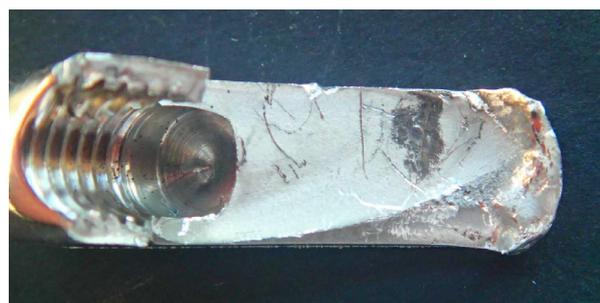
Fig. 5: Fracture surface morphology of the distal (lower) part of the broken femoral stem.

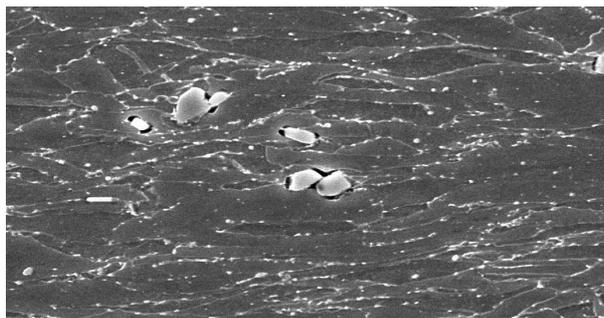
The fracture morphology is consistent with fatigue failure. The presence of grain-boundary *M23C6* carbides suggests susceptibility to intergranular corrosion, which, under cyclic physiological loading, likely accelerated the degradation process (Fig. 6).

Fig. 6: Microstructure of the fractured stem highlighting grain-boundary carbides associated with fatigue failure and intergranular corrosion.

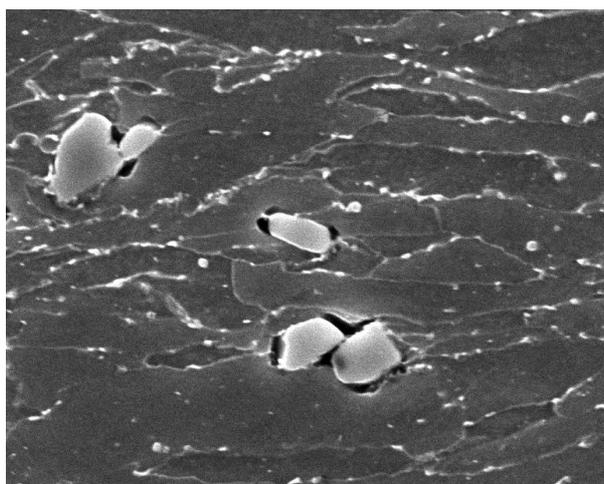
The microhardness profile, peaking near the surface, suggests strain hardening induced during the final mechanical polishing. In contrast, core hardness fluctuations may indicate non-homogeneous heat treatment (e.g., suboptimal solution annealing) following forging (Fig. 7).

Fig. 7: Microstructural detail showing M23C6 carbides and grain morphology relative to the microhardness profile.

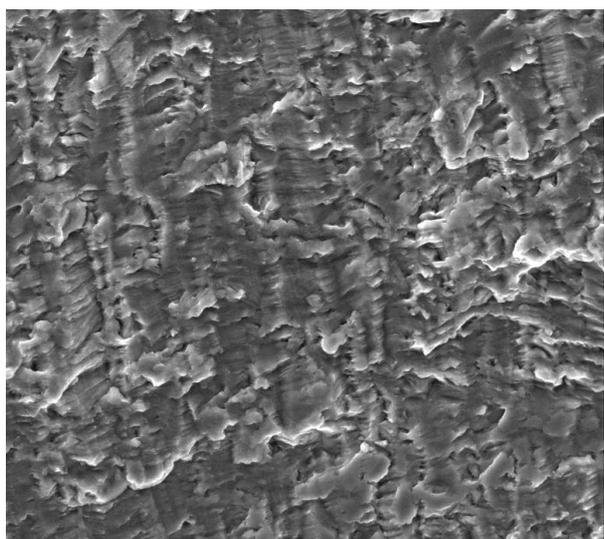
Furthermore, the presence of corrosion products on the fracture surface suggests a potential galvanic effect between the dissimilar metals (AISI 316L and AISI 347), acting synergistically with mechanical fatigue in the aggressive biological environment (Fig. 8).

Fig. 8: SEM micrograph of the fatigue fracture cross-section showing typical fatigue striations and localized corrosion products.

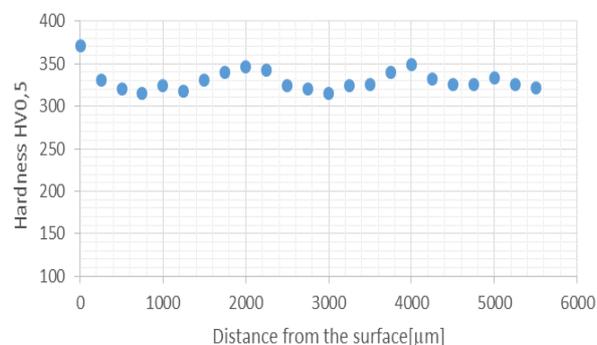
Microhardness testing (HV0.5) revealed a non-uniform distribution ranging from 315 to 370 HV. To assess the mechanical implications, the local ultimate tensile strength (R_m) was estimated using the empirical conversion $R_m \approx 3.2 \times HV$, a standard approximation for austenitic stainless steels. Based on this relationship, the observed hardness variation of 55 HV corresponds to a local strength fluctuation of approximately 150–170 MPa. Each data point represents the mean of five indents (HV0.5) per location; measurement variability remained low, with a standard deviation typically within ± 5 HV.

Fig. 9: Microhardness profile across the femoral stem cross-section. Data points represent mean values from six fractured stems, measured along a radial path from the outer surface to the central axis.
