FIRES IN WOOD INDUSTRY

Nenad Papi

Forensic Science Centre „Ivan Vu eti “, Ilica 335, 10000 Zagreb – Croatia

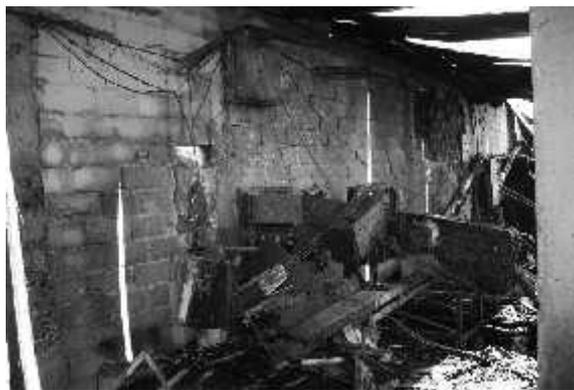
A review of electrical installation in the packing room, see Fig. 1, it was determined that on the wall are five metal distribution cabinets.

Fig. 1 Electrical installation in the burned room

By review of the first and second electric box, it was found that there was a complete thermal destruction of all combustible parts of the wire insulation and others, and protective elements that were in the boxes are dropped and are located in the fire debris. By examining the fuses were found in the fire debris that they were thermal completely destroyed so it is not possible to determine the technical characteristics and condition of protective elements.

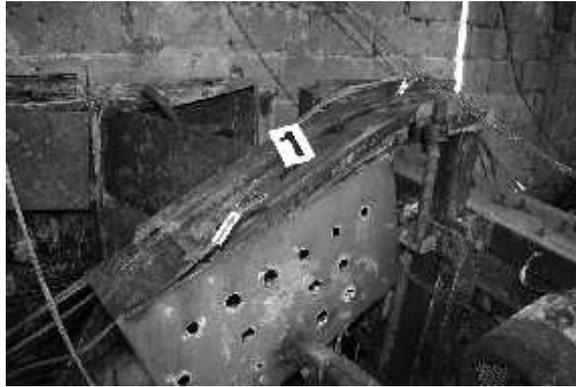
The review of second electric box, it was found that in one of the cables exiting through the top of the metal enclosure are traces of break and melting of copper wires, on the part of the cable which is located on the machine after the cable fell off the wall together with metal channel, see Fig. 2.

Fig. 2 Cable with traces of thermal damage and break

- A review of electrical installation in the packing room can be found on the four-wire cable, which was located in the channel on the wall of the room, characteristic traces of break and melting on a single copper wire.

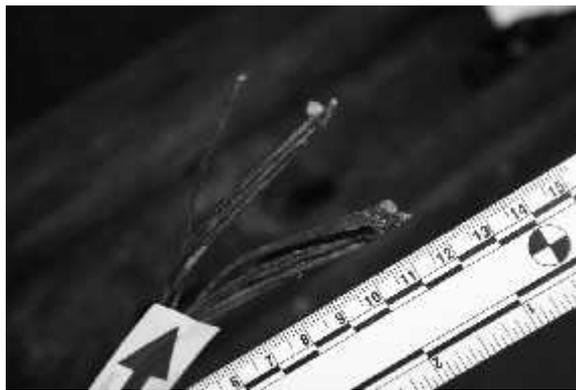
By review of the cable it was found that it is a four-wire cable that is thermally damaged in the form of complete burning insulation of cables and wires, and in one place there are traces of break and melting in one of the cable conductor. Detailed examination the place of a break on wires, there are the traces of melting in the form of balls, see Fig. 3.

Fig. 3 Traces of melting wires at the place of break

- A review of material of expertise, it was found that in a wire break place are traces of melting wire in the form of balls, which indicating that there was a short circuit which could ignite the first insulation of conductor, and then a wooden structure of the roof of the facility which is located above the channel in which laid the cable installation.

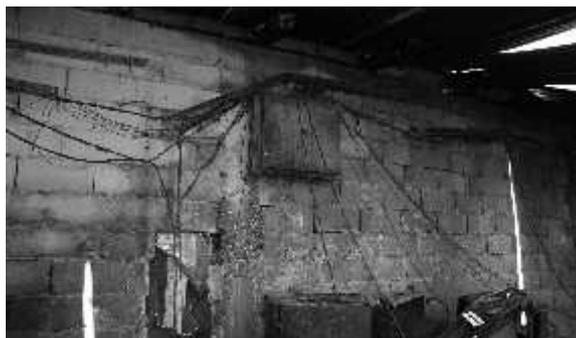
By examining the electrical installation on the wall above the distribution cabinets, it was found that electric cables were placed in metal channels that were located on the wall above the distribution cabinets near the ceiling of the room, see Fig. 4.

Fig. 4 Metal channels with cables

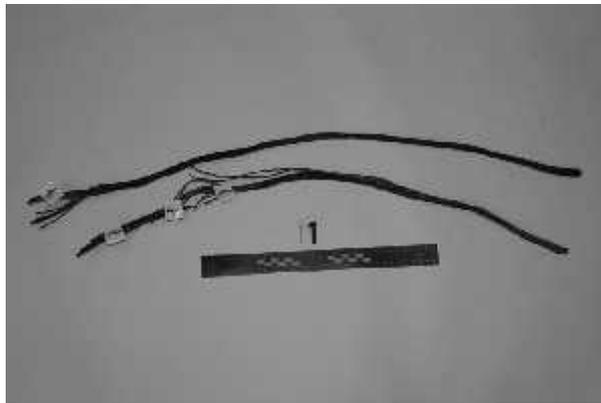
- Examination materials of expertise were found to be delivered two pieces of copper conductors multi-wire cross-section, who are cut off at one end. Cooper conductors are thermally damaged in the form of complete combustion of insulation, see Fig. 5.

Fig. 5 Material of expertise

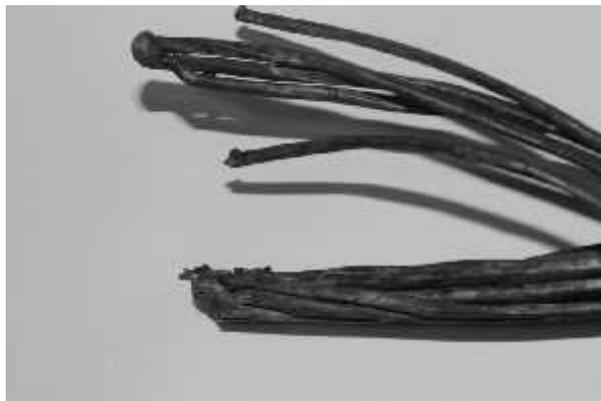
- Delivered one piece of copper conductor of 14 profile copper wires. At the end of the copper wires are traces of interruption, melting and mutual welding between the individual wires in the form of balls, see Fig. 6.

Fig. 6 Traces of the primary short circuit at the end of the conductor

Short circuit, which has led to the fire, was created due to the damage of the insulation of conductor, which might be due to mechanical damage during the assembly, ageing and the breakdown of the insulation, the overload or the other.

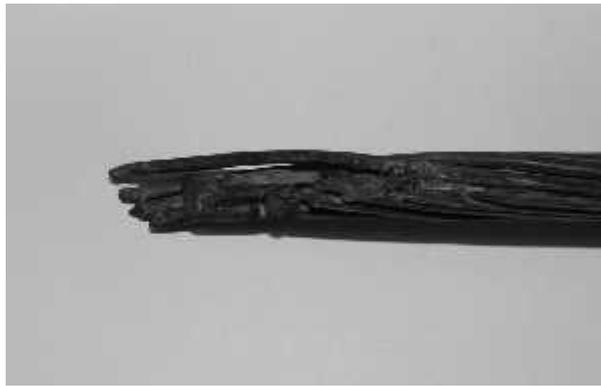
- Delivered is another piece of cooper conductor consisting of 14 profile cooper wires. At the end of the copper wire are traces of interruption, melting and mutual melting between the individual wires, see Fig. 7.

Fig. 7 Traces of the secondary short circuit at the end of the wire

- Traces of melting on the other parts of the conductor are the result of secondary short-circuit, resulting in the electrical installation as a result of the previously created fire.

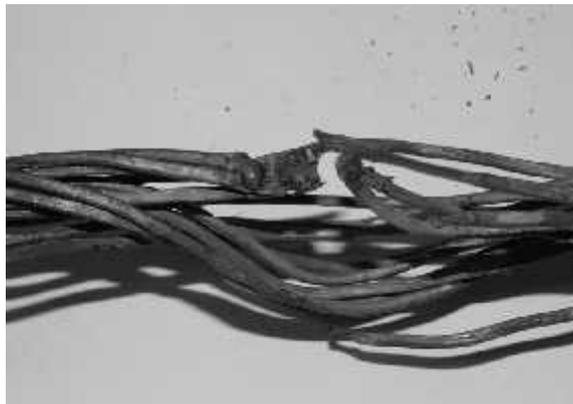
- Similar traces of interruption and melting are located in several places of the wire, see Fig. 8.

Fig. 8 Traces of the secondary short circuit at the part of the wire
