## EVALUATION OF THE FIRE SEPARATING WALL AFTER THE FIRE

### Technical assessment of the loadbearing masonry wall exposed to high temperatures

Paweł A. Król <sup>a</sup>

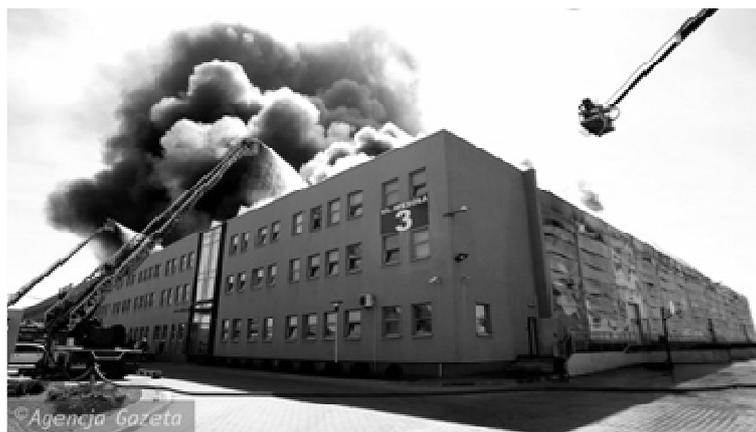
Fig. 1 View of the complex during the firefighting (internet source); in the foreground the administrative-office part of the building is seen

The building was divided on its length by four expansion joints, spaced about 30 m. The aforementioned warehouse burned down in a fire, which broke out in the building on May 10, 2011, (Fig. 1). The rescue action lasted uninterrupted for more than two days. Due to the presence of fire separation wall located between two parts of the building and smoothly conducted firefighting, flames did not spread to an office premises, but the construction of the wall - in a result of the simultaneous action of high temperatures and coolant - suffered quite extensive damage, which decreased the strength parameters and its ability to carry loads.

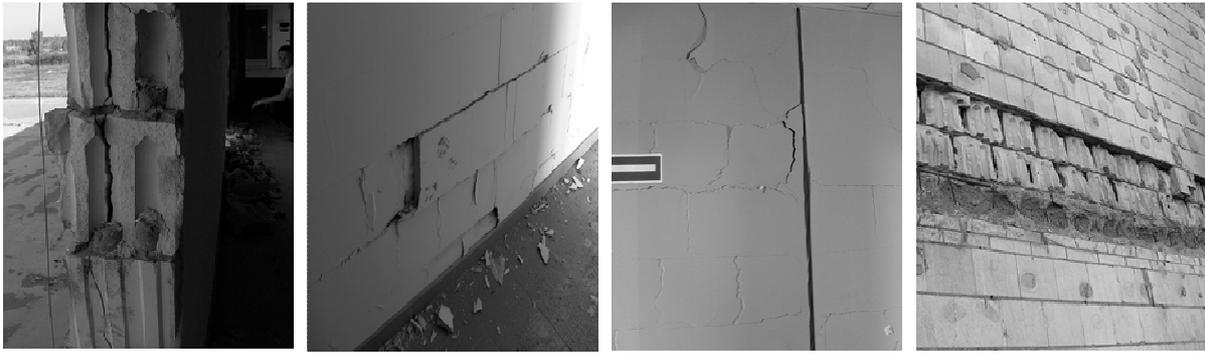
On a large wall area it has been observed a violation of its structure through the crack spreading along the designated location of hollow channels in the silicate blocks, (Fig. 3). Some parts of the wall have suffered mechanical damage, most likely as a result of being hit by the falling roof structure elements. Relatively large lateral displacements of individual silicate blocks observed on site reinforced this assessment, (Fig. 3).

Quite similar picture of damage, but occurring in the middle of the floor, could be seen on the fragments of the wall, located near the middle of the distance between expansion joints. Here, however, the deformation of the wall was more uniform in nature and tended to indicate wall buckling out of its plane – rather than other reasons - as a result of inability to compensate for the thermal elongation strains due to too long distance between the expansion joints. Deformation of the wall that was measured on the height of a single story reached about 20 mm whilst the standard deviation limits allowed for thick walls (> 24 cm) should not exceed 6 mm. The deformations that occurred as a result of thermal effects were so significant that existing compensation joints were not able to compensate for them, leading to pressing interaction between the two wall portions, located on opposite sides of the joint. To be more strict, with temperature increase of 400°C, the wall 30 m long and made of silicate blocks is able to increase its length of about 12 cm, which confirms the observations made on site, during inspection, (Fig. 3).

In addition, as a result of high temperature exposure of the floor ring beams, there was a concrete spalling observed, not only within the concrete cover, but also in the deeper layers. Due to the explosive nature of the phenomenon of spalling, on certain passages also some silicate wall blocks were significantly damaged, especially those ones located in the immediate vicinity of the ring beam. In many places, the wall material losses reach about 50% of the wall thickness, (Fig. 3). There could be also found some wall sections in which, for various reasons, the wall thickness defects reached even 75-80% of its original thickness. Not only spalling itself but also the concrete color change indicated during the inspection proved the change of the internal structure and mechanical properties of concrete paste. Some secondary damage within the wall material was caused by the firefighting itself, causing dampness of walls, destruction of internal gypsum plasters, lime efflorescence and mold beginnings.

Fig. 3 Examples of the structural damage to the wall

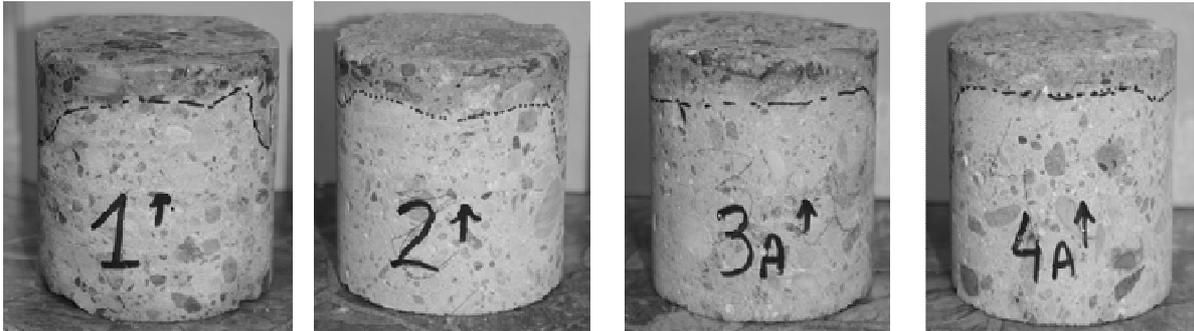
Fig. 4 Discoloration depth corresponding to the depth of destruction of the drilled concrete cores

As can be seen from the above given analyzes the concrete surface layer has been destroyed in a result of high temperatures exposure and sudden cooling down, and its strength was significantly reduced by 3 classes.

Since, during sampling, some clear discolorations of subsurface of cores were observed and in addition to strength testing also some detailed visual analysis of the four samples were carried out, (Fig. 4). It was supposed that the visible discoloration was the most likely caused by the damage of concrete internal structure. To accurately determine the depth of discoloration, samples were evenly moistened, and then after 3 minutes the destruction range was marked with the marker. Discoloration depth corresponding to the depth of destruction reached from 1.5 up to 5 cm. After the cores destruction an additional test of concrete carbonation depth of breakthroughs were done. The depth of carbonation ranged from 1.5 to 2.5 cm. In addition, it was found that the extent of carbonation range in sample No. 1 has already reached more than a size of concrete cover of stirrups, which may cause rapid corrosion of reinforcing steel, deprived of protective covering layer, (Fig. 5).

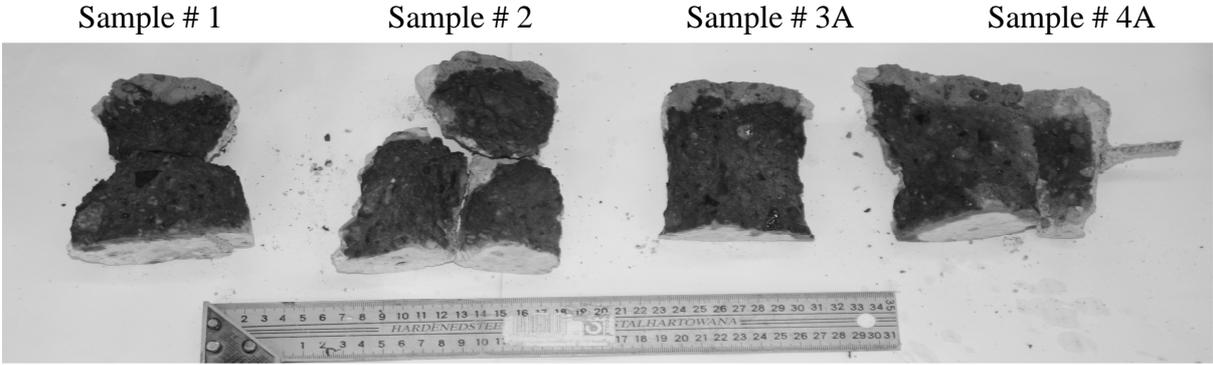
Fig. 5 Depth of carbonation in drilled core breakthroughs
