DAMAGE ASSESSMENT OF CONSTRUCTION COMPONENTS OF THE JAKARTA SION CHURCH BUILDING

ABSTRACT

Damage assessment, Building maintenance and ability, Jakarta Sion Church building

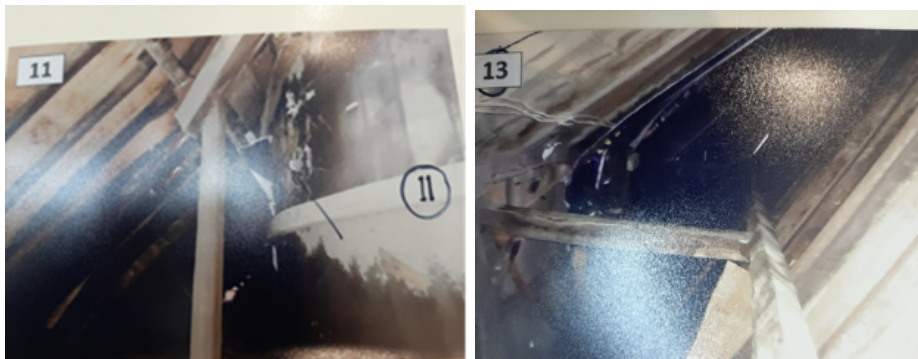
Fig. 2 - Damage to the roof frame of the Jakarta Sion Church.

The roof covering of the Sion Church building is in the form of a trapezoid (shield), while the roof of the conservatory building (church court) is rectangular. The roof frame covering the Sion Church is made of clay tile, as shown in Figure 1. This clay tile was only used in the 20th century, so tile was only used when the Sion Church was restored in 1978. The roof supporting pillars of the Sion Church looks big and sturdy. Overall, the condition of the roof of the Sion Church building is in the medium damaged category. It can be seen from the shifting of the roof tiles because the roof truss has also begun to break down and there is weathering, causing leaks in the prayer room (church pulpit). The damage is caused by natural factors (weather and climate) and biological damage.

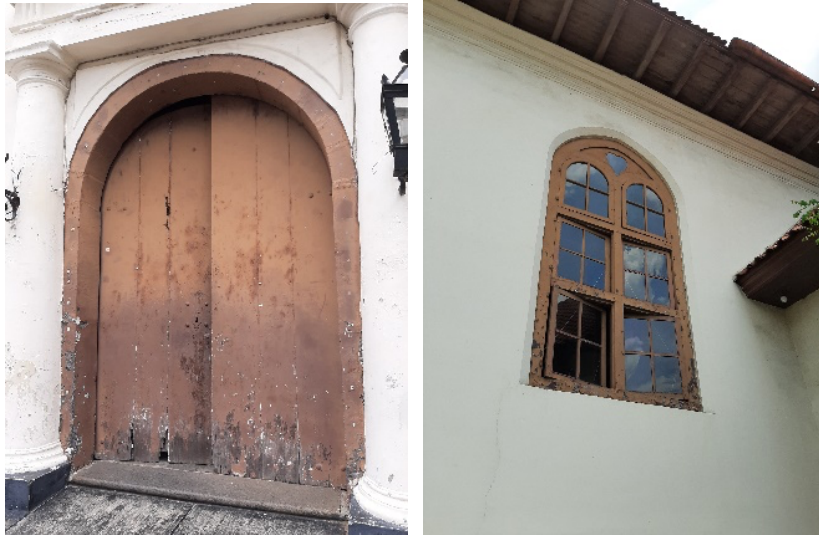
The wooden door's paint is faded, like the paint color on the windows and walls (visible from the outside). The bottom ends of the doors and windows were torn off. It is not definite that the door and window materials of this Sion Church are made of certain types of wood. Perhaps because it was restored in 1920 and 1978, material that was used was possibly traded wood, for example, camphor wood. In general, the conditions of damage to the doors and windows of the Sion Church are categorized as severely damaged. This damage occurred because the doors and windows in the Sion Church were without a canopy or gurgling to shelter rainwater

Fig. 3 - Door and window of the Jakarta Sion Church

and sunshine. It indicates that the doors and windows of the Sion Church should be replaced with better wood materials and make a canopy to protect them from rain and sunshine.

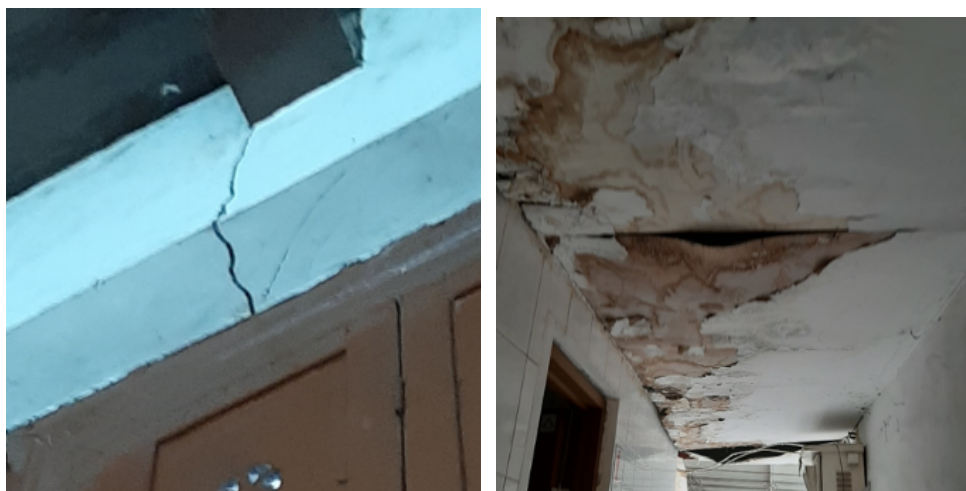
Fig. 4 - Cracked wall pairs (left) and damaged ceiling (right).

but there is a distance between a wall and a door/window, indicating a settlement in the foundation. The decrease in the foundation was caused by land subsidence [18]. From the lowering of the wall, the damage to the Sion Church foundation categorizes as medium damage. Wall pairs in the Sion Church were found to be quite cracked. It is due to the condition of the foundation subsidence that occurs during the life of the building. The cracks that occur significantly affect the condition of the building. From the examination results on the wall pairs, the damage condition has reached the medium damaged category.

The ceiling material for this building is made of white plasterboard and supported by six dark brown teak wood poles. Meanwhile, many damaged ceilings were found. The damage occurred due to the ceiling damp condition due to rainwater seepage on the roof. Damage to the ceiling is included in the medium damage category. The interior walls are still visible in their original state, in shape, material, and size. The maintenance carried out was inadequate, so the quality of walls in the Sion Church building looked quite apprehensive. Damage conditions to the inner walls and upholstery are in the heavy category. The Sion Church stairs condition is quite alarming, as well as the staircase railing. Stairway and stair railings at Sion Church are made of good quality wood. However, with long service life, weathering has occurred, mainly due to biological factors (termites). The condition of the damage to the stairs and railings is in the medium damaged category. The building facilities referred to in this case are a consistory building and a church bell. The condition of the Sion Church's consistory building is in the category of moderate damage. The church bell is currently on the wooden tower beside the church's north entrance. The condition of the damage to the Sion Church bell is included in the medium damaged category.

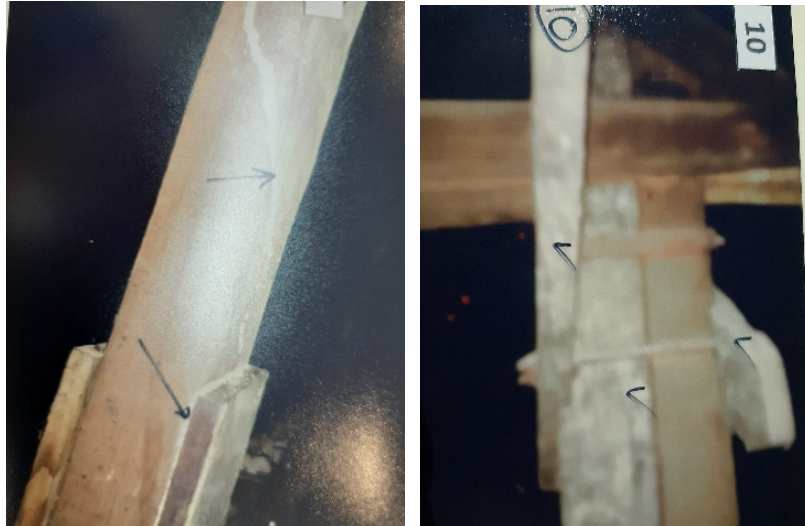
Fig. 5 - Condition of roof truss of the Jakarta Sion Church

In the structural frame system, there has been damage (weathering) to the roof truss. To maintain the roof frame of the Sion Church, people make wooden supports to hold the weight of the roof. Seeing the condition of the roof truss, of course, it needs immediate repairs, but until now, no repair work has been carried out. Meanwhile, with the occurrence of land subsidence, it is easier for rainwater to penetrate the slot surface of the building, which results in a decrease in the condition of the column (cracks). The damage that occurred in the framework system of the Sion Church structure was included in the medium damage category. Overstek in this building seems to have started to rot and dirty, caused by weather and biological factors. Besides, the roof cover (tile) can be seen without wooden battens on the overstek and only

visible wooden rafters. In this case, it is necessary to replace rotten rafters in the overstock to support the load of the roof tiles above. The condition of the supporting components of the Sion Church building is in the category of heavy damage and is in dire need of immediate repair.
