STABILITY DETERIORATION OF CLIFF FACES DUE TO HISTORICAL MINING IN THE ELBE SANDSTONES PROTECTED AREA

Zuzana Vařilová¹, Kamil Podroužek², Natálie Belisová¹ and Jan Horák²

ABSTRACT

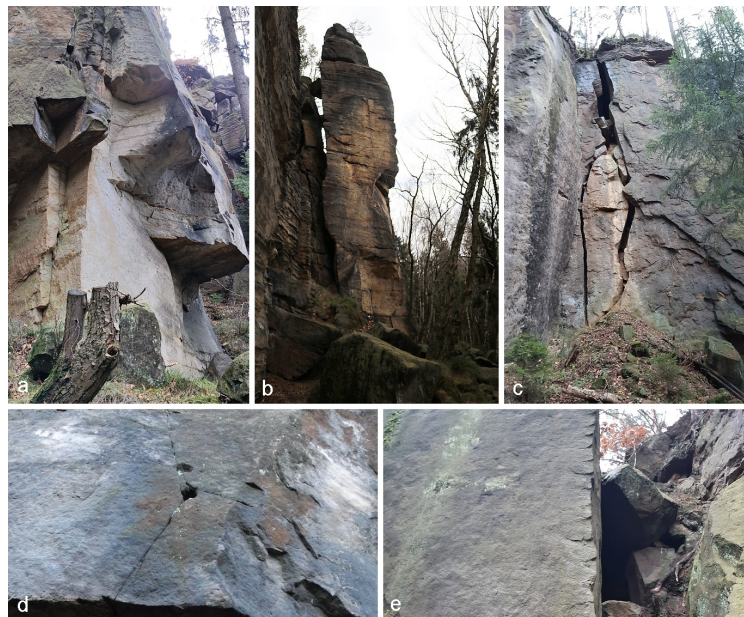
undercuts, many tons in weight. Unfinished undercuts have the form of overhangs with flat ceilings and even floors. These unfinished undercuts pose the main hazard of spontaneous rockfall in the future (Figure 2), together with unreclaimed breakups of fracture zones and free-lying fallen boulders on the slope [4]. The extent of this technique of building-stone extraction is exceptional. Its biggest boom dates to the 18–19th century. It was applied especially to the right-bank slopes of the Elbe River canyon from the mouth of the Suchá Kamenice River to the south across Belvedér and Podskalí as far as to Loubí. It was also practiced in the adjacent part of the valley of the Suchá Kamenice River, the channel of which is buried beneath incompletely worked boulders in its lower reach. This mining method can be equally identified in the valleys of the Olešnička and Kamenice rivers, and was widely used also on the Saxonian side of the Elbe River canyon [5].

Fig. 1 - Methods of sandstone mining inducing instabilities in rock massifs (examples from the Suchá Kamenice River valley and the adjacent part of the Elbe River canyon: a) a shelf quarry in the valley of the Suchá Kamenice River with well visible traces after quarry-face mining using the technique of undercutting, b) Zlomiskova věž Pillar, produced by extraction of joints and surrounding sandstone blocks, primed for induced fall to the Elbe River canyon by undercutting its base, c) a crevice (dilated tensional joint) formed by unloading of the massif by mining in the Comiteebruch Quarry, d) borings for loading explosive cartridges, e) bags after the insertion of splitters (photo by K. Podroužek)

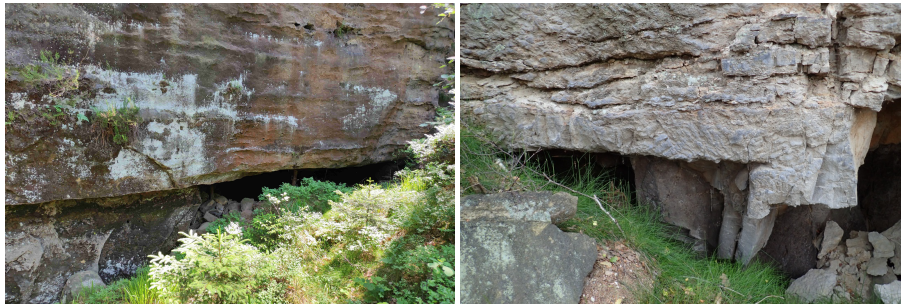
Fig. 2 - Unfinished mining using the undercutting technique in the Elbe River canyon: left) in the area of the Comiteebruch Quarry, preserved as a deep “overhang” 7×3 m in size; right: unstable rock wall in the whetstone quarry near Podskalí (photo by Z. Vařilová)

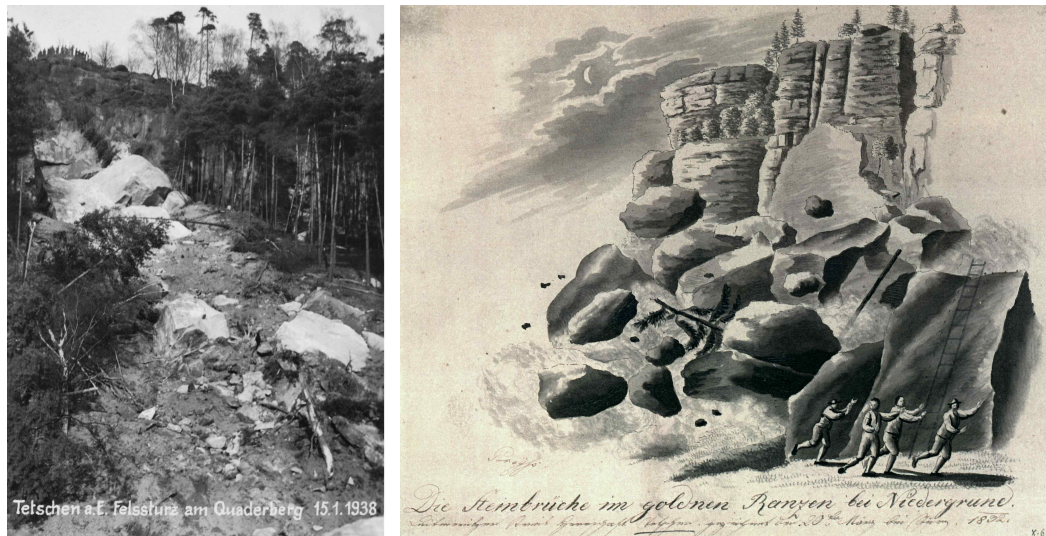
For example, repeated rockfalls were encountered at **Kvádberk Hill** (cadastre of Děčín) at the site of former sandstone quarrying above the municipal pasture of “Kühweg” (Viehweide) in years 1835, 1893 and 1931. Another catastrophic event at the same site was the big rockfall of 1938 (Figure 3) which induced damage to the local water-supply tank and a part of the forest and city park [7, 8]. This event was induced not only by stability degradation due to a giant artificial incision in the rock massif contributed by unfavourable weather conditions but also, most importantly, by the improper location of the quarry at the intersection of two tectonic fractures. Based on an expert opinion from 1960s [9], safety measures were proposed for separate parts of the hill and selected unstable objects. The above-mentioned shelf quarry was evaluated as the highest-risk portion by these reports. Based on an updated stability study (2003), extensive remediation measures were realized in the area of this quarry face degraded by fracturing and shearing to avert the threat of a rockfall thousands of m³ in volume (removal of high-risk blocks, fixing of blocks by basal walls, rod rock bolting, filling of joints by gunite, construction of a retaining wall). Remediation of another rock pillar in the former quarry took place in 2013. The area of the old quarry continues to pose, despite all realized technical measures, potential risk of fall of stones and smaller loose parts of the rock massif.

Fig. 3 - Left: A historical photograph of rockfall in a quarry at Kvádrberk Hill in 1938 (archive of P. Joza); Right: A wash drawing by J. Preyss, the parish priest of Hřensko, showing the rockfall of March 20, 1832 in the Goldenen Ranzen Quarry (near the Suchá Kamenice River); then, blocks at the foot of the slope were quarried by wedging, and a spontaneous fall of the quarry face occurred in the upper part of the slope (collections of the Municipal Museum of Ústí nad Labem)

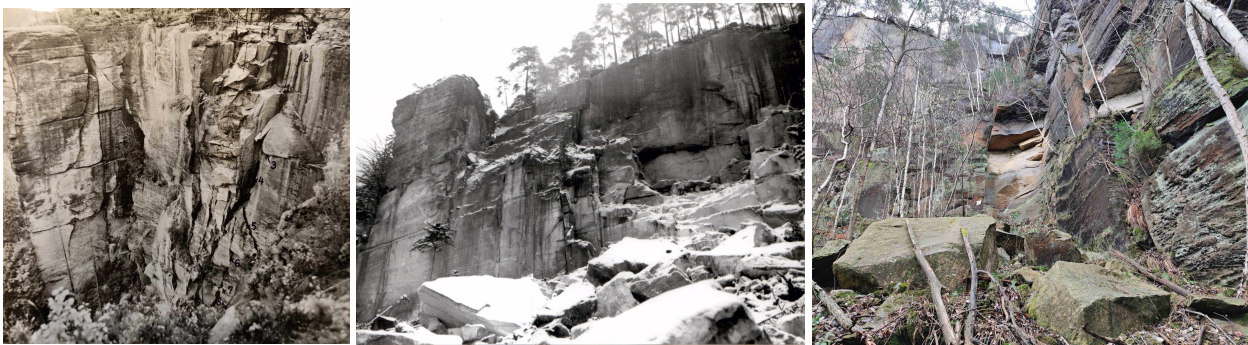
Possibly the best example to demonstrate this type of hazard is the serial rock exposure over 300 m long south of the confluence of the Suchá Kamenice and Elbe rivers. It represents **the area of several quarry faces** known as **Goldene Ranzen (Elbleiten)**. Rock extraction was started in the 18th century here, and the building stone was used, e.g., for the construction of the fort of Terezín or for buildings in the near town of Děčín. The rocky slope is strongly weakened down to considerable depths and, moreover, affected by old quarrying. The intense, deep-reaching disintegration of rock massif is also evidenced by the presence of extensive systems of crevice caves. The area is therefore subject to long-term monitoring by engineering geologists. Repeated rockfall events were encountered here at the time of the quarry operation and thereafter – e.g., in 1832 (Figure 3), 1862, 1864, 1882, 1962 and 1980. One of the last big rockfalls, 1 360 m³ in volume, in January 1984 (Figure 4) was successfully predicted based on block-movement monitoring, and the affected road could be closed in time [10]. Remediation of a part of the quarry face pillar was made to avert threat to road traffic again in 1986. Two years later, a prelude to another catastrophic rockfall was accelerated by controlled downing of a part of the face. Another emergency remediation (quarries Goldene Ranzen_1 and 2) was realized based on data from revision monitoring in 1999. In a part of the area (“P31” corresponding to quarry Goldene Ranzen_3), technically demanding security measures were adopted for several rock massifs (volume about 3 000 m³) threatening to fall onto the road in 2007 [11]. Detachment and fall of a fractured portion of the rock massif directly from the face of the former quarry Goldene Ranzen_2 occurred in the neighbourhood of the remediated area in autumn 2010; this event was induced by the degradation of the rock massif by mining, intensive fracturing and saturation with precipitation (Figure 4). Processes like joint dilation, rock deformation and tensional joint formation, loosening and removal of blocks or rock plates continue to the present. The broader area of these old quarry faces still belongs to the most hazardous portions of the Elbe River canyon.

Fig. 4 - Left: A face of the Goldene Ranzen_1 Quarry near the mouth of the Suchá Kamenice River to the Elbe River (a historical photograph from the 1980s during remedial work); Middle/Right: A catastrophic rockfall of 1984 and a smaller-volume rockfall of 2010 at the site of an old quarry face in the Goldene Ranzen_2 mining area (photo from [12] and by Z. Vařilová 2022)

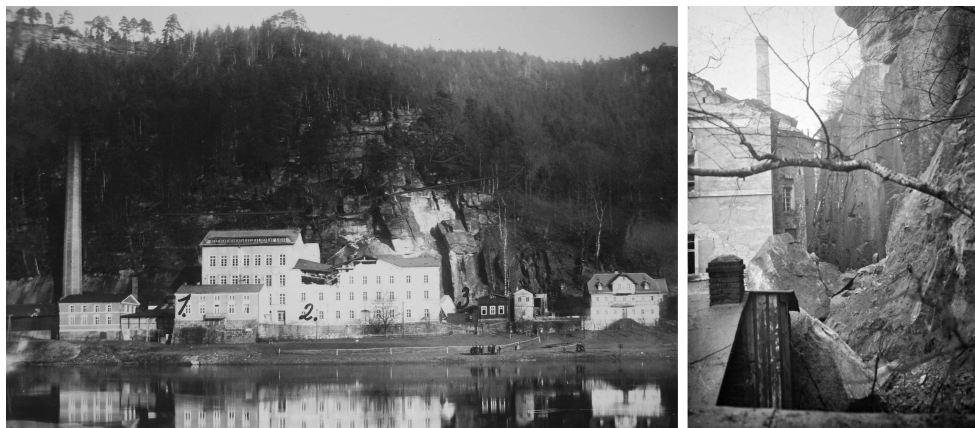
Fig. 5 - Zwirnfabrik Eiselt (Duty free shop) site – photographic documentation is available for the rockfall event of 1938, when sandstone mass from an old quarry face 400 m³ in volume induced damage to the adjacent building [14]

Another exemplary site is the cliff face behind the **Duty-free shop** building – the original spinning mill of Zwirnfabrik Eiselt at Hřensko. It experienced repeated catastrophic rockfalls in 1886, 1938 (Figure 5) and 1944. New threat, identified in years 2002/2003, called for technically demanding security measures. Repeated rockfall events and extensive remediation works preclude any precise determination of the original shape and size of the quarry face.

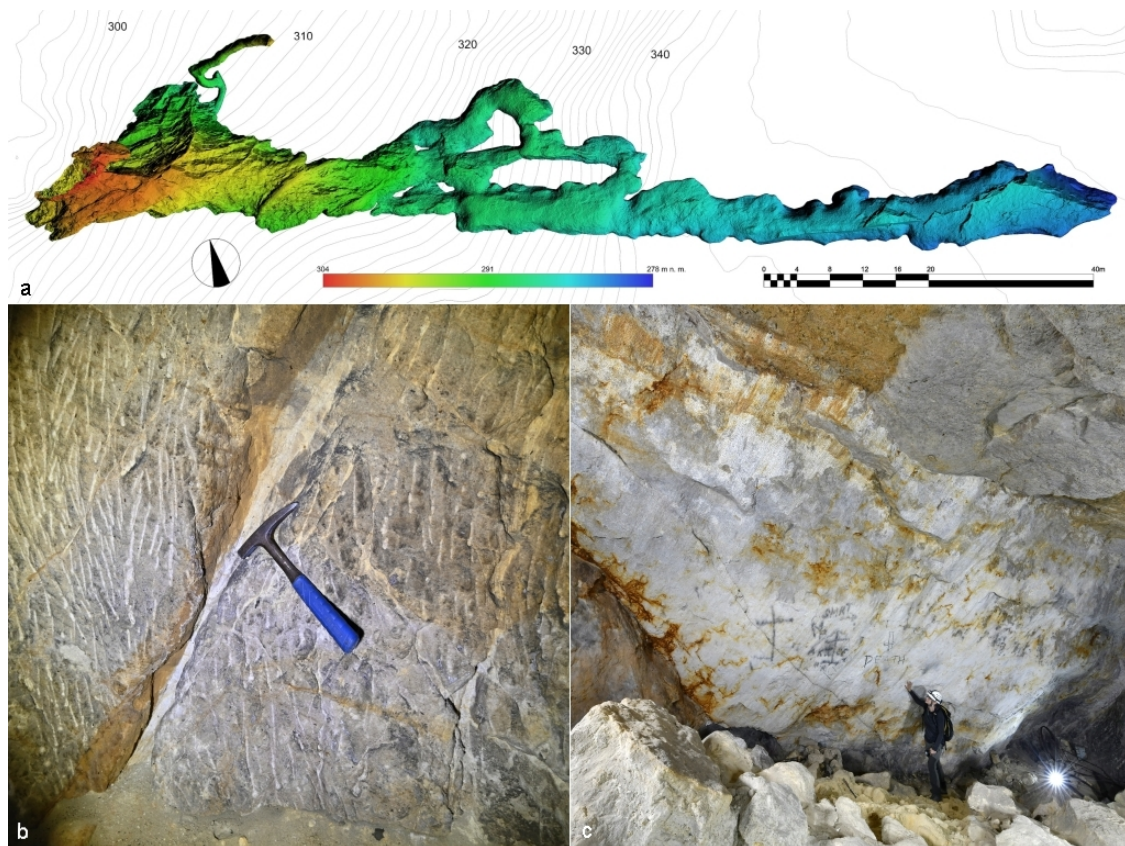
Fig. 6 a) - Hypsometric analysis of surfaces of excavated underground spaces at Ludvíkovice, b) a minor shear fault in a side of the adit, c) an exposed striated shear plane now forming the wall of the terminal dome at the site of repeated ceiling collapses and deadly rockfalls (photo by Z.Vařilová and J. Preclík)

Underground sand pits exploiting friable sandstone represent a specific type of mining objects. One of the largest excavated objects in the area of interest is the Labyrinth or **Sandloch** site (cadastre of Ludvíkovice, Figure 6). This Labyrinth was originally promoted as a point of interest in tourist guidebooks in the second half of the 19th century. After a fatal injury by fallen rock mass during sand extraction in 1914, mining operations were stopped and the entrance to the adit was closed [17, 18]. The entrance to the underground sand pit lies at the foot of a hill in an immediate proximity of the developed area of Ludvíkovice. The overall length of all documented underground spaces is 132 m, maximum height is 6.5 m (height of artificially carved corridor max. 5.5 m). The present size is markedly affected by repeated falls of the ceiling and parts of walls even at recent times (traces of fresh fallout). The extracted material was low-strength quartzose sandstone, showing dips of strata of max. 20° and intensive fracturing. Shear faults and their intersections, fractures and prominent lithological boundaries functioned as detachment surfaces of rockfalls. Fresh-looking detachment surfaces in the entrance dome and the terminal dome confirm the presence of imminent risk. A potential threat of subsidence of a part of the undermined slope cannot be excluded.

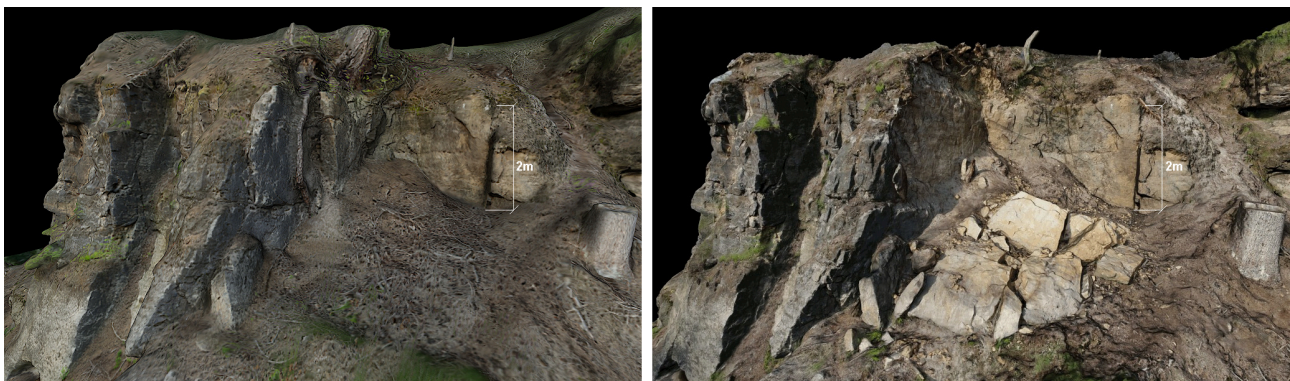
Besides rockfalls documented by archival data, several new events from the break of 2021/2022 were identified (e.g. Figure 7, 11). These mass movements were induced by a combination of factors: intensive fracturing of the rock massif and artificial overhangs, saturation with precipitation water or meltwater, often facilitated by uprooting and wedging of the root system of adult trees on top edges of quarry faces. The problem of stability of old quarry faces is, however, not restricted only to the selected sections of the right slopes of the Elbe River canyon between Děčín and the state border. The present survey and documentation of old quarries identified hitherto unknown sites of potential hazard, where old quarry faces or their parts are endangered by rockfall (Suchá Kamenice River valley, Rabštejnské údolí Valley, close to the network of tourist trails leading to the Dolský Mill, above buildings and roads at Děčín-Podmokly and Dolní Oldřichov, Martiněves, Růžová, Ludvíkovice and Janská areas, Pekelský důl Valley and other sites). In only a few cases, however, potential rockfalls pose a threat to inhabited and man-frequented areas.

Fig. 7 - A collapse of a part of a cliff face, 2.6 m³ in volume, caused by a tree uprooting at the model site of Bruckgraben (Vysoká Lípa cadastral area) – a comparison with the use of a photogrammetric quarry model (June 2021 and March 2022)

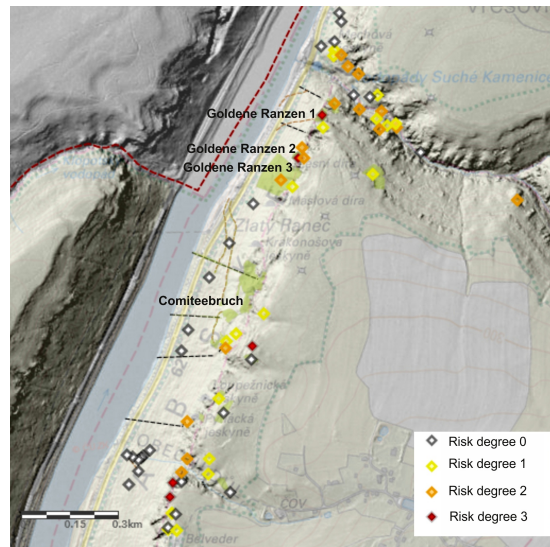
Fig. 10 - The Suchá Kamenice River valley and a part of the right bank of the Elbe River canyon with marked positions of surveyed quarries with inferred rockfall risk degrees (the green polygons correspond to the Goldene Ranzen_1–3 and Comiteebruch mining areas); based on the DEM of Bohemian Switzerland [29]

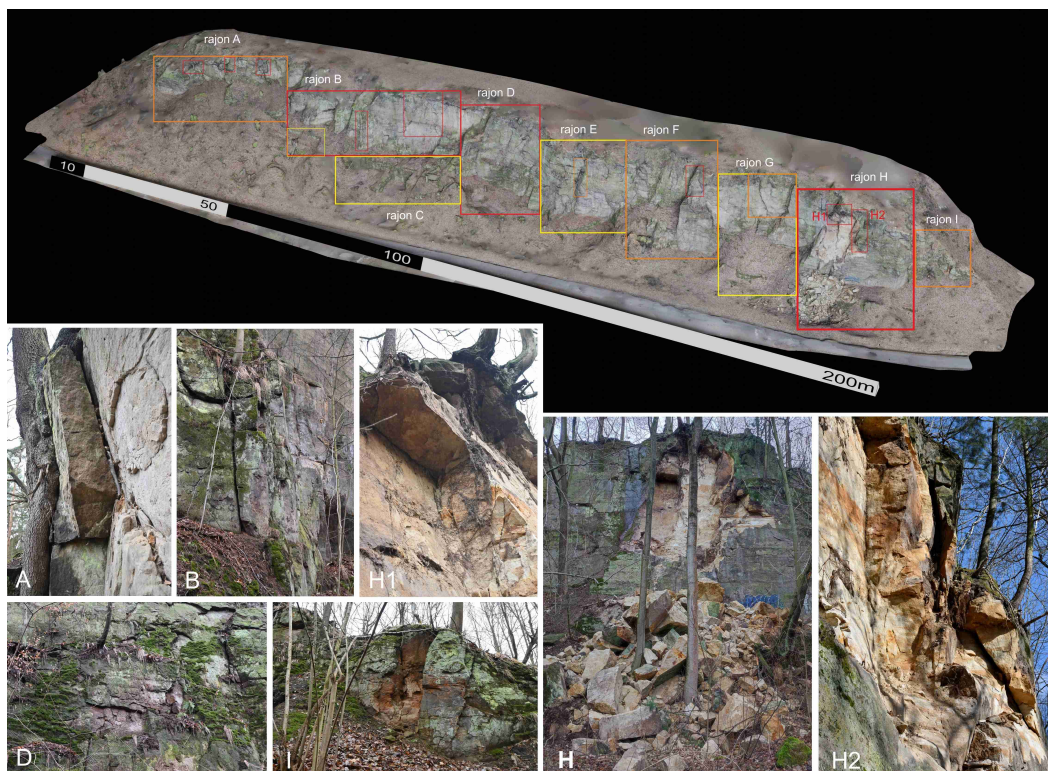
Fig. 11 - Model locality – a quarry face in Rabštejnské údolí Valley divided into individual parts according to the determined degree of risk, and examples of unstable parts of the cliff face (old parts of rock wall A, B, D, I and fresh risk zones H1, H2 corresponding to the shear surface of the rockfall); a rockfall 78 m³ in volume occurred here in February 2022 (H) (cadastral area of Dolní Kamenice, photo by Z.Vařilová)

High-risk areas and sites should be given more attention by the users/managers of the potentially affected land. The main recommendations include: Awareness of land owners, authorities, forest managers, nature protection authorities; continuous monitoring of the state of high-risk sites (3–5 years); elimination of mature trees from quarry faces and their upper edges; proper marking of risk and safeguarding the entrances to dangerous quarries /underground spaces. Recommendations in the case of endangering buildings, roads/railways, and frequented tourist routes: detailed engineering-geological survey of selected quarry sites; securing the slopes under the quarry faces (impact beds, terraces, retaining walls and fences); control monitoring of the faces of abandoned quarries (e.g. [38]); remediation of immediately dangerous parts of the rock massif; revitalization and repair of original structures (buildings, retaining walls, roads, skids, etc.); taking into consideration old mining remains in the management of forestry interventions.
