# EXPERIMENTAL RESEARCH INTO THE RESPONSE OF HISTORICAL STRUCTURE TO THE EFFECTS OF NATURAL SEISMICITY

## LUBY RECTORY

## **ANALYSIS OF FAILURES IDENTIFIED DURING A PRELIMINARY VISUAL BUILDING TECHNICAL SURVEY**

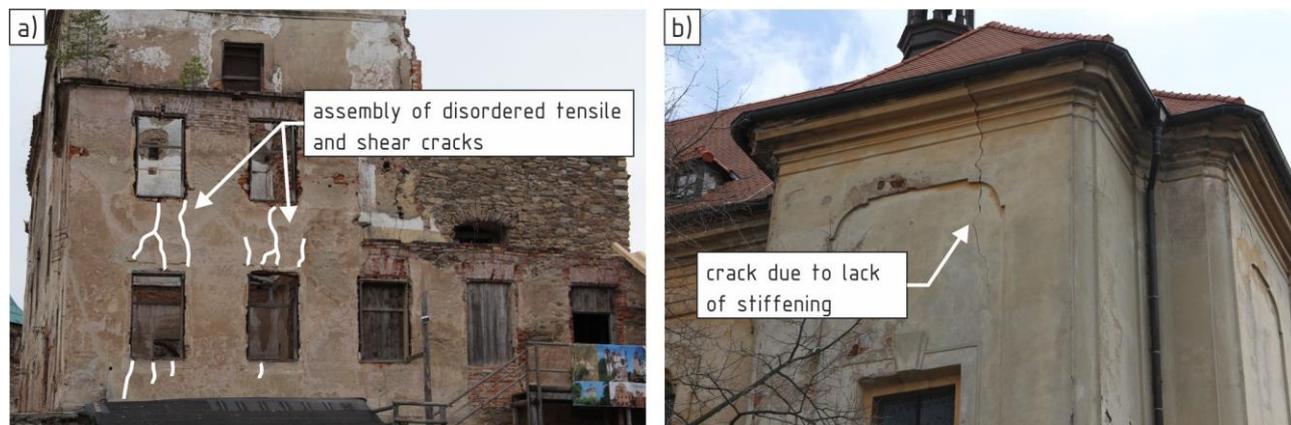
Fig. 1 - Illustration of damage to historic buildings in seismically active regions – a) Hartenberg Castle, Josefov (end of 12th and beginning of 13th century.), b) St. Anna's Church, Karlovy Vary – Sedlec (18th century)

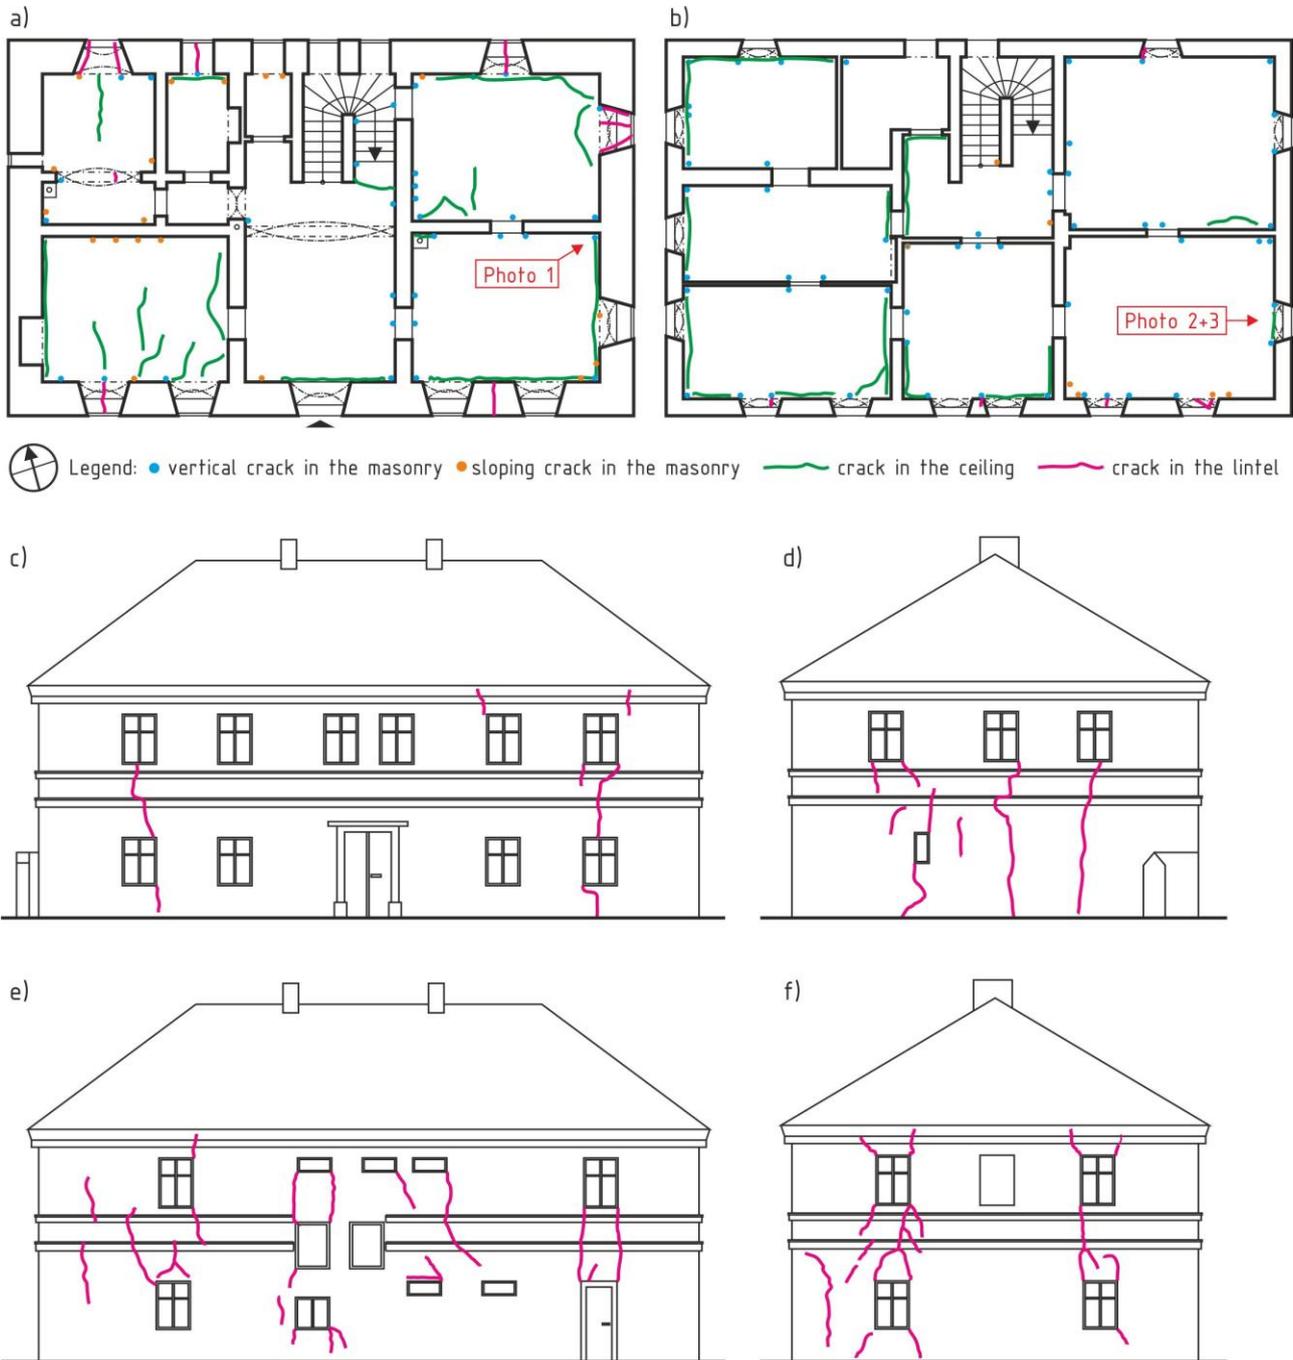
The damage to the rectory building in the form of cracks is evident both on the facade and on the internal load-bearing and dividing structures. There are tensile or, to a lesser extent, shear cracks. Looking at the facade cracks occur most often in the corners of openings. The cracks are found on both overground storeys, they have a slightly inclined shape and interconnect the superimposed window or door openings. A typical crack found in the facade begins on the eaves, continues to the window head on the 2<sup>nd</sup> overground storey, then passes across the window sill to the window head on the 1<sup>st</sup> overground storey, and from there it continues via the window sill of the 1<sup>st</sup> overground storey as far as the masonry footing. Some cracks branch into several other cracks. The crack width varies along the building's height. The narrowest cracks are above the foundations and gradually widen towards the roof. Cracks are found both in surface finishes and the masonry. Cracks occur with varying intensity on all facades, but the building has suffered most damage on the north and east facades (Figure 3).

At the entrance to the building on the 1<sup>st</sup> overground storey, there are prominent cracks in the right and left corners of the room separating the transverse load-bearing walls from the southern perimeter wall of the building. Cracks of a similar type are found in all connections of internal and perimeter vertical structures on the ground floor. The cracks in the corners of rooms are, in some parts, followed by a number of inclined cracks in the load-bearing walls. There are cracks in the vaulted heads of the openings extending into the ceilings of the floor structure where they often copy the connections of individual structural members of the soffit. The cracks on the 1<sup>st</sup> overground storey are most often found in the places of connections of structural members – e.g. the connection of the interior and perimeter walls, in the cavettos of the floor structure's connection to the load-bearing walls, mounting of the vaulted strip in the masonry, etc.

Fig. 3 - Schematic drawings of the rectory with marked failures and points where photographs were taken – a) plan of 1<sup>st</sup> overground storey, b) plan of 2<sup>nd</sup> overground storey, c) southern elevation, d) western elevation, e) northern elevation, f) eastern elevation

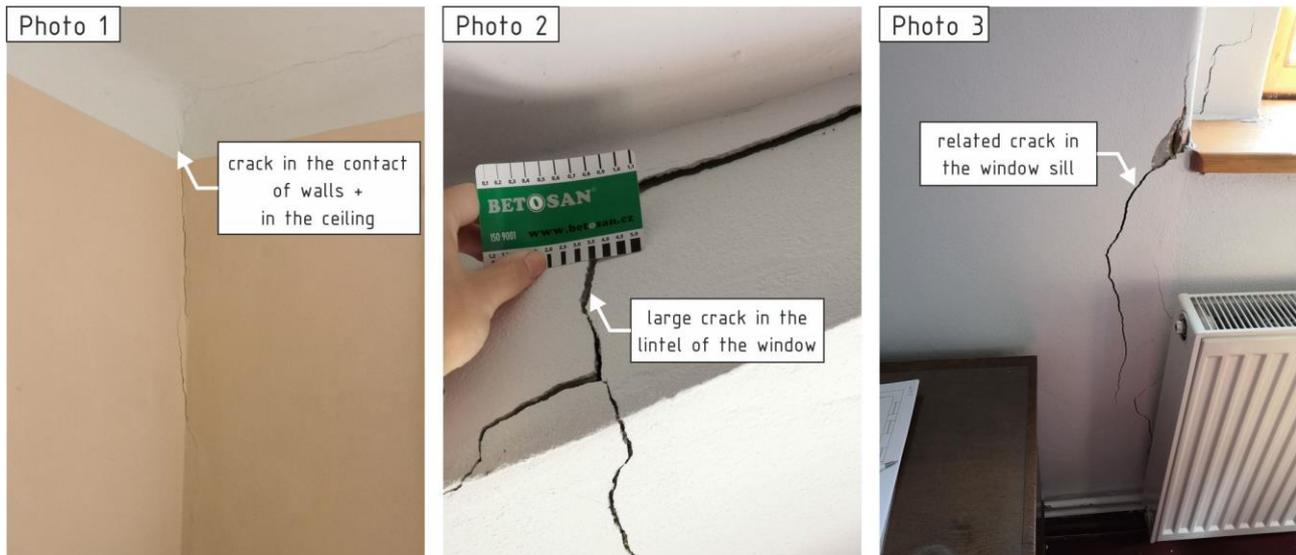
The type of cracks on the 2<sup>nd</sup> overground storey is similar to that on the 1<sup>st</sup> storey. The cracks most commonly occurring there are vertical or slightly inclined cracks in the corners of rooms, cracks in walls and partitions, in the vaulted heads of window and door openings and cracks between individual ceiling elements. On the 2<sup>nd</sup> overground storey, the rectory building is damaged by more prominent cracks than on the 1<sup>st</sup> storey. The most prominent - widest cracks are found in the eastern part of the building, where they are 2.5 to 4 mm wide in the perimeter wall. These cracks originate from a horizontal crack separating the floor structure from the perimeter wall, continue all the way to the window recess and then further on across the window sill. Due to

the type and location of these prominent cracks, it can be assumed that unless their further development is prevented, they may become the cause of a significant decrease in the structural capacity of the building as a whole in the future (Figure 4).

Fig. 4 - Illustration of damage to the building

Based on the analysis of the information and findings obtained during the evaluation of the preliminary building technical survey, we may assume that the cause of the occurrence and development of cracks are the effects caused by seismic loads.

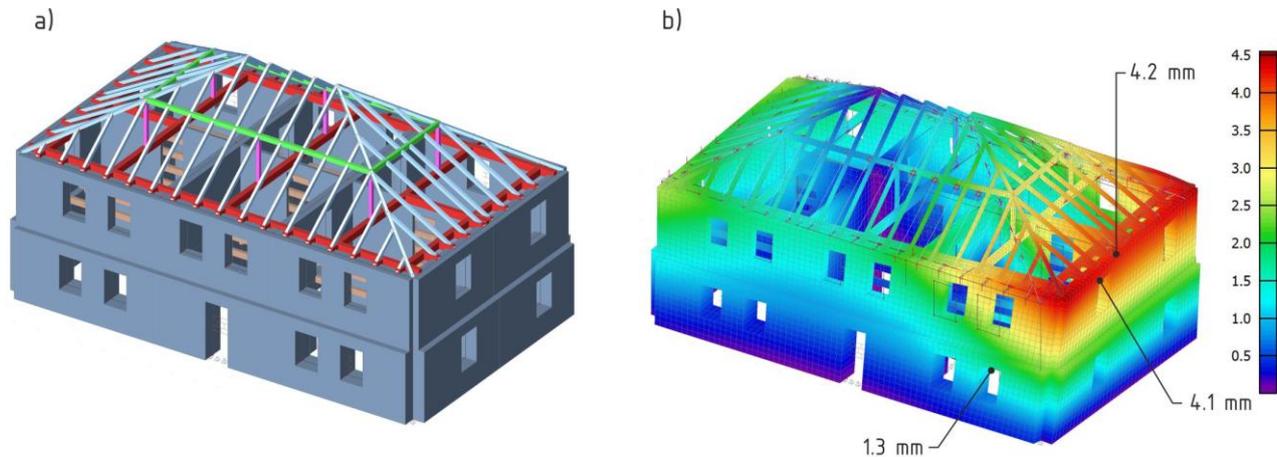
Figure 5 displays the computational model and the first mode shape of the structure. The first mode shape corresponds to the theoretically identified first natural frequency of 4.29 Hz. The largest theoretical deformations are located in the eastern gable and correspond to the most extensive damage found on the site. The calculated values of deformations in the places of failures exceed the deformation values for the formation of tensile cracks in the masonry.

Fig. 5 - a) computational model of the building, b) building's first mode shape

The first mode shape of the structure identified on the basis of numerical analysis and associated deformations confirm the assumption of seismic loading as a possible cause of failure of the masonry structure.

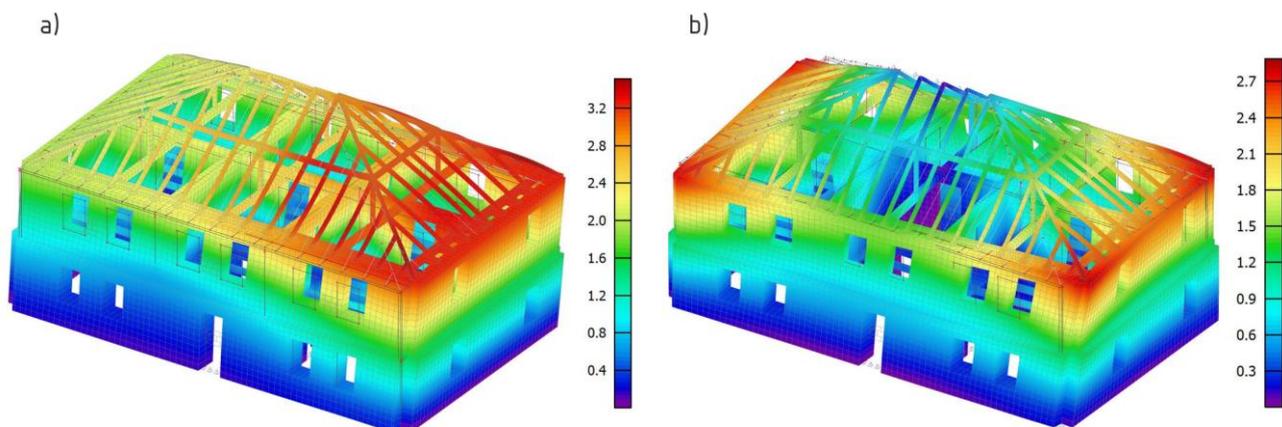
Fig. 9 - Building's first mode shapes: reinforcing of perimeter walls (a), reinforcing of perimeter and inner walls (b)

A numerical analysis of reinforcing (prestressing) of the building using lamellas based on carbon or aramid fibres is performed as a part of building's rehabilitation design. The reinforcing was introduced into the computational model of the building in two steps. In the first step, the reinforcing of perimeter walls at the level of the ceiling of the 1<sup>st</sup> and 2<sup>nd</sup> floors and reinforcing of the building's corners were modelled. Figure 9a shows the first mode shape of the building with reinforcement. The maximal values of deformation decreased to 70 % of the values of deformation of the building without prestressing (see Figure 5). The calculated first natural frequency increased to 5.12 Hz. In the second step, in addition to the reinforcing of perimeter walls, the reinforcing of inner walls was introduced. The character of the first mode shape has slightly changed and the largest values of calculated deformations also occur on the opposite side of the building (Figure 9b). The maximal value of deformation reaches approximately 60 % of the deformation of the building without prestressing and it decreased by 15 % in comparison with the value of deformation for reinforcing only of the perimeter walls. The theoretically determined first natural frequency of the building with reinforcing of perimeter and inner walls was 6.22 Hz. The numerical analysis confirmed the positive effect of prestressing on increasing the rigidity of the building.
