DEFECTS AND FAILURES OF JOINTS OF HISTORIC ROOF TRUSSES AND POSSIBILITIES OF USING FRP MATERIALS IN THEIR REHABILITATION AND STABILIZATION

Tomáš Čejka¹, Klára Kroftová², Markéta Šmidtová³ and Radek Zigler⁴

SURVEY OF SELECTED ROOF TRUSSES OF HISTORIC BUILDINGS

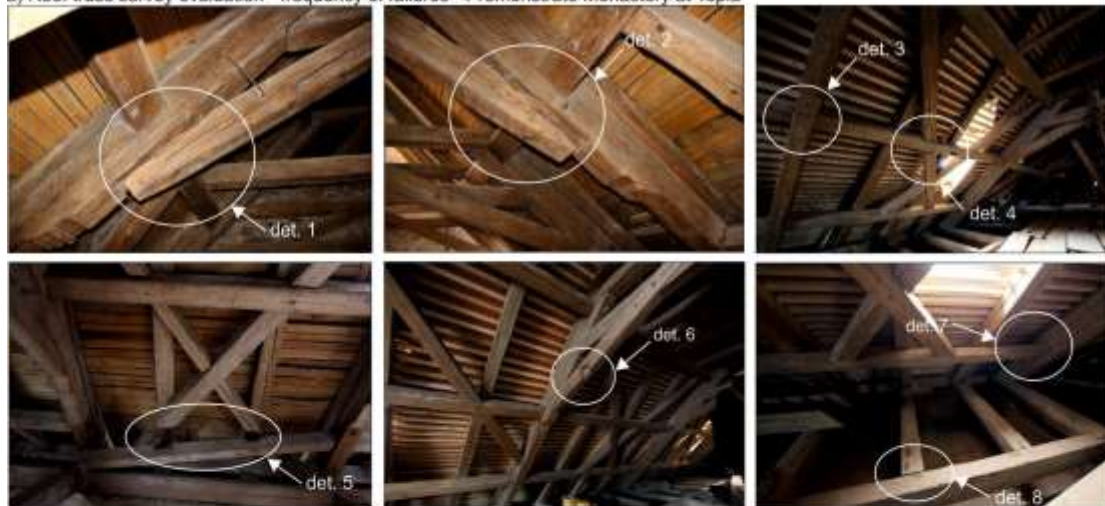
a) Roof truss survey evaluation - frequency of failures - Premonstrate Monastery at Teplá

The evaluation of the visual survey of roof trusses of selected historic buildings pointed out that the highest frequency of defects and failures have been found in the following carpentry joints: dado 36 – 60% of degraded joints, bird's mouth 25 – 45% of degraded joints, mortise and tenon 55 – 60% of degraded joints and butt 35 – 45% of degraded joints.

In bird's mouth joints, non-precise shaping of the "cog" appeared most frequently, its excessive length and different planeness of contact surfaces (the element does not fit in the entire area of the joint). In the case of mortise and tenon joints, the most common failure was partial or total slippage of the tenon from the mortise, tenon deformation or large tolerances and the ability of tenon "movement" in the mortise. In the case of butt joints, the most frequently occurring defect was different planeness of contact surfaces, in dado joints large tolerances and also different quality of the bearing surfaces. Some of the above defects are, to some extent, affected by volume changes of wood. Based on the survey of selected historic buildings, we may summarize that the most common defects of selected historical roof trusses from the perspective of joints of truss elements are poor quality or loosened joints, their insufficient rigidity and bearing capacity, inappropriate joint design, insufficient spatial rigidity of the truss system in the transverse and longitudinal direction (faulty, loosened connections). The most common failures of joints according to the research are the loosening or damage of joints, loosening of nails, bolts, loosening of carpentry joints, etc., nail corrosion in wood (using wet thin wood), loosening of anchoring iron ties (straps) of eaves plates, excessive deformations of the roof truss due to insufficient rigidity of principal trusses or loose or unsecured joints, degradation of the roof truss due to unqualified interventions (removal or damage of e.g. tie beams, purlin posts, etc.), initial deformations of built-in elements or their excessive shrinkage. The prevailing part of the above failures is caused by the properties of wood (shrinkage or swelling, biological degradation, poor quality of wood), while failures caused by the overloading of the construction, excessive deformations or insufficient dimensions of some elements are represented to a lesser extent.

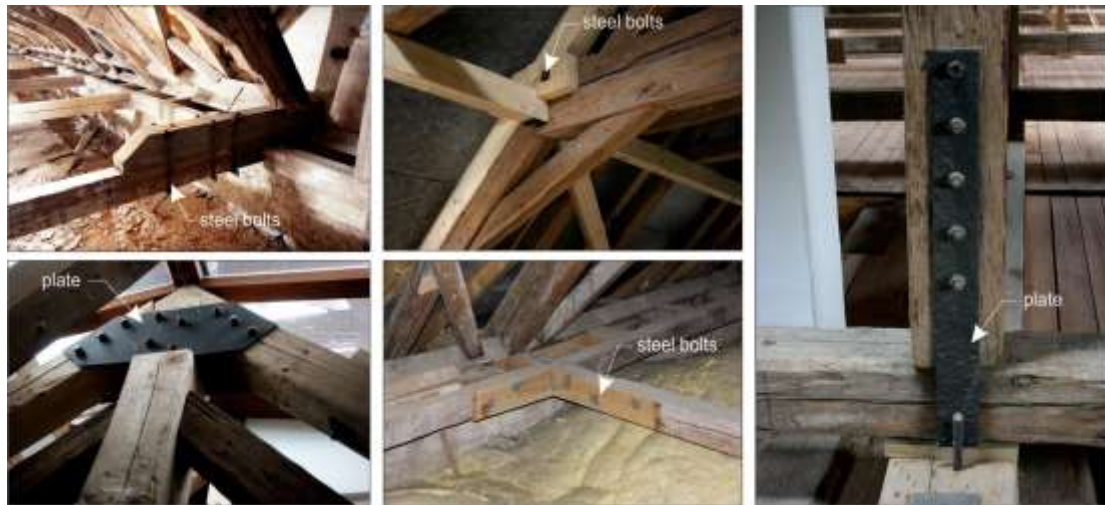
Fig 3. Traditional strengthening and stiffening of joints of roof truss members – using steel bolts and plates

To ensure a long service life and functional reliability of historic roofs we must, above all, provide conditions that minimize the risk of biological degradation of wooden elements and their joints i.e. prevent the penetration of elevated moisture levels into the roof truss construction. At the same time, it is also necessary to secure sufficient strength and rigidity of the roof truss construction, both of its individual elements and their joints. The methods used presently for the rehabilitation of joints and increasing their load bearing capacity are invasive methods (e.g. inserting steel plates and bolts). They reduce, to some extent, the historical value of the roof truss and are not reversible (Fig. 2).

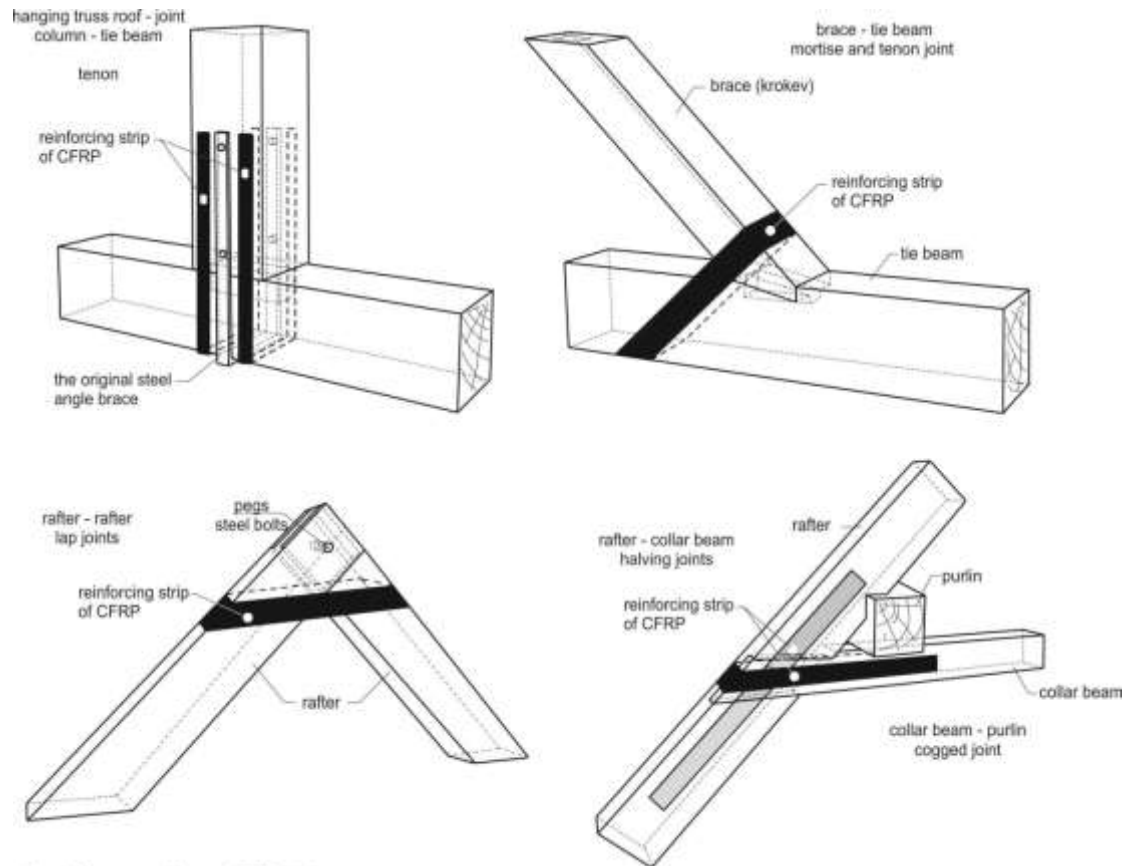
Fig 4. Rehabilitation of selected joints by means of surface application of CFRP composite fabrics and epoxy resin

The application of composites based on high-strength fibres and epoxy resin for the rehabilitation and strengthening of joints of roof truss members is advisable in terms of the minimum additional loading of the construction and the minimum dimensional changes of the connected elements. Fig.3 shows reinforcement and bracing options for the most frequently damaged joints of roof truss elements selected on the basis of the survey. Apart from the low weight and width (thickness) of the reinforcing layer of a composite based on high-strength fibres and epoxy resin, another important characteristic, from the perspective of current heritage conservation, is the non-invasiveness of these materials in surface applications and a possibility of their later removal.

The proposed rehabilitation and strengthening techniques of joints of timber truss elements are designed for surface applications of composite strips of fabrics of high-strength fibres and epoxy resin: surface applications reduce further weakening of stressed joints which would otherwise require the execution of holes or grooves for inserting bars or lamellae. The disadvantage of surface reinforcement is the necessity of ensuring adequate anchorage lengths of reinforcing strips and the necessity of previous surface treatment of wooden elements to secure the highest quality of the contact between the reinforcing layer and the elements of the reinforced joint.
