GEOTECHNICAL ANALYSIS AND REMEDIAL DESIGN OF A POTENTIALLY UNSTABLE CUTTING

Zdenek Siska

Czech Technical University in Prague, Faculty of Civil Engineering, Department of Geotechnics, Prague, Thakurova 7/2077, 166 29, Czech Republic; siskazde@fsv.cvut.cz

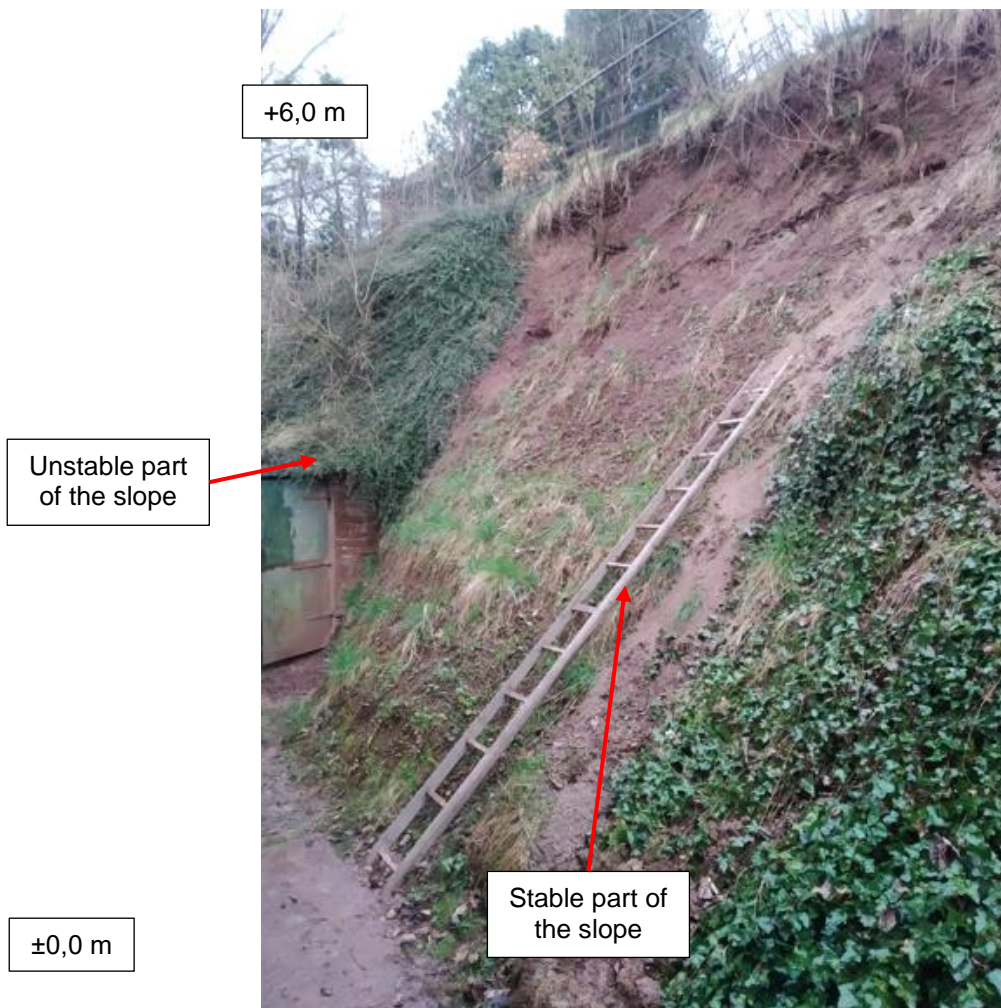
The area of interest can be seen in Figure 1. It is a cutting made approximately 80 years ago which in its northern part experiences a continuous sliding of material due to surface erosion. There is limited access to the cutting as it is adjacent to an existing structure. The constrained spatial conditions, together with the need for a cost-effective solution, limit to some extent the use of larger and more robust technologies for both exploration and subsequent remediation.

The cutting consists of a stable part with healthy sandstone, which is covered with vegetation, and an unstable - exposed part (see Figure 1). The unstable part is the main focus of this paper, as it is identified as potentially the most critical part of the cutting.

Fig. 1 - The cutting with the stable part covered with vegetation and the exposed unstable part

Since the structural analysis did not identify problems with the stability of the slope, so the remediation design of the cutting may be limited to anti-erosion measures in the form of an anchored lining of its face. This measure is necessary for the part of the cutting visibly degraded by surface erosion, referred to in this text as the 'unstable part' (see Figure 1). It is possible that the part of the cut referred to in this text as 'stable' (see Figure 1), consisting of more solid rock, may not require this measure. However, since the stable part of the cutting is presently covered by climbing vegetation, it is not possible to assess it comprehensively in terms of rock quality, discontinuities, loose blocks of rock, etc. For this reason, and also for the sake of a uniform appearance of the face of the cutting, a single remediation design has been submitted for the entire cutting.

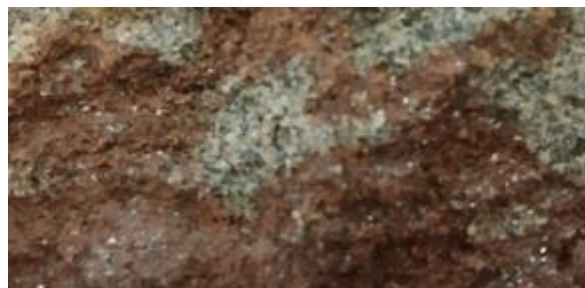
are alternating grey and red colored sandstones (see Figure 2). According to the 1:50 000 geological map [2], these are Upper Carboniferous and Permian in age. The Quaternary cover of the sandstones, according to in situ inspection, consists of sandy silts. According to the mapped slope deformations [3], there are no landslide areas in the area of interest.

Fig. 2 - A rock sample from the weathered face of the cutting with an interface of grey and red sandstone

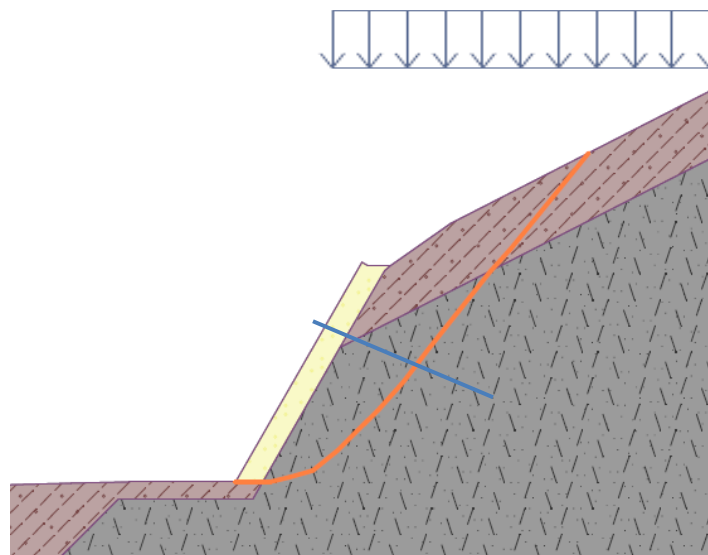
On the basis of the in-situ inspection and archival documents, a geotechnical profile was made (Figure. (4)3). The slope of the cutting is approximately 60° and the slope of the ground above the cutting is 27° .

The rock in the form of sandstone is overlaid by 2 m of sandy clay. The thickness of this Quaternary cover above the cutting was determined by in situ inspection considering the data in the archive borehole survey as well. Below the base of the cutting, the geotechnical profile took into account the brook inundation area according to the bedrock encountered during the nearby well excavation and also from the archival survey for the local irrigation reservoir [4]. A 0.5 m thick weathered zone was also defined in the face of the cutting representing weathered rock with poorer properties. The groundwater level was set at a depth of 3 m below the base of the cutting.

Fig. 3 - Optimized polygonal slip surface with marked snow load and position of extensometer in the upper third of the cutting

The evaluation was made using the Bishop, Sarma, Spencer, Janbu and Morgenstern-Price methods. The minimum permissible degree of stability was determined according to the Czech technical standard CSN 73 6133 [9]. It requires a minimum factor of safety of the cutting in the rocks $FS = 1.3$ when considering the peak effective shear parameters. The results of all the methods are summarized in Table 2. According to these results, the cutting can be declared stable, only with problems caused by surface erosion. These are addressed by the remediation design in the next section.

For verification of the design and the results of the structural analysis, an extensometer placed in the upper third of the cutting is proposed as monitoring. Its length is required to be 4 m to reach safely beyond the possible expected slip surface (see Figure 4). Various types of extensometers are possible to use here ranging from standard rod to FBG extensometers.

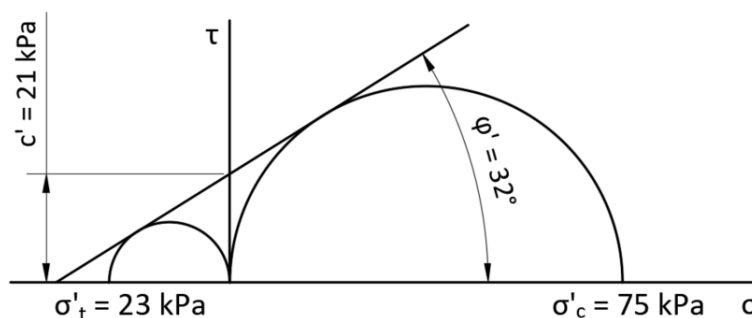
Sandstone samples were taken from the weathered zone during the in-situ inspection and were subjected to the point load test. Subsequently Mohr-Coulomb shear parameters were estimated using a conversion of the resulting point load index to obtain uniaxial compressive strength

and uniaxial tensile strength which is shown in Figure 4. The whole procedure is in detail explained in [5].

The resulting estimations of the effective angle of inner friction equals 32° and effective cohesion equals 21 kPa. As aforementioned, these parameters relate to the weathered zone. It wasn't possible to obtain rock samples from larger depths under the face of the cutting by hand because of rapid increase in strength of the sandstone. Therefore, these shear parameters represent very conservative lower limit of the solid sandstone capabilities, which can compensate for unknown positions of discontinuities or disintegration into blocks. Shear parameters for the weathered zone itself were chosen to have the same angle of inner friction as the ones estimated for the sandstone, but no cohesion which is supposed to characterize long term weathering. Shear parameters of the overlaying sandy clay were estimated with respect to parameters of the original rock and the parameters reported in the Czechoslovak national standard CSN 73 1001 [6]. The resulting Mohr-Coulomb material Parameters are summarized in Table 1.

Fig. 4 - Determination of $\phi' = 32^\circ$ and $c' = 21$ kPa based on uniaxial compressive and tensile strength [5]

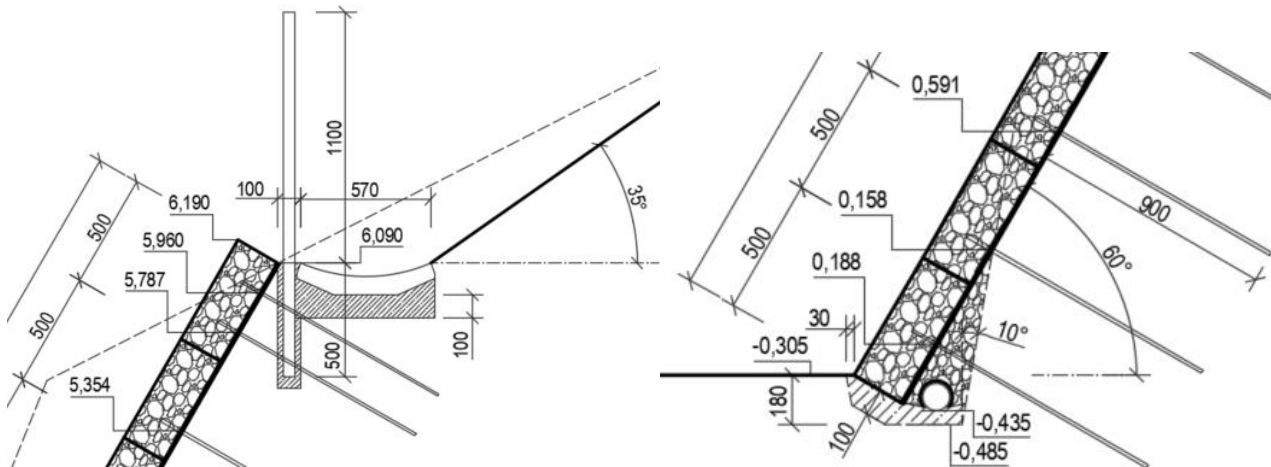
Fig. 5 - Preview of the anti-erosion measure of the face of the cutting - nailed gabion lining; on the left the drained back of the structure at the foot of the slope; on the right the surface drainage of rainwater above the cutting

The proposed design consists of gabion lining covering the face of the cutting through the separating geotextile and surface water drainage situated at the crown and at the base of the cutting. The lining is secured by nailing up to the healthier rock (see Figure. 5). The nailed gabion lining system has been evaluated again by structural analysis. The design emphasizes construction using only hand tools with regard to the spatial constraints mentioned above and the need for a cost-effective solution. Other types of lining would be possible as well (e.g. sprayed concrete), but always in combination with nailing for securing its stability.

The gabion's back mesh is anchored through the base plates with a nail through the weathered face into the healthier rock. The primary purpose of the nails is horizontal and vertical stabilization of the erosion control lining.

The nails are 1 m long and consist of an M12 threaded stainless steel rod. They are inserted into 30 mm diameter boreholes 900 mm deep filled with cement grout. A 100 mm long nail will therefore protrude from the aligned and cleaned face. Stainless steel is essential when grouting with cement grout. This precludes the use of zinc-coated rods as the hardening cement loses its strength in the presence of zinc [10].
