REHABILITATION OF CEMENT CONCRETE PAVEMENT STRUCTURES AT BRATISLAVA AIRPORT

ANDREA ZUZULOVÁ*, DOMINIKA GLASNÁKOVÁ

Slovak University of Technology in Bratislava, Faculty of Civil Engineering, Department of Transportation Engineering, Radlinského 11, 810 05 Bratislava, Slovak Republic

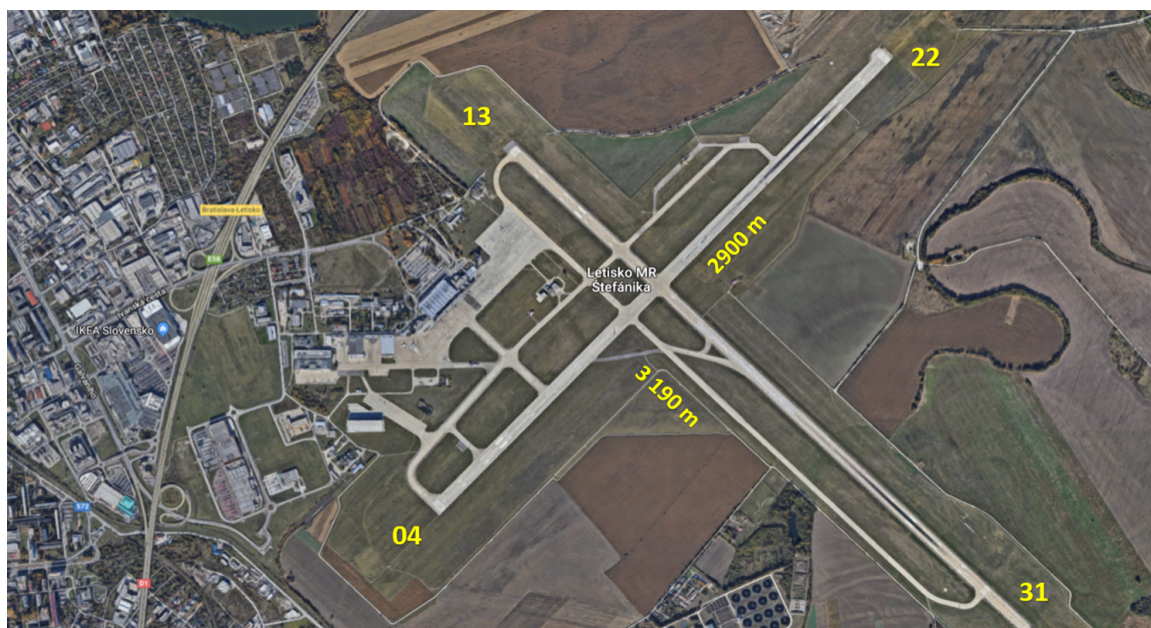
The runway system of the airport are two perpendicular take-off and landing runways and taxiways (Figure 1), which enable arrivals and departures for critical aircraft (critical aircraft B 747-400). Runway 13-31, which is the main runway, is 3 190 m long and 45 m wide. It is equipped with a system of lighting and navigation devices enabling accurate approach under III A category conditions. Runway 04-22 is 2 900 m long and 60 m wide. It is equipped with lighting and radio-navigation devices for accurate approach under category I conditions. Apron, as an integral part of every airport, must have the required functions in order to achieve the safety, smoothness and efficiency of airport operations. These requirements are ensured if all regulations and policies for the relevant type of airport and critical aircraft are fulfilled. All these surfaces have a cement concrete surface.

FIGURE 1. Runway system of Bratislava Airport.

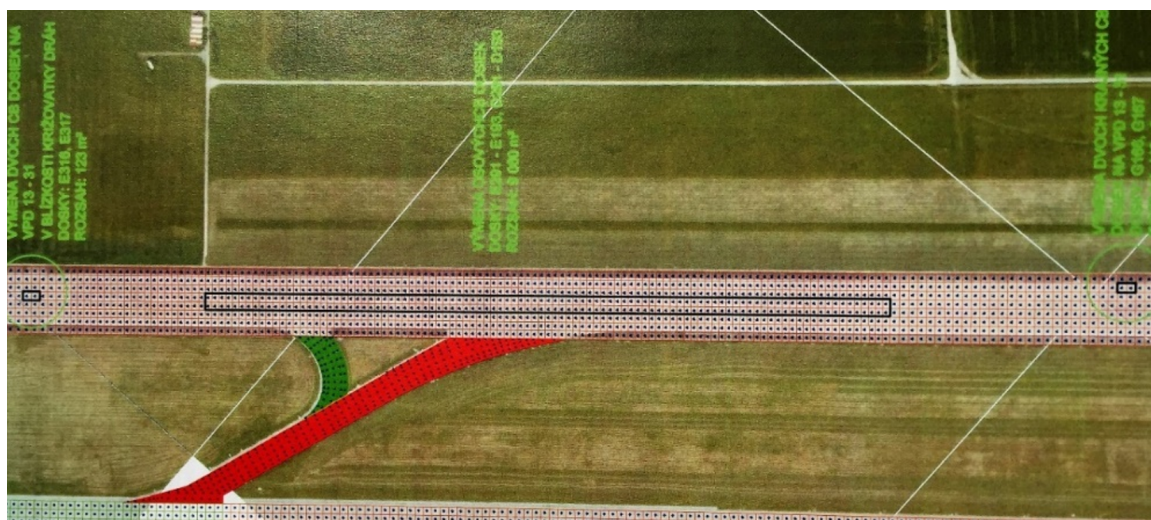
FIGURE 2. CC slabs replacement plan for Runway 13-31.

Degradation of Runway 13-31 in terms of technical and operational status continued at larger repairs to ensure the required operational safety in the future. As part of these measures, the replacement of the upper layer of the cement-concrete pavement cover was proposed (Figure 2). The replacement concerned the two axial strips of the runway, which are the most heavily loaded and are in direct contact with the main landing gear of the aircraft. The length of the repaired section was 604 m in km 1 159 and the total area of the repair was 9 086 m² [3]. Runway 13-31 is divided in the longitudinal direction into eight strips marked from A to H (Figure 3). The strips marked A and H have an asphalt cover, and the other strips B to G have a cement concrete cover. The proposed repair concerned the replacement of the cement-concrete pavement cover together with the asphalt intermediate layer in two lanes in the runway axis marked D and E with a total width of 15 m.

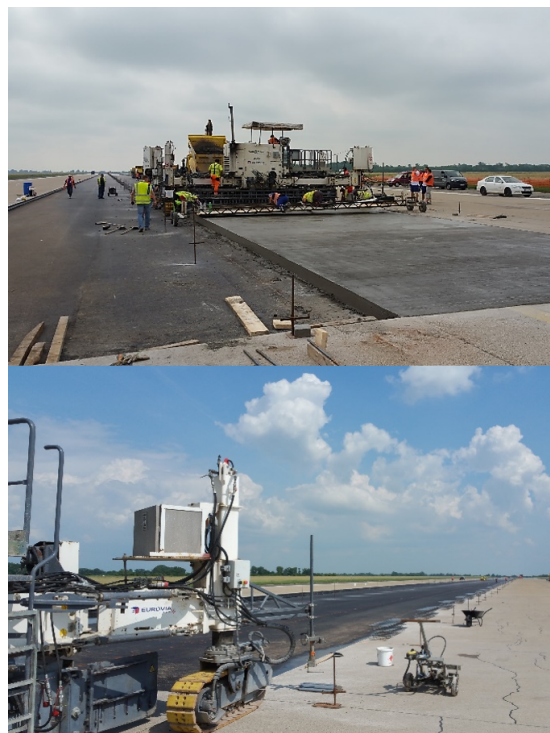
FIGURE 4. Paving of cement concrete slabs on runway 13-31.

A new composition of the pavement structure was proposed. The change is in the top two layers. The other layers of the pavement were left in their original state. The transverse and longitudinal joints of the cement concrete cover were reinforced with dowels at a distance of 250 mm and tie bars of 4 per length of the slab, placed in one plane, parallel to the pavement surface and perpendicular to the joint [4–9].

The work procedure consisted of cutting transverse and longitudinal joints at the junction of slabs C-D and E-F, the existing tooth was removed in the longitudinal joint of slabs C-D, in the longitudinal joint of

slabs E-F the existing groove was concreted together with CC slabs. Subsequently, the area of CC slabs with an asphalt intermediate layer was demolished. After removing the layers, a different cross-section of the lower CC slabs and the upper CC slabs than was considered in the project was found. For this reason, the project was changed and the number of longitudinal joints increased by two, on each side from the runway's axis at a distance of 3.0 m. A bond coat spray was applied to the prepared surface and an asphalt intermediate layer with a thickness of 30 mm was laid. Subsequently, the concreting of the cement-concrete cover was using a paver in two strips from the end of the section. Strip D was implemented first, followed by strip E. Transverse and longitudinal joints were reinforced. In the places of the transverse working joints and the longitudinal joint at the junction of slabs D and E, dowels and tie bars were inserted into pre-drilled holes. After paving, transverse and longitudinal joints were continuously cut, pre-sealed and then filled with asphalt sealing (Figure 4). After the completion of the construction works, the traffic markings were restored according to the original markings before the repair.

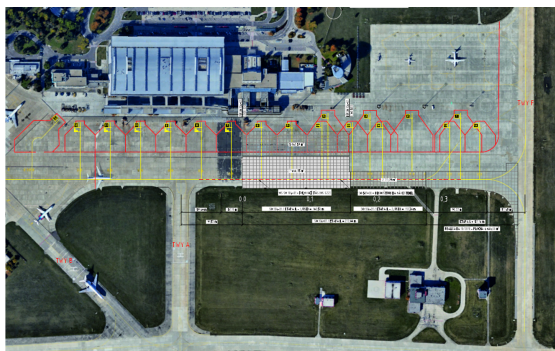
The apron is divided into two parts from the point of view of operation – the taxiway and stands for check-in and parking of aircraft (Figure 5). The mentioned part of the apron fundamentally affects the operation of the airport and the process of aircraft check-in, as they are the busiest stands and at the same time the taxiway allows aircraft taxiing even in low visibility conditions. The reconstruction of part of the apron increased the safety and technical operating conditions.

FIGURE 5. Apron of Bratislava Airport.

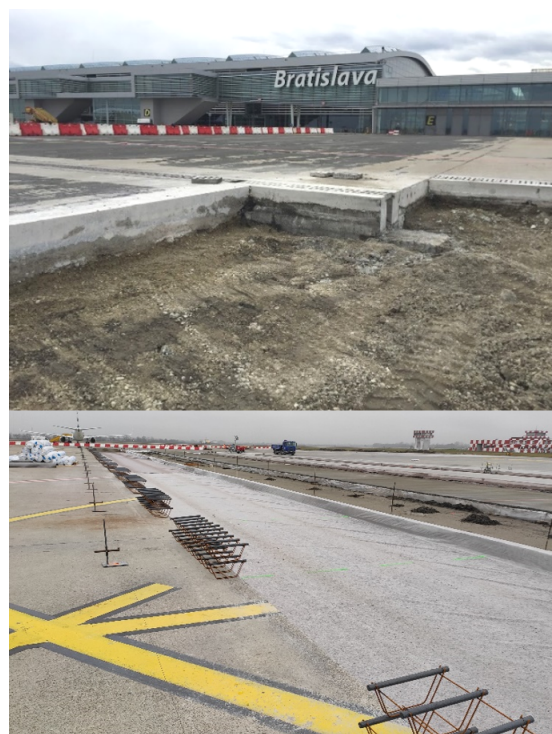
The cement concrete pavement cover is made as a single layer. The dimensions of the slabs are designed to be 5.0 m in the longitudinal direction up 4.5 to 5.5 m in the transverse direction (Figure 6, Figure 7). On the solved traffic surface, all joints are considered as transverse. The reinforcement of the transverse joints is with dowels $\varnothing 30$ mm and a minimum length of 500 mm at a mutual axial distance of 500 mm. The

FIGURE 7. Realization of cement-concrete pavements on the Apron.

connection of the new CC cover to the existing CC cover is solved as an expansion joint, reinforced with dowels $\varnothing 30$ mm and min. 500 mm long at a mutual axial distance of 500 mm, with an assessment of the need for dilation and the need to guide the displacements of part of the surface (strips) due to climatic changes [11]. Between the CC cover and the base layer, there is a separation intermediate layer made of geotextile, which serves to prevent the copying of cracks.

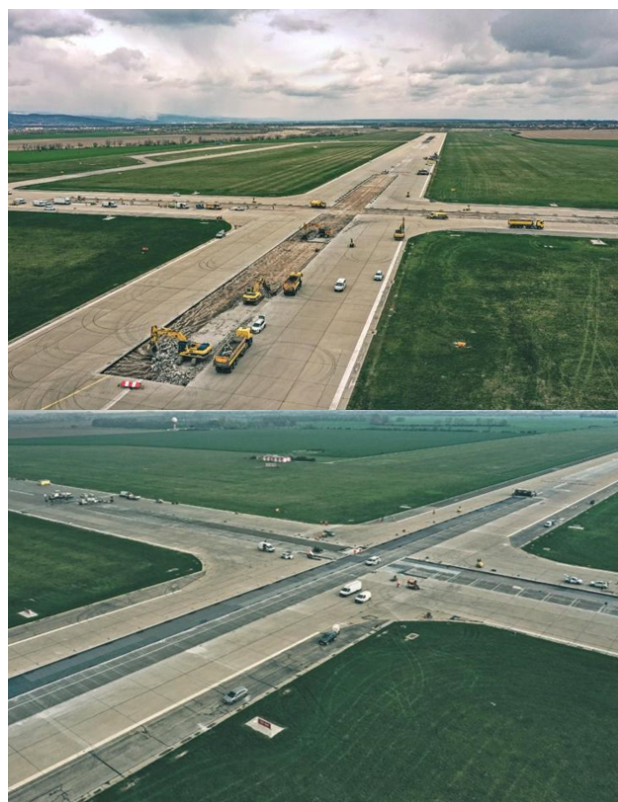
junction cost the airport 2.27 million euros without VAT (Figure 9).

FIGURE 9. Rehabilitation of the junction of the RW 04-22 and RW 13-31.
