DURABILITY EVALUATION OF SURFACE SOFTENED STEEL BAR FOR PRESTRESSED CONCRETE

KEYWORDS: Delayed fracture, durability, prestressed concrete pole, surface softened steel bar.

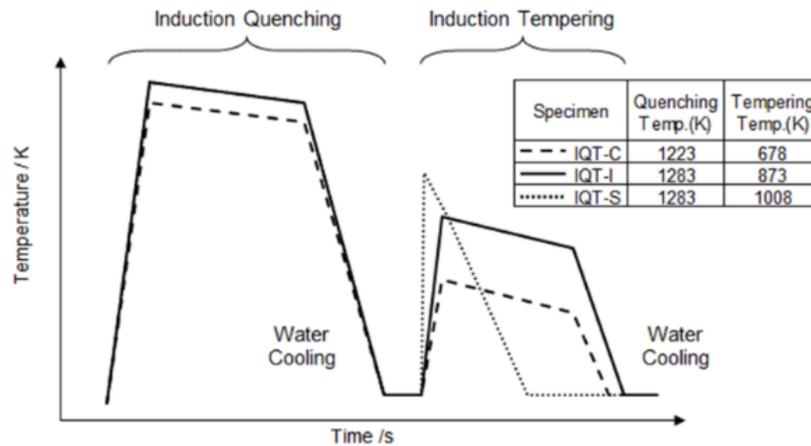
FIGURE 1. Schematic diagram of heat-treating cycle of IQT-C, IQT-I and IQT-S.

Rolled wire rods with chemical composition shown in Table 1 were shaped by deformed wire drawing process and subjected to continuous high frequency induction quenching and tempering. By increasing the amount of Si compared to IQT-C, the maximum tempering temperature for IQT-I was able to be raised until 880 K. The surface-softening tempering process was conducted for IQT-S using the same equipment as to IQT-I, in which the material was first subjected to high temperature and short time tempering and then the cooling time was adjusted so that the rate of tempering progression throughout the materials sur-

face was maximized. It was possible for the maximum tempering temperature of this material to reach until 1028 K. The schematic diagram for the heat treatment cycles are shown in Figure 1.

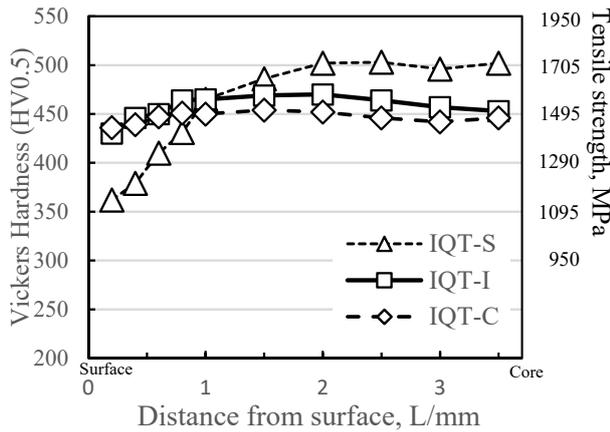
FIGURE 2. Vickers hardness from the surface to the core of IQT-C, IQT-I and IQT-S.

The mechanical properties for the materials are shown in Table 2. The tensile properties were measured in accordance with JIS G3137. The tensile strengths for IQT-C, IQT-I and IQT-S are almost the same and their mechanical properties satisfy JIS G3137. Figure 2 shows the measurement result of Vickers hardness from the surface to the core in radial direction as well as tensile strength calculated from the Vickers hardness. There are relatively no changes in the hardness from the surface to the core of IQT-C and IQT-I. The Vickers hardness for IQT-S gradually increases from 350 HV at the outermost surface towards the same hardness as common IQT material at around 1 mm from the outermost surface. Then, the hardness remains relatively unchanged at 1.5 mm from the surface until the core.

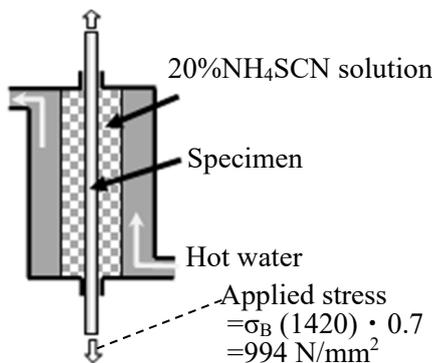
FIGURE 3. Schematic diagram of FIP test method.

Figure 3 shows the schematic diagram of FIP test. To maintain the temperature inside the reaction cell at 323 ± 1 K, test containers equipped with hot water circulation were used in the test. The reaction cell was filled with 20% NH_4SCN aqueous solution at 323 K and smooth bar specimen is set up so that it passed through the cell. Hydrogen entry into the specimen occurs due to chemical reaction between the specimen's surface and the test solution. The test was conducted in a way where the reaction cell was firstly filled up with test solution and then immediately tension stress of 0.7 times of standard strength ($1420 \times 0.7 = 994 \text{ N/mm}^2$) was applied to the specimen. The time until fracture was measured and test was stopped at 200 h even when no fracture occurs.

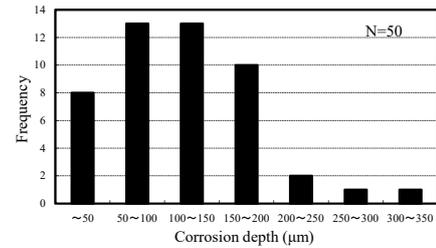
FIGURE 4. Pitting corrosion depth distribution of tendon in CP after completion of service.

Figure 4 shows the corrosion pits depth distribution of tendon in CP after completion of service. The maximum depth of corrosion pit measured is about $350 \mu\text{m}$. V-notches of depth 0.3 mm or 0.4 mm were applied on the specimens to model the corrosion pits found in service materials. The radius of the notch tip where stress concentration occurs was machined to 0.12 mm for evaluation of materials with harsher condition than the ones in service environment. The dimensions of the specimen are shown in Figure 5.

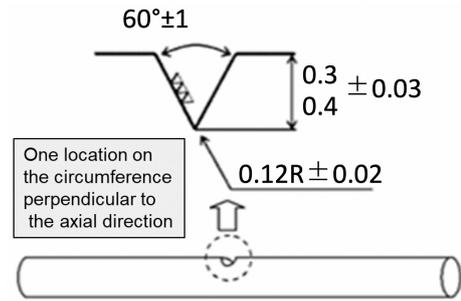
FIGURE 5. V-notch shape of specimen.

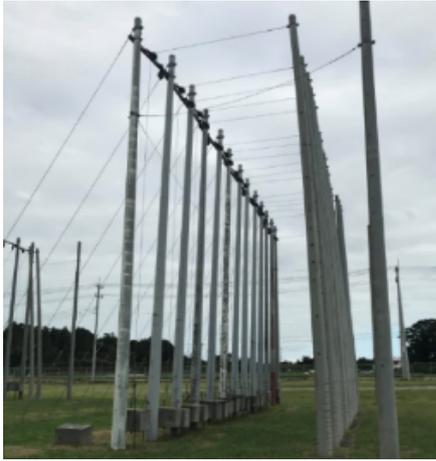
FIGURE 6. Exposure test of "CP500" utility poles at the Choshi test site in Japan (started in August 2010).

CP500 were set up at Choshi, Chiba in Japan (About 4km from southern coast) and exposure tests were started from August of 2010. The tests were set up such that design load (4.9kN) which is the instantaneous abnormal high load such as from typhoon, as well as 1.2 times the design load (5.9kN) were always applied towards the horizontal direction of the CP's upper part. Figure 6 shows the condition of the exposure tests. CP350 were set up at Muroran, Hokkaido in Japan (About 20 m from sea) and exposure tests were started from July of 2013 by always application of design load (3.4kN) or 1.3 times the design load(4.4kN) in the horizontal direction of the upper part of the CP. The tests condition is shown in Figure 7.

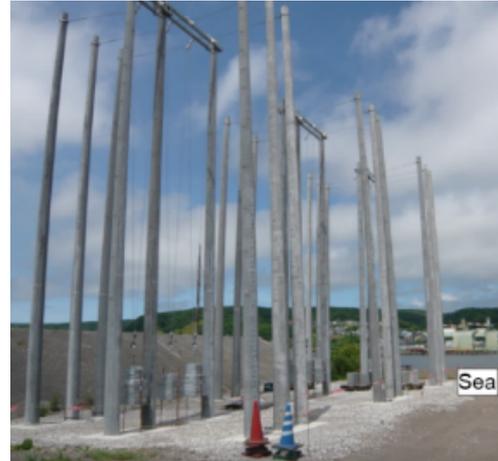
FIGURE 7. Exposure test of "CP350" utility poles at the Muroran test site in Japan (started in July 2013).

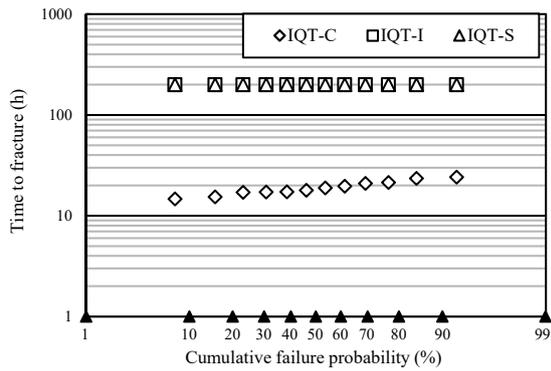
FIGURE 8. Delayed fracture resistance evaluation using quasi-FIP test.

Figure 8 shows the result of FIP test. Each data was sorted using Mean Rank Method and then cumulative failure probability was calculated and presented as lognormal probability plot. At 50% cumulative failure probability, fracture is recorded at 18.8 h for IQT-C, while no fracture is recorded at stop time of 200 h for IQT-I which has higher Si composition. Moreover, surface-softening tempered IQT-S also experiences no fracture at 200 h, showing substantial improvement in delayed fracture durability that is not possible to be evaluated by FIP test alone.

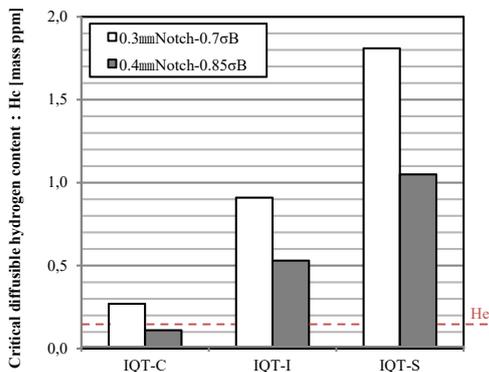
FIGURE 9. Measurement result of critical diffusible hydrogen (Hc) without delayed fracture after 100 h.

The concentration of hydrogen that enters from environment (He) is found to be around 0.15 ppm from previous research [6] and it is suggested that the higher Hc is from 0.15 ppm, the better the durability of the material against delayed fracture. Figure 9 shows the measurement result of Hc. In "slightly harsh environment" condition (0.3 mm Notch- $0.7\sigma_B$), Hc was higher than He regardless of the types of material. However, in "harsh environment" condition (0.4 mm Notch- $0.85\sigma_B$) Hc decreased until below 60 percent than that of in "slightly harsh environments" and Hc from IQT-C became smaller than He. Regardless of the environment model, the pattern for Hc was $\text{IQT-C} < \text{IQT-I} < \text{IQT-S}$. The effectiveness of the methods for improving durability against delayed fracture was confirmed from this result.

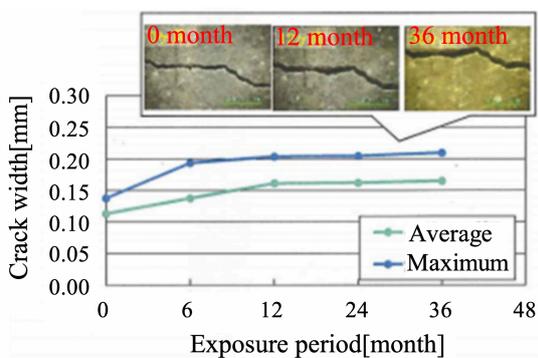
FIGURE 10. Crack width measurement result of CP500 utility poles using IQT-S as tendon.

Figure 10 shows the crack width measurement result of the cracks found on the surface of CP at the third

year of exposure test. The cracks occurred immediately after load application and expanded until as large as 0.2 mm at around the first year. It was observed that the cracks' enlargement slowed down following the first year. Figure 11 shows the external observation of utility poles after 10 years of exposure test. The result of using leakage magnetic flux method to detect any fracture in the steels shows that there were no major abnormalities nor any fractures detected for all IQT-C, IQT-I and IQT-S. Thus, the exposure test is still ongoing in the present time.

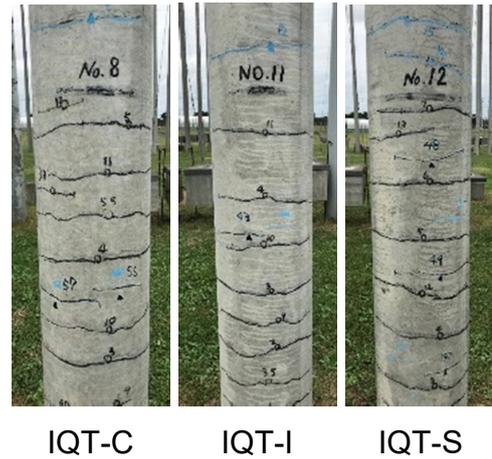
FIGURE 11. Results of external observation of CP500 utility poles exposed to bending for 5.9kN for 10 years.

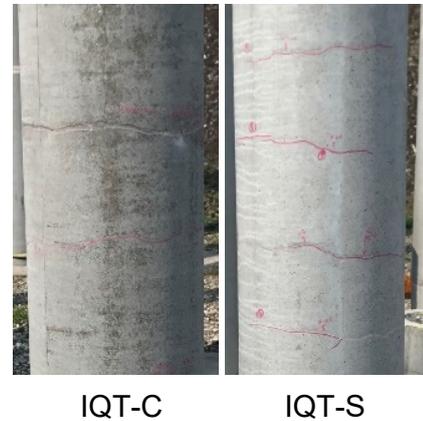
FIGURE 12. Results of external observation of CP350 utility poles exposed to bending for 4.4kN for 5 years.

Figure 12 shows the results of external observation of IQT-C and IQT-S utility poles after 5 years of exposure test. Several cracks were found on the surface of CP. The cracks were after enlargement until about 0.2 mm, there were no remarkable changes in the width of cracks on the CP surface. There was no fracture detected by using leakage magnetic flux method at the fifth year of exposure test. The IQT-C and IQT-S utility poles were dismantled and the condition of

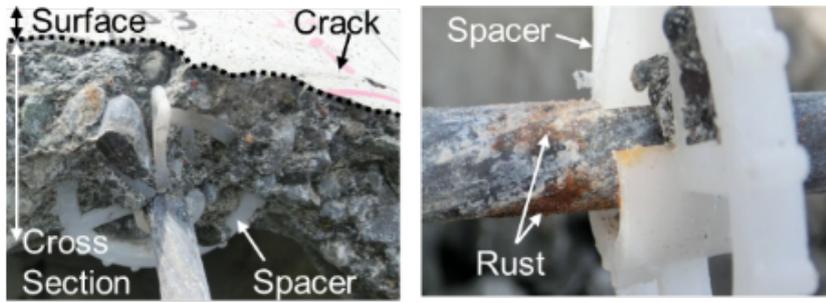
FIGURE 13. Observation results of cracks and spacers during dismantling of the utility pole.

fracture, cracks as well as rusts of the steel parts was examined. After dismantling, it was found that no fracture occurred in the PC steel bars of both utility poles. Figure 13 and Figure 14 show some examples of the crack parts during dismantling of the utility

poles. Local rusts were spotted on the surface of the steel bar located directly under the cracks. Several cracks were located in the vicinity of the areas where the bond strength is weak between the reinforcing bar and the concrete due to locally no contact existing between them, such as at the spacers put before the pouring of concrete into the formwork. Rusts also observed along the longitudinal direction of the formwork joints position of CP where is tends to low density concrete by centrifugal molding method.

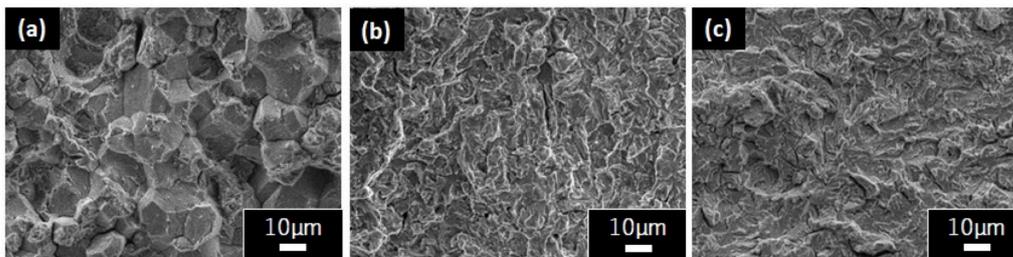
FIGURE 15. Microscopic fracture surfaces near the notch tip after delayed fracture test; (a) a IQT-C specimen shows intergranular (IG) fracture, (b) a IQT-I specimen shows quasi-cleavage (QC) fracture and (c) a IQT-S specimen also shows quasi-cleavage (QC) fracture.

Figure 15 shows the observation results of the fracture surfaces from the materials. Intergranular fracture was observed in IQT-C which has short time to

fracture in FIP tests as well as small H_c . Meanwhile, intergranular fracture was not observed in IQT-I and IQT-S in which the composition of Si in the materials was increased. This correlates to the effects of Si in suppressing the formation of intergranular fracture as reported by previous study [7]. It is also thought that the addition of B in the materials suppressed the formation of intergranular fracture due to the effects of B in increasing the strength of grain boundaries as reported before [8].

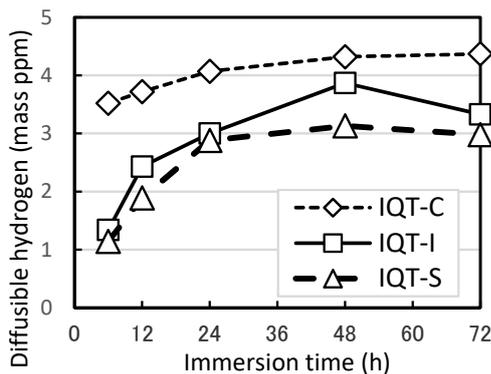
FIGURE 16. Relationship between immersion time and diffusible hydrogen content in 323 K-20% NH_4SCN solution.

as follows. Figure 16 shows the relationship between immersion time and diffusible hydrogen content when the specimens were immersed in 20% NH_4SCN solution. The rate of hydrogen diffusion is in the order of $IQT-S < IQT-I < IQT-C$.

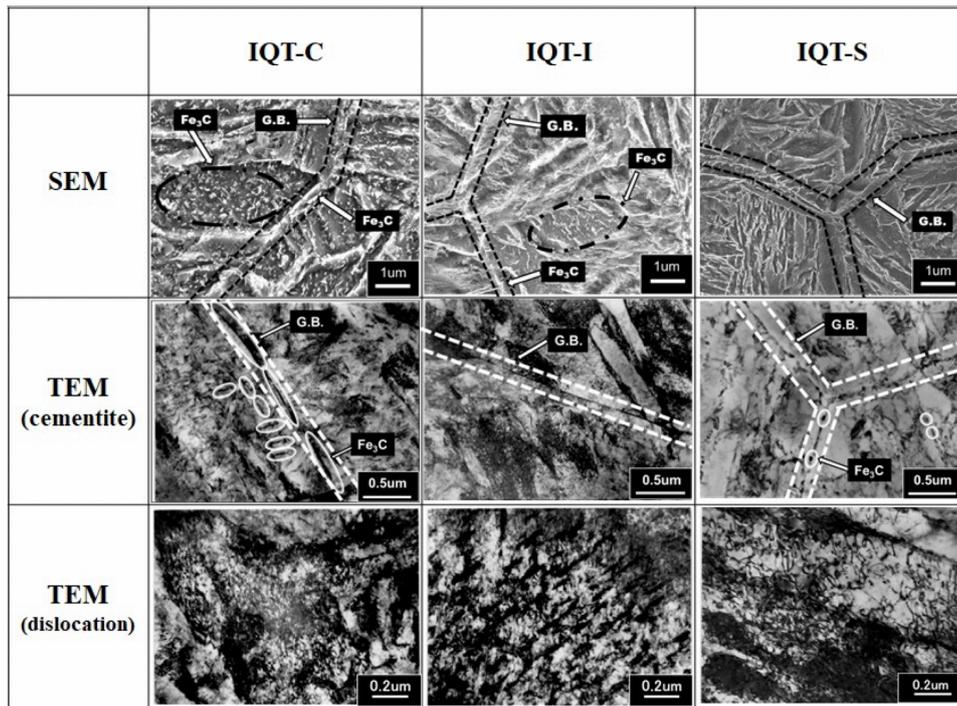
FIGURE 17. Microstructures of specimens obtained by a scanning electron microscopy and a transmission electron microscopy. The micrographs of IQT-S specimen are observed in surface-softened area at 0.4 mm apart from the surface.

As the rate of hydrogen diffusion in IQT-S is slower than IQT-I, this indicates that the surface-softening layer has certain resistance towards hydrogen entry into the material. In order to investigate this point, SEM and TEM observations of the microstructures of each material were conducted, and the results are shown in Figure 17. The observation results are summarized in order of increasing tempering temperature (IQT-C, IQT-I, IQT-S) as follows.

1. As the tempering temperature increases, the carbide precipitations become smaller and the precipitation sites change from the grain boundaries to the inner grain parts. These are also the characteristics of materials that have undergone high frequency induction tempering (short time heating).
2. As the tempering temperature increases, the shape of the carbide precipitated on the grain boundaries changes from plate-shape to film-shape and lastly to divided sphere-shape.
3. The areas with high dislocation density are shown as black contrast areas in the TEM observation results. As the tempering temperature increases, the white areas which represented areas with low dislocation density increase, confirming the progression of tempering.

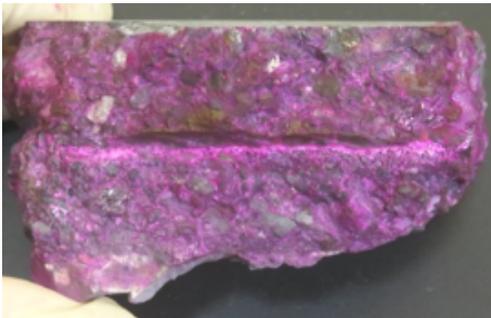
FIGURE 18. Observation results of steel mark in concrete test piece after neutralization test.

In this section the factors behind no fractures occurring for IQT-C and IQT-S reinforcement bars at the CP350 Murooran exposure test are discussed. After dismantling of CP350, neutralization test using phenolphthalein was conducted towards the concrete parts which included the crack parts. Figure 18 shows one example of the test results. The observed surface changed pink colour which indicated that neutralization did not occur whether on the crack part nor the steel mark part. Thus, it can be inferred that even though rusts form on the steel bars, since either the rust progression was slow or the corrosion environment was not sustained, entry of hydrogen exceeding Hc did not occur even in IQT-C with low Hc value. Furthermore, it should also be noted that the cold climate and low humidity at the Murooran test site may affect the corrosion's rate of progression and sustainability. However, fractures were also not recorded at the CP500 (Choshi test site) where it is warmer and more humid than Murooran. Thus, further plans for the verification of durability in real environment involve the continuation of tests while also recording environmental data.
