THE ROAD TO CIRCULARITY: A FRAMEWORK FOR AND EXPERIENCES IN COLLECTING ROAD DATA IN A CIRCULAR RENOVATION PROCESS

BRAM ENTROP

Saxion University of Applied Sciences, School of Business, Building & Technology, Research Group Sustainable Environment, M.H. Tromplaan 28, 7513 AB, Enschede, The Netherlands

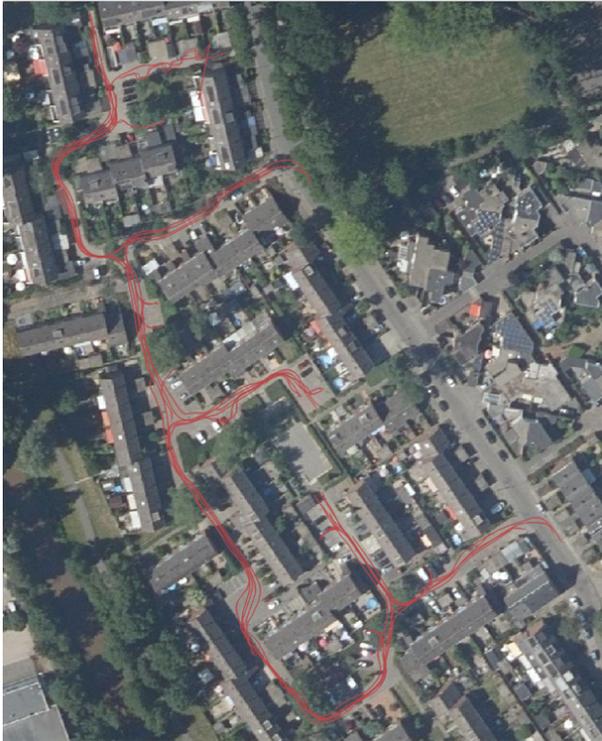
FIGURE 2. Lines of measurement in Griffiersveld.

In order to test if we can easily complete the data automatically, an initial scan of Griffiersveld was made on the 7th of April 2020. An IDS RIS Hi-Pave ground penetrating radar system at the back and a gamma spectrometer at the front of a van were used. The van drove approximately five times through Griffiersveld resulting in a dataset, that seems to consist of lines, but are in fact measuring points in close proximity (see Figures 2 and 3). The data collected by the gamma spectrometer offered insights into radioactivity levels (in Bq/kg) of pavements. The ground penetrating radar made it possible to assess the type of pavement and its thickness, namely around 5 cm thick concrete paving slabs and 8 cm thick concrete pavers. Furthermore, it was possible to get insights into the thickness of the sand package under the pavement, that seems to vary from 1.4 to 22.0 cm.

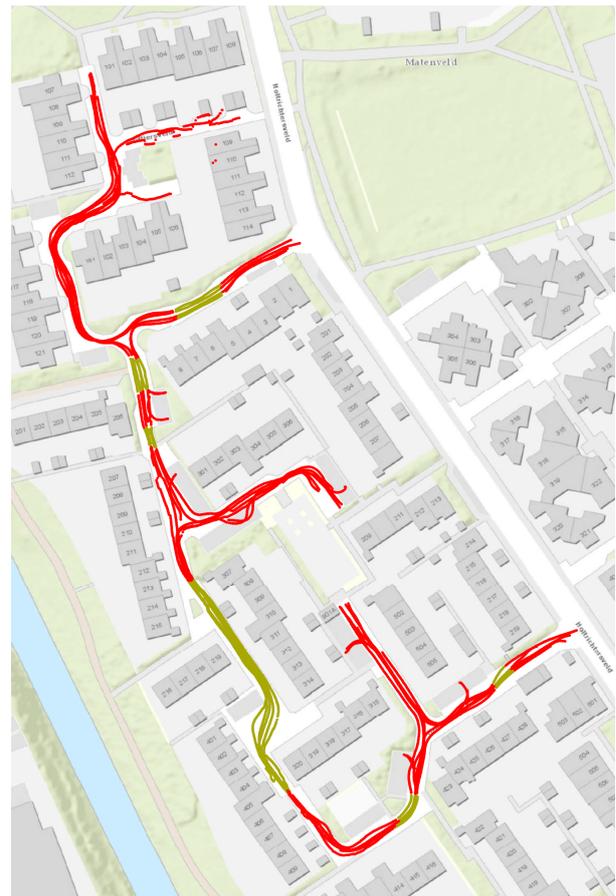
FIGURE 3. Applied pavement materials (red = concrete pavers, green = concrete paving slabs).

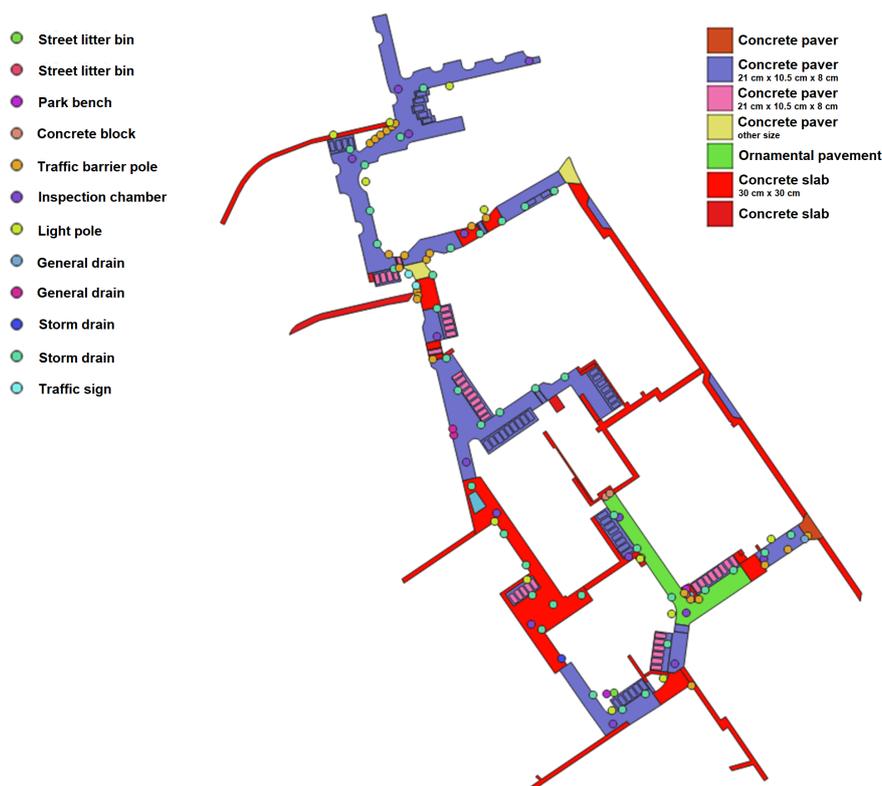
FIGURE 4. Results of scanning Griffiersveld through collecting images, radar and laser data.

jects located in and adjacent to Griffiersveld. Pavers, paving slabs and edge beams can be checked regarding typology, colour, thickness and condition. Furthermore, a GIS-based inventory was made of inspection chambers (or manholes), road gullies, street poles, light posts and street furniture (Figure 4).
