## PROVIDING STABILITY TO A HIGHWAY CUT IN A LANDSLIDE AREA WITH THE USE OF DIAPHRAGM WALL PANELS

**ABSTRACT.** The route of the D1 highway in the Lietavská Lúčka - Dubná Skala section near Žilina is taken forward by a 17 m deep cut in a section about 300 m long. The first proposed solution of the highway route was based on the assumption that it is a stable area. However, during the construction of the highway cut an old landslide area with a depth of shear surfaces of up to 25 m was identified right in the area of the cut. Therefore, massive measures had to be designated to assure that the area above the highway and the access to the tunnel portal were not threatened by landslides. When addressing the security of the cut, an unusual solution was used - anchored diaphragm wall panels of underground concrete walling oriented towards the slope. Currently, this given solution is under construction and is controlled by inclinometers incorporated into selected diaphragm wall panels.

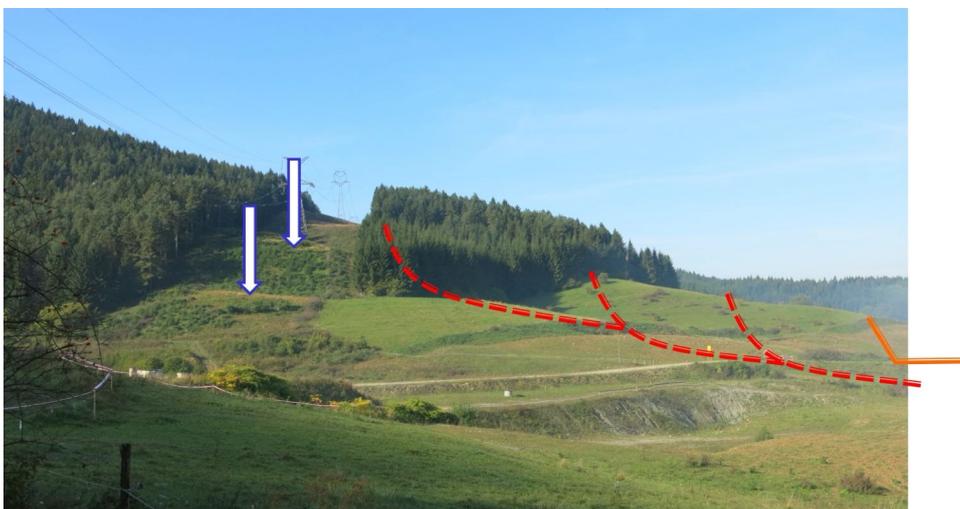
FIGURE 3. Distinct morphological blocks of rocks under the power line (blue arrows) and a diagram of blocks with shear surfaces (red lines).

The landslide area through which the highway route passes has an extent of approximately 600 × 700 m. The development of the landslide area took place in the distant geological past. It was a tectonic uplift of the marginal parts of the basin and a subsidence of the basin itself, where our interest area on such a tectonic edge is located. Vertical movements caused the division of the Paleogene formation into several blocks. These began to slide towards the valley forced by gravity. Subsequently the Mesozoic limestone blocks lying in the higher parts of the slope also started to move. In such a way, two block fields have been formed with a NE-SW direction of movement and has created morphological terrace-like elevations on the slope (Figure 2 and 3).

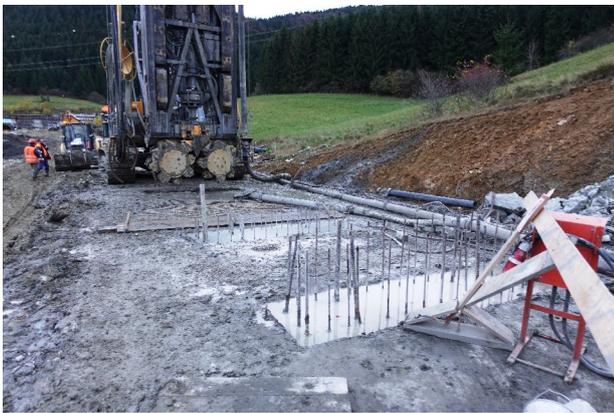
FIGURE 7. Excavation for the diaphragm wall panels with width of 2.8m.

Construction of the diaphragm wall panels was carried out by a combination of excavation by a cable grab to the level of 7.0 m and afterwards an excavation to the designated depth conducted by a hydrofraise

(Figure 7) was carried out.

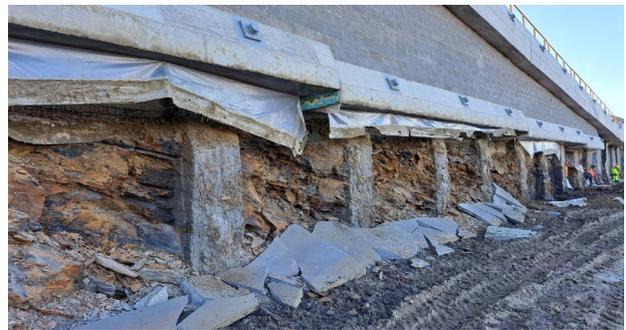
FIGURE 8. Exposed panels with visible beams and anchors.

Diaphragm wall panels are in the head part interconnected by a head monolithic beam 1500 mm high and 4500 mm wide. According to terrain configuration, 1–2 beams of dimensions 800 × 800 mm were also used, which additionally stabilize the individual diaphragm wall panels against possible rotation (Figure 8).
