STRUCTURAL HEALTH MONITORING OF CONSTRUCTION

JAKUB NIEDOBA

Brno University of Technology, Faculty of Civil Engineering, Veverí 331/95, 602 00 Brno, Czech Republic

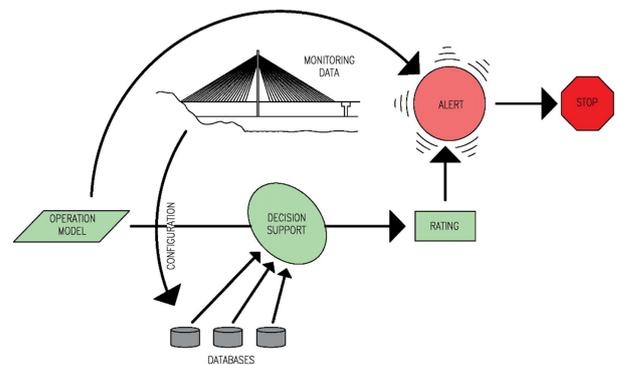
FIGURE 1. Diagram of SHM [1].

Structural health monitoring – SHM enables continual monitoring of the mechanical-physical properties of structures, subsequent evaluation of their health and determination of damage. A simplified diagram of SHM is shown in Figure 1 [1]. SHM of constructions is defined as continual monitoring and analysis of a selected construction [2]. The monitoring is performed using measuring sensors, which are fitted to the structure or in its close proximity. The sensors monitor the mechanical-physical and geometric properties, and climatic changes in the vicinity focusing on changes over time. The goal of SHM is an evaluation of the health of the structure based on the data obtained. Subsequently, the data can be used to identify the location, extent, size, and seriousness of the defect or failure.

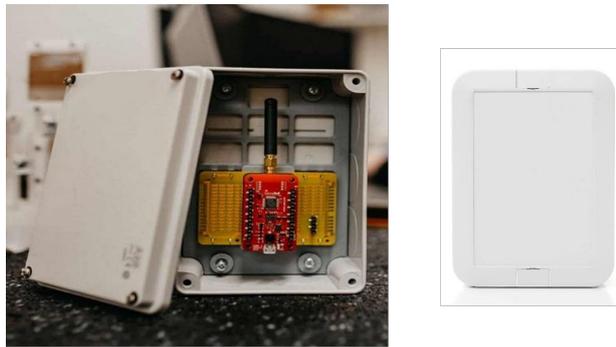
FIGURE 2. Wireless sensor.

The wireless sensors used for the measurement are shown in Figure 2. The sensors contain inclinometer, accelerometer, temperature and humidity sensor. The measurement accuracy of the sensors is shown

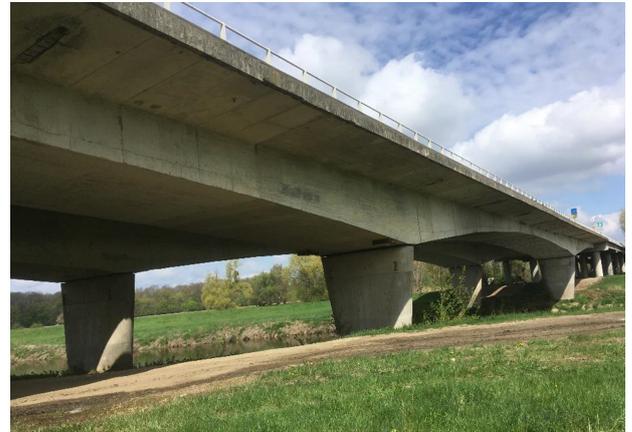
FIGURE 3. View of a box girder bridge against the direction of stationing (view in the direction of Brno).

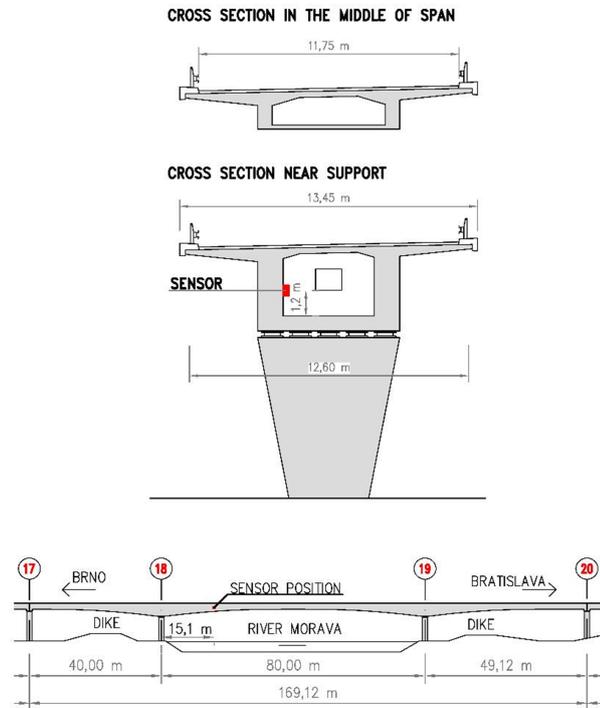
FIGURE 4. Longitudinal and cross section of the bridge.

The supporting structure of simple span units comprises 9 prefabricated prestressed DPS girders with the axis distance of 1 500 mm which are joined in the transverse direction with a reinforced concrete slab with a thickness of 200 mm. The bridge construction spanning the Morava river is a single-box bridge with a closed rectangular profile. The width of the chamber is 6 550 mm and its height is variable from 1 300 to 3 500 mm. The thickness of the vertical walls is 200–700 mm; the thickness of the lower plate is 150–650 mm and that of the top plate is 220 mm. The upper, passable part of the bridge is widened on both sides using 3 300 mm cantilever. The box girder was originally prestressed with 24 tendons Pz of 7 mm. In 1991, it was reconstructed and 4 pieces of external tendons were added. All the spans of the supporting structure are placed on pot bearings.

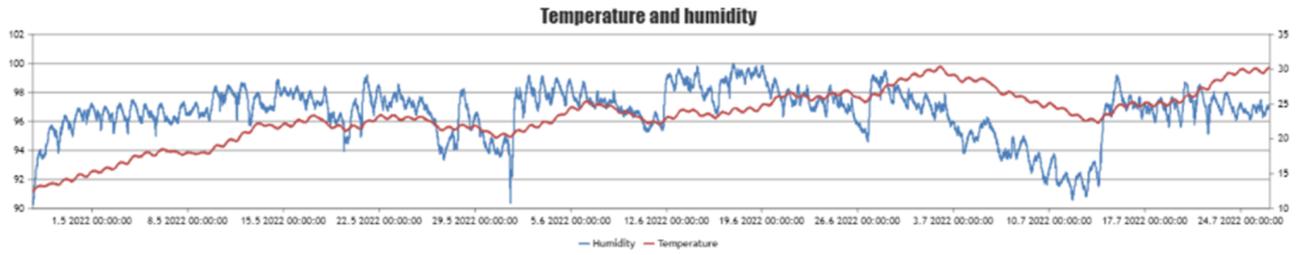
FIGURE 5. Temperature and humidity.

In the first six month of the monitoring, the functioning of the mechanical connections between the sensors and the structure was checked as well as the functioning of the sensors on the structure. Figure 5 shows the temperature and humidity in the chamber. The data show that, even during the summer months, the chamber is excessively humid and a considerable leakage into the structure occurs. Figure 6 shows that on 1st June, 26th June and 16th July excessive leakage occurred. This corresponds with the records from the meteorological station located in the adjacent town, see [14]. The meteorological data show that, on 1st

June, 25th June and 15th July, there were heavy rains. The most significant change in humidity, recorded on 26th June (from 90.8 to 98.1 %), occurred after all-day rain with the rainfall being 32.7 mm/day. The leakage into the bridge chamber was also confirmed by the preliminary diagnostic results and the main inspection of the structure (see the photo of the bridge chamber in Figure 7). The long-term humidity in the bridge chamber in the summer months (June and July), when the average temperature of the surrounding environment is 25.6 °C, is 96.2 %.

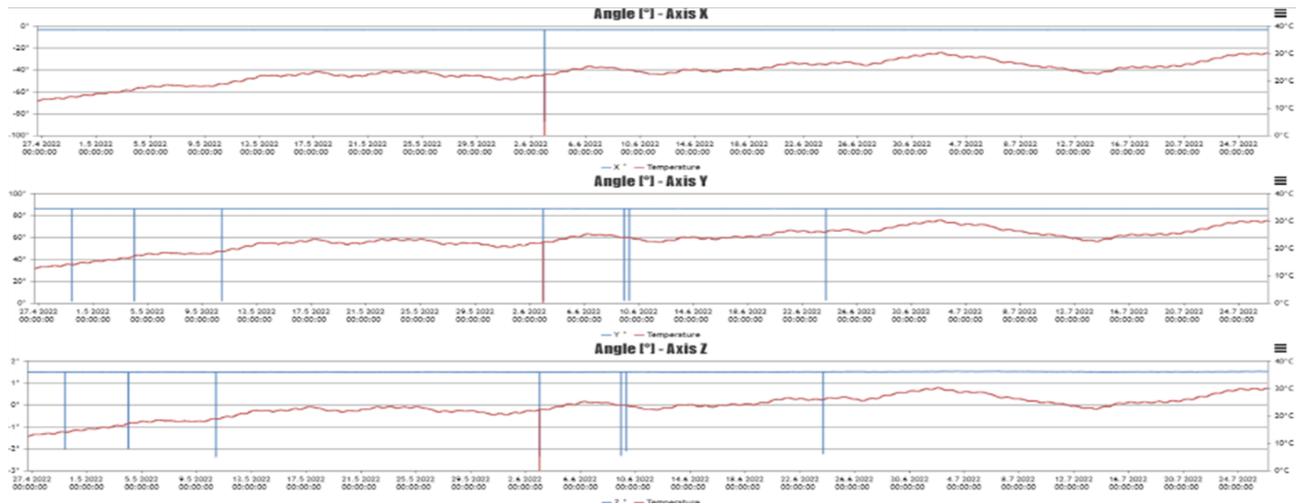
FIGURE 6. Raw data from tilt sensor.

The tilt of the structure along all the axes is very stable. Since the sensing takes place once every 6 minutes, the dynamic traffic load cannot be sensed. Vertical lines showing incorrect measurement can be detected in the recorded data. These errors were probably caused by signal drop-outs of the sending device. The data can be used to determine a change in the longitudinal tilt of the box girder bridge caused by the temperature. At a temperature of 15 °C the tilt of the chamber was -0.179° . At the highest temperature recorded, 30 °C, the tilt of the chamber was -0.216° . The difference between the angles can be used to determine a change in the deflexion in the middle of the longest bridge span. The deflexion changed by approximately 25.8 mm.

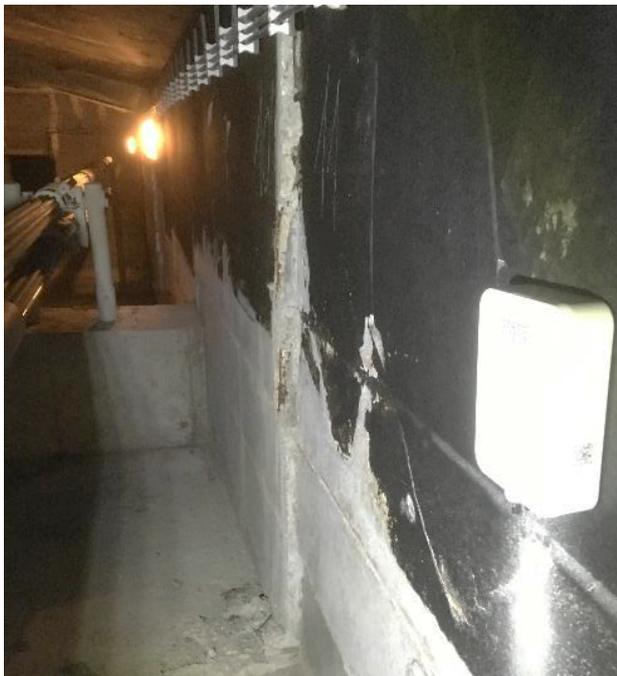
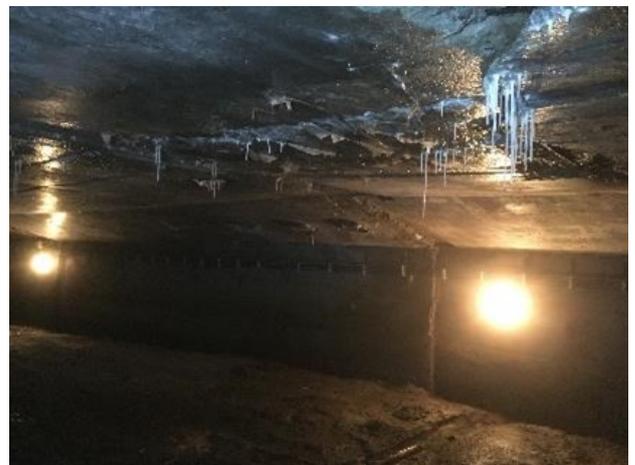
FIGURE 7. On the left – a view of a sensor placed on the wall of a box girder; on the right – a view of the top plate of a box girder, where leakage and urban dripstone occur.

In the experiment, wireless sensors were fitted to the border overhead road. The sensors were placed on the right border box girder bridge. In total, the construction was fitted with 2×3D accelerometer, 2×3D tilt sensor, 2× temperature sensor and 2× humidity sensor. The sensors were fitted to the walls in the central span of the box girder bridge closer to the Czech Republic. The location of the sensors is shown in Figure 4. As the structure has long-term static problems and failures occur both in the supporting structure and in the substructure, it was decided that an extensive diagnostic of the bridge overhead road would be performed. The diagnostic is focused on the material properties of the structure, detection of failures, checking the condition of the concrete repair

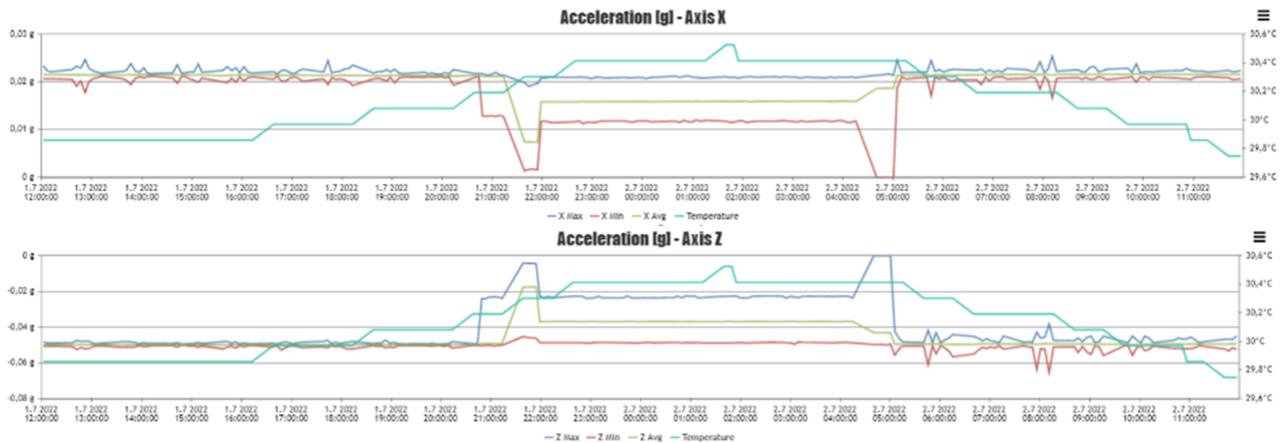
FIGURE 8. Record of the acceleration during the repair of the road.

The acceleration of the structure is also stable. A change in the acceleration occurred during local renewal of the abrasive layer carried out at night-time between 1st July and 2nd July. This renewal caused a change in the acceleration along all the axes. The change in the acceleration was recorded by both sensors at the same time. This change was apparent for the entire time of the repair, i.e., over 8 hours. When the road was being repaired, no significant change in the tilt of the structure occurred, probably due to the fact that the extent of the repair was small.
