# ANALYSIS OF THE EFFECT OF HYDRATION HEAT RESULTING IN THE FORMATION OF CRACKS ON THE EXPERIMENTAL BLOCK OF THE SPILLWAY AT ORLIK RESERVOIR

SIMONA POTUČKOVÁ\*, MILAN HOLÝ, JIŘÍ KOLÍSKO

Czech Technical University in Prague, Klokner Institute, Šolínova 7, 166 08 Prague, Czech Republic

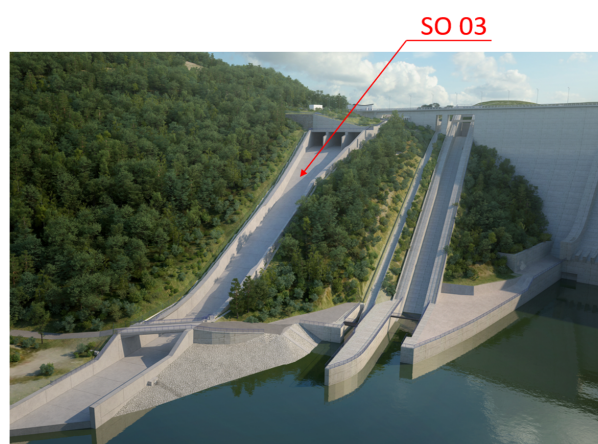
FIGURE 1. Visualisation of the open part of the chute spillway (SO 03 on the left) [5].

The geometrical shape of the experimental block is based on one of the chute floor sections of SO 03 (Figure 1), with a maximum gradient of 40 % (Figure 2), plan dimensions of 7.5 m × 12.0 m and a variable construction thickness of 1.5 m – 1.8 m (Figure 3), all concreted at the same time [5].

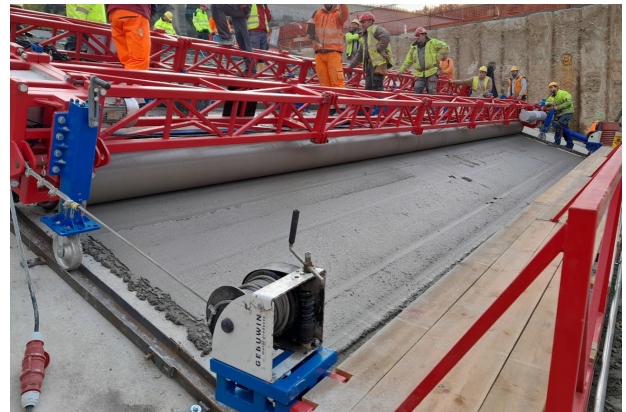
FIGURE 5. Finalisation of the surface.

Metrostav Ltd. secured and managed the concreting of the test block on 2nd November 2022 (Figure 5). Prior to the concreting of the block, the Klokner Institute, with the consent of the company Aquatis, Ltd., arranged the installation of a total of 26 strain gauges (Figure 6).
