# Operating Damages of Bushings in Power Transformers

KAPINOS Jan

**Abstract** — In the paper there are presented typical operating damages of bushings in transformers installed in the national power system. In the paper there are described the basic diagnostic methods for preparation of appraisal of technical conditions of a bushing installed in a power transformer. It is emphasized that it is necessary to increase the frequency of tests in the framework on ongoing control of the bushing technical state. The result of above is an increase of the transformer availability in the power system.

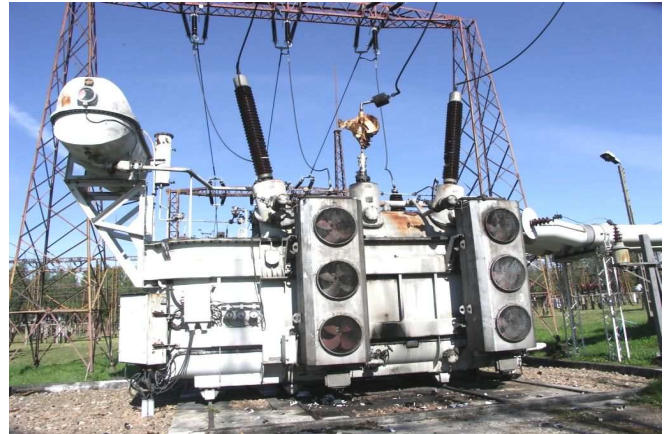
During operation of 160 MVA power transformer 220 kV bushing in L2 phase exploded. Damage of the bushing (Fig. 2) caused occurrence of single-phase short-circuit and fire at the transformer stand. Fire-fighting action was finished relatively quickly. After-failure tests of the transformer were made after installation of substitute 220 kV bushing in place of disassembled damaged bushing.

Positive results of tests confirming correct internal state of the transformer decided that the decision was taken up concerning performance of transformer repair at the site. Porcelain elements of exploded 220 kV bushing made mechanical damages of 220 kV bushings of other phases and porcelain of 110 kV bushings and neutral point. Also porcelain of electric equipment in neighboring 110 kV field was damaged. As result of the fire accessories of the transformer were damaged and firing in some places of the tank occurred.

Fig. 2. Damaged bushing 220 kV in the 160 MVA power transformer

Analysis of results of dielectric losses factor  $\text{tg } \delta_1$  and  $C_1$  capacitance measurements of the damaged bushing from last years of operation did not disclose exceeding of typical values allowed by the manufacturer .

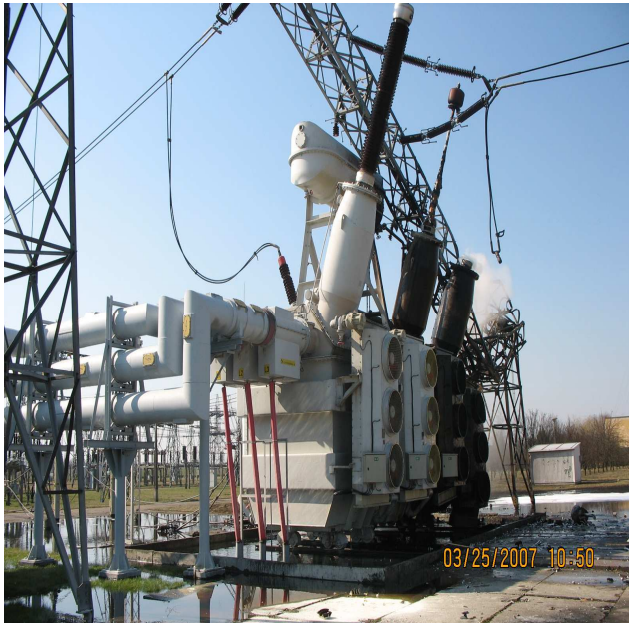
During normal operation of 250 MVA power transformer explosion of 400 kV bushing in L2 phase and next fire of the transformer occurred (Fig. 3). Explosion of the bushing was caused by an earth breakdown in capacitance part. As a result of strong arc quick decomposition of oil in the bushing took place as well as sudden increase of the gas product pressure – of the oil decomposition.

Next the porcelain shield of the bushing exploded and ignition of oil and paper insulation impregnated with oil and next quick spread of transformer fire occurred. Impetuous development of fire was result of oil escape from the transformer tank. Probably in initial phase of fire oil escaped from the tap changer conservator via damaged oil level indicator that was smashed by porcelain part of the damaged bushing or broken as a result of high temperature of the burning oil. During the fire spread the tank was unsealed and oil flowed out via damaged coolers. Fire devastated the transformer completely together with its infrastructure – for example transformer gate, oil bowl.

Analysis of results of dielectric losses factor  $\text{tg } \delta_1$  and  $C_1$  capacitance measurements of the damaged bushing from

last years of operation did not disclose exceeding of typical values allowed by the manufacturer. Close before the 250 MVA transformer failure thermovision tests of temperature distribution at surface of 400 kV bushings were made.

Fig. 2. Damaged bushings 400 kV in the 250 MVA power transformer

Thermovision measurements of temperature distribution on the bushings surface showed differences between temperature distributions. The bushing 400 kV of L2 phase in comparison to other bushings showed highest non-uniformity of temperature distribution – approximately of 1.0 °C. However it is impossible to say unequivocally that this non-uniformity of the temperature distribution on 400 kV bushing surface in “L2” phase could be the result initial failure condition of this bushing.
