# Prague Loretto – Measurements of Moisture Content in Sculptural Group Material

J. Římal

*An innovative method of spatial measurement of the moisture distribution in a sculptural group has been developed and verified. This method facilitates monitoring of moisture distribution and, therefore, the condition of the sculptural group in a spatial perspective. The seven-month measurements were in order to account all climatic effects influencing the sculpture. These measurements resulted from the practical requirement to provide source material for future conservation interventions to be conducted on the sculptural group in the Prague Loretto.*

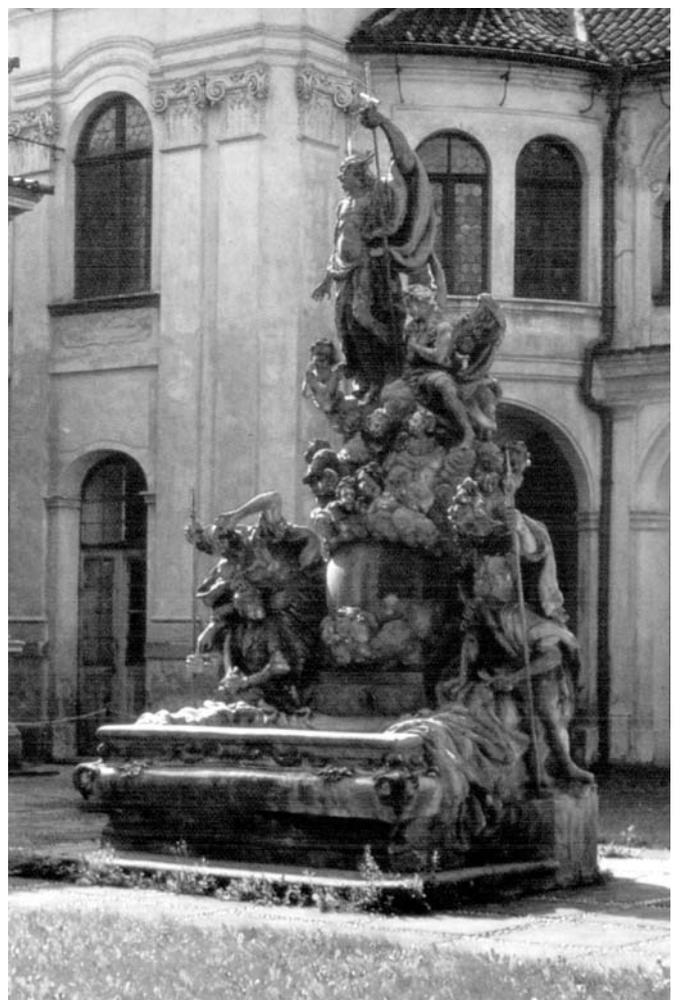
Fig. 2: Fountain decorated with the sculpture of the Resurrection of Our Lord – Jan Michael Brüderle and Richard Prachner, (1739–1740)

The distribution of the selected measured points is indicated in Fig. 2. In all, 14 measured points were numbered from the bottom edge of the sculptural group almost to the top of it.

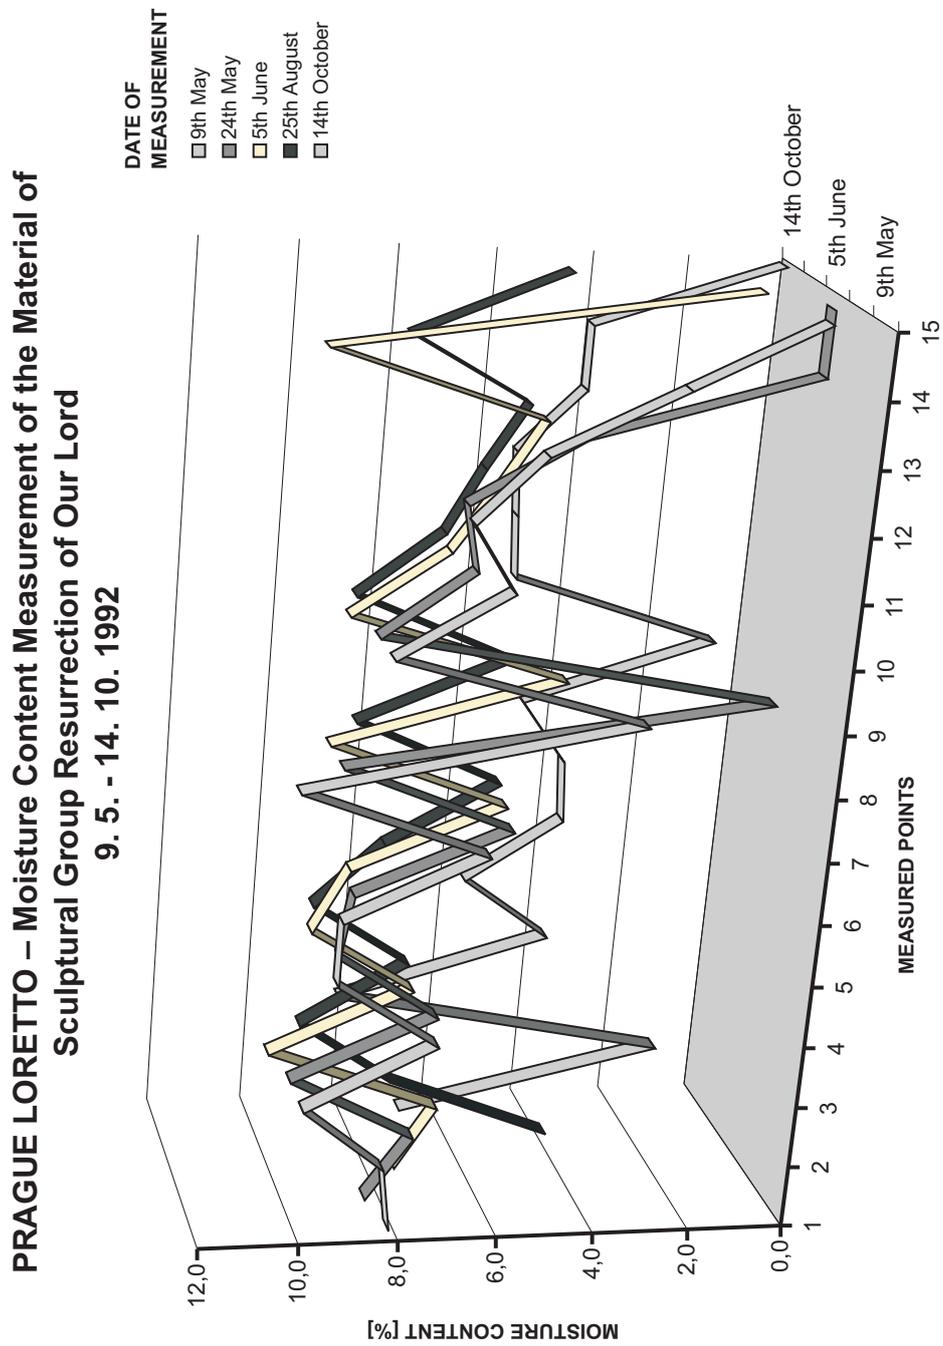
Graph No. 1

The results of the measurements are summed up in a graphic form (see Graph No. 1, No. 2). The charts treat the actual values of the mass moisture content in various ways in relation to the time of measurement and the mutual positions of the measured points, over a seven-month period in order to show a nearly cycle, including spring, summer and autumn. Graph 2 shows the gradients of the moisture field measured at a certain selected point in relation to other (14) points measured all over the statue.

The charts make it clear that we managed to collect complete sets of moisture data for the measured period. The analysis and interpretation enables us to draw wider conclusions on the moisture distribution inside the sculptural group and on the movement of the moisture zones inside the structure during one season of the year. It is also evident how the sculptural group reacted to heavy rainfall and how the water

**PRAGUE LORETTO – Moisture Content Measurement of the Material of  
Sculptural Group Resurrection of Our Lord  
1. 10. 1992**

moved or was retained inside chinks and caverns, or how it migrated through the porous sandstone system. A study of the moisture profiles enabled the water contributions due to capillary elevation and rainfall to be estimated.

Though some combinations of measured points show considerable fluctuations of values depending on the actual moisture contents, it is possible to trace the basic moistening trends during the different seasons and also during the period of intensive summer drying up of the surface parts and their successive wetting after a heavy downpour.

**In absolute values, the highest mass contents range above 10 %, but with regard to the erosion and corrosion behaviour of the sandstone, the steady average moistening of roughly the lower half of the sculptural group ranging from 6 to 8 % seems to be more dangerous, as this is roughly twice the value of the corresponding balanced moisture content of the respective sandstone. These values of moistening are probably the basic source of failures in the intermediate material stages of the structure.**

**To conclude, we recommend that long-term rehabilitation measures on the sculptural group require the installa-**

**tion of a damp-proofing barrier against moisture capillary elevation from the subsoil, and at the same time, the installation of roofing above the structure. Only complete elimination of excessive moisture sources can guarantee the success of any preservation or conservation interventions that will be needed on the sculptural group.**
