# APPLICATION OF CORROSION PLATES IN DRINKING WATER

MICHAL SKALICKÝ\*, PAVEL BURIÁNEK

*Czech Technical University in Prague, Department of Sanitary and Ecological Engineering, Czech Republic*

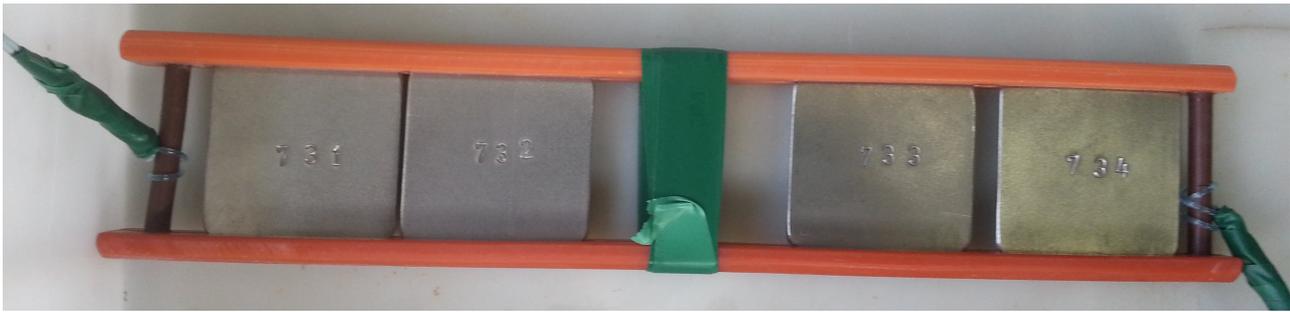
FIGURE 1. Four testing plates mounted in a holder and prepared to be put into the pipeline

At the beginning the steel plates from carbon steel are weighed accurate to the nearest 0.0005 g and are fastened to the holder by 4 pieces (Figure 1).

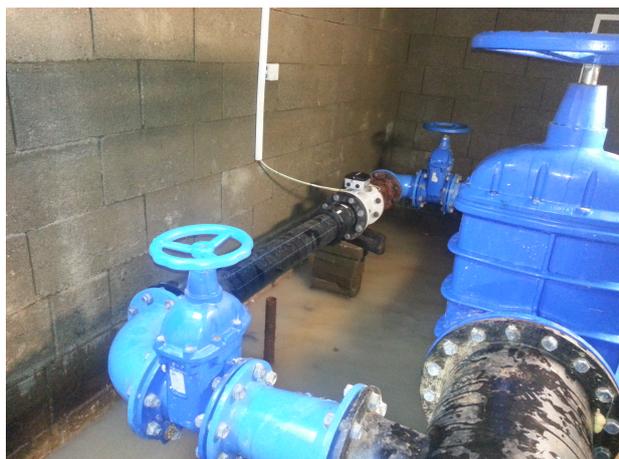
FIGURE 2. Placement of the plates

Holders with testing plates are then installed at the prepared place of the distribution system (Figure 2).

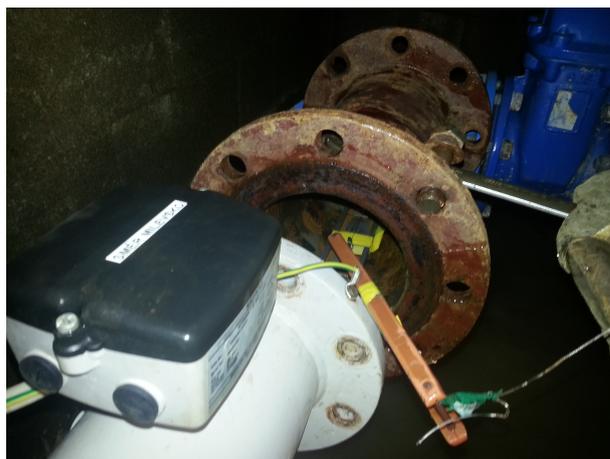
FIGURE 3. Removal of the plates after the required exposure time

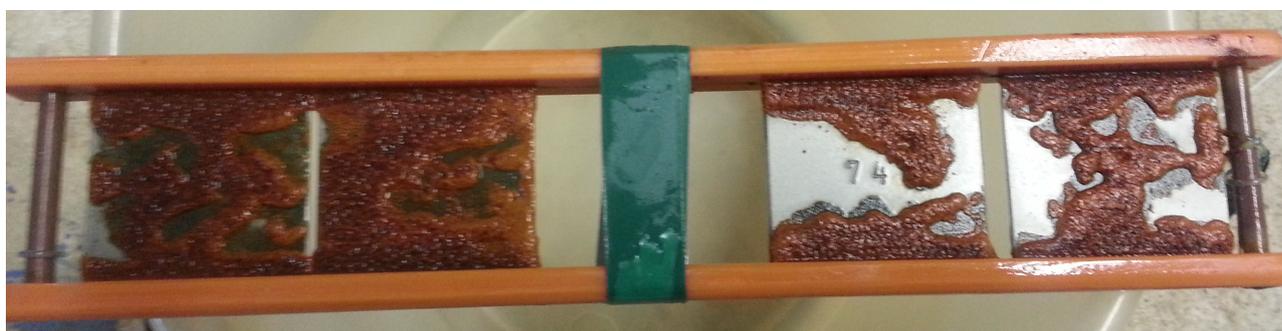
FIGURE 4. Testing plates after extraction from the pipeline

After the required time, the plates with an inlay are removed (Figure 4), dried (THE LAB DRYING ROOM KBC G 100/250) and placed to the desiccator.

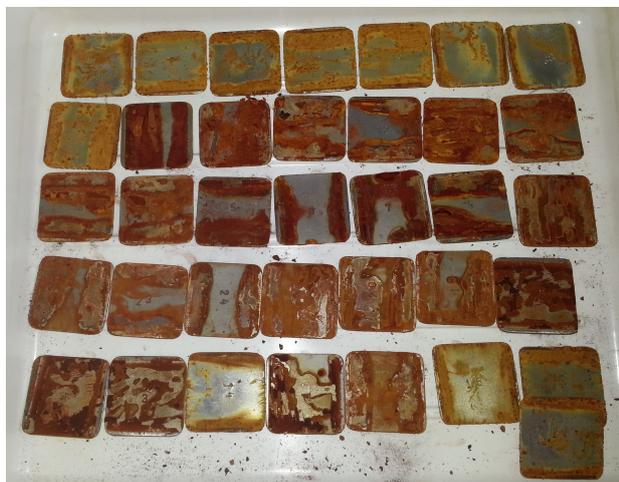
FIGURE 5. Coupons before staining in hydrochloric acid

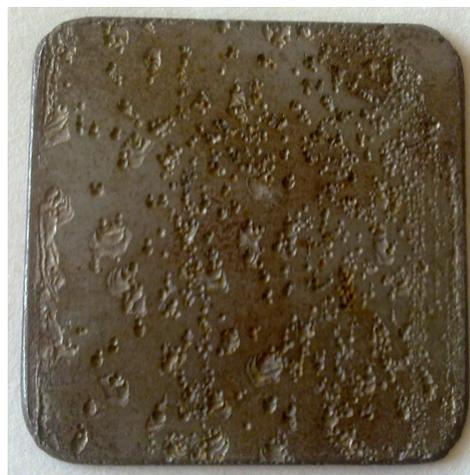
FIGURE 6. Coupon after exposure
