CZECH WW2 CONCRETE FORTIFICATIONS: CORROSION PROCESSES AND REMEDIATION METHOD BASED ON CRYSTALLIZING COATING

JIŘÍ PAZDERKA^{a,*}, PAVEL REITERMAN^b

The present paper deals with a long-term diagnosis of the actual state of a concrete defensive fortification built in the 1930s and with a recommendation of a non-invasive procedure for its effective remediation. The interior parameters of the monitored bunker are also studied, as these originally military structures currently serve for different purposes. The recommended solution for the remediation of these structures is based on the previous research and practical experience.

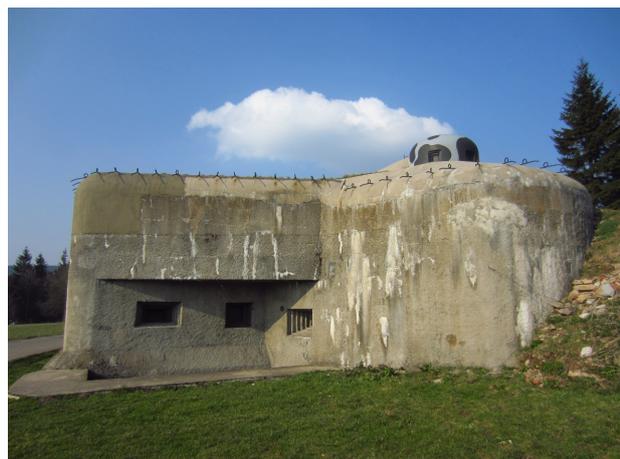
The authors of the article chose a well preserved, two-storey, heavily fortified bunker, R-S-74, near the town of Rokytnice v Orlických Horách, situated close to the northern border of the Czech Republic (former Czechoslovakia), for the building survey (Figure 1, Figure 2). The bunker was not connected by underground tunnels to any other neighbouring buildings (detached building). The bunker was built in the highest class of resistance (of that time) – ceiling thickness: 2.6 m, front wall: 2.75 m, back wall: 1.25 m. According to historical sources [30], the construction took place in 1937 – 1938, the concreting of bearing structures was carried out in December 1937.

FIGURE 1. Contemporary appearance of the heavily fortified bunker R-S-74.

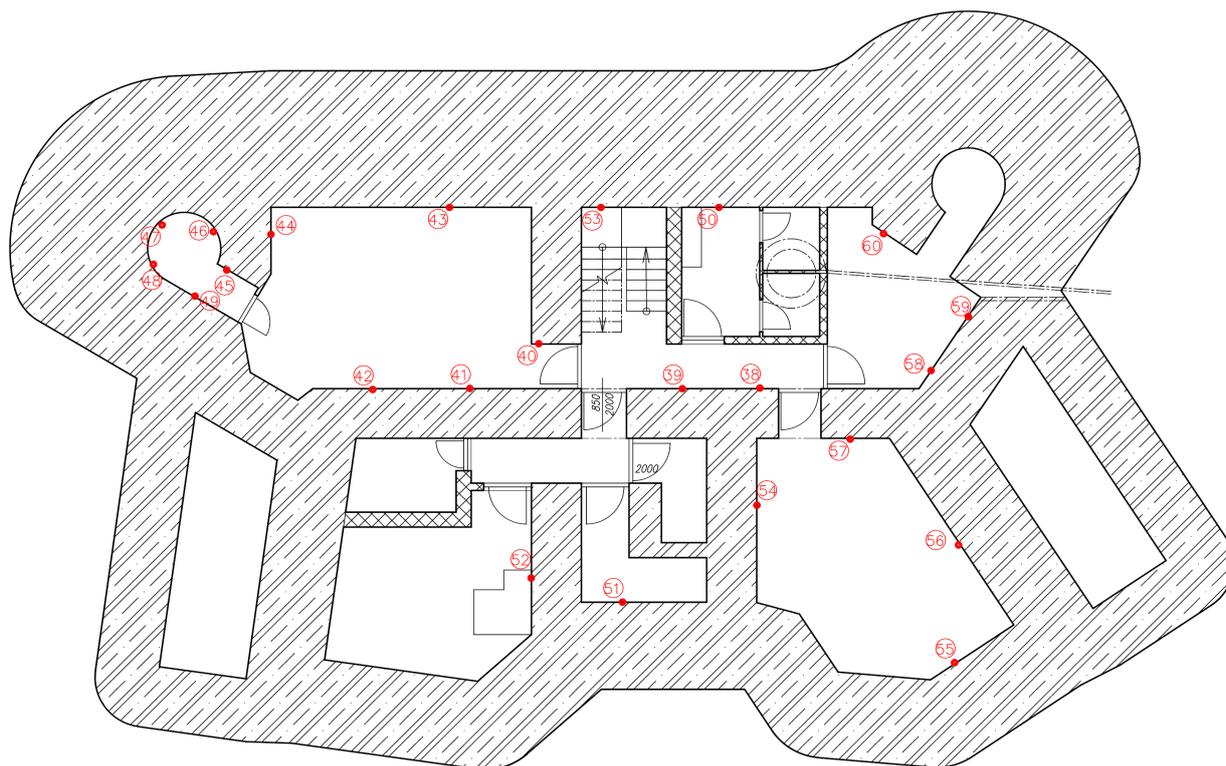
The analysis of moisture contents in the monitored structure required a complex approach, hence the bunker was divided into smaller sections the distribution of which is shown in Figure 3 and Figure 4. All concrete interior walls were measured, except the walls with a steel plate facing where the measurement was impossible. Moisture was measured at three heights - the distances from the floor were 0.2 m, 1.2 m and 2.4 m; 180 points were measured in total. The moisture content measurement was conducted by using a non-destructive capacitive method preferably to limit invasions into the structure. However, the calibration by traditional gravimetric measurement (Eq. 1) was necessary for the required accuracy and reliability of this method. Additionally, samples for gravimetric measurement were extracted at different depths to assess the real moisture state of the concrete.

FIGURE 4. Internal layout of measurement points on the underground (lower) floor.

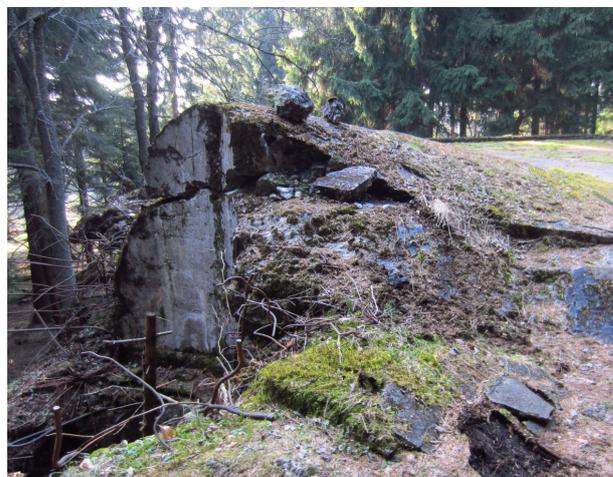
FIGURE 5. Sampling site - ruined structure of the nearby bunker R-S-73.

substitute solution: obtaining the samples from the nearby R-S-73 bunker, which had been heavily damaged shortly after WW2 by extracting raw materials. The obtained samples are part of the ruined structure, therefore, no damage was done to the historic bunker due to their extraction (Figure 5).

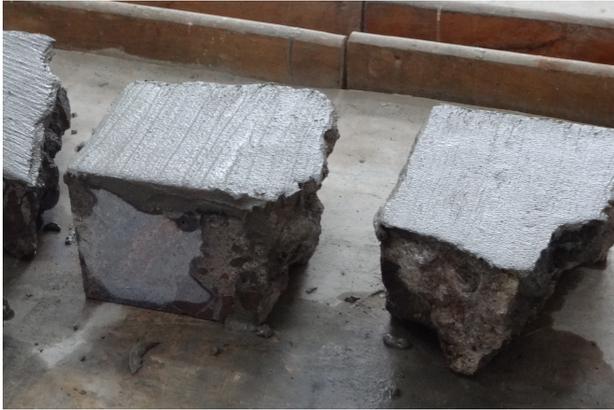
FIGURE 6. Samples with an applied crystallizing coating.

Laboratory measurements were carried out on the basis of positive references documenting the sealing effect of crystallizing coatings to verify the possibilities of their successful application during the restoration of the fortification system from the 1930s. The Canadian crystallizing coating, Xypex Concentrate, was selected. The main aim of the performed programme was the assessment of the efficiency of the crystalline agent in improving the highly permeable part of concrete which is more than 80 years old, to reach its total water impermeability. Additional four pieces of concrete were extracted from the bunker No. R-S-73 for the test. They were partially fallen-off parts interconnected with the rest of the concrete structures by sticking-out reinforcement rods. The dimensions and shapes of all samples were adjusted in the laboratory to be suitable for the water penetration test. Three samples were unilaterally treated with a crystallizing coating (Figure 6). The last sample was kept as a reference one, without any surface treatment. The samples were subsequently cured in a special box simulating real moisture conditions in the bunker.

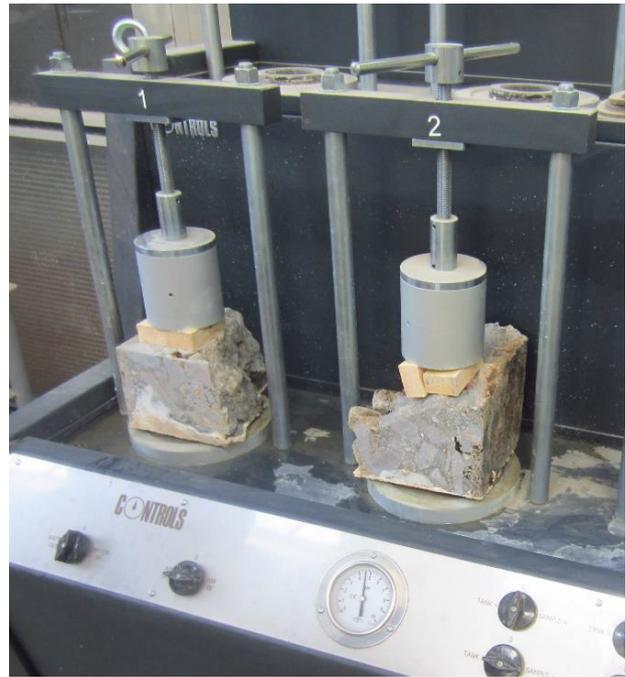
The measurement of the water penetration depth (EN 12390-8 [6]) was carried out after four months of curing with respect to literature [35]. A longer time interval of the subsequent testing was chosen due to the high age of the treated concrete where a high rate of hydration was expected. The presence of any hydrating minerals is a necessary prerequisite for the efficiency and the start of the secondary hydration process. The dimensions of the used samples were not accurate according to EN 12390-8 [33] due to the above limitation during the sample extraction. The samples were subjected to a water pressure of 0.5 MPa, which corresponds to the hydrostatic pressure of a water column with 50 m in height (Figure 7).

FIGURE 7. Samples with a crystallizing coating under the water penetration test (EN 12390-8).

The maximal obtained depth of the water penetration reached values of up to 2 mm, which highly exceeds common requirements for all exposure classes defined in EN 206 [34]. The effectiveness of the remediation

procedure was verified. The results manifest the sealing effect of the used surface crystallizing treatment (Xypex Concentrate), which had been confirmed in other studies [13–18]. Highly permeable parts of the historical army structure were positively influenced by the gradual secondary crystallization so that the entire mass of concrete could be considered as impermeable. Now, the application to real bunkers will follow.

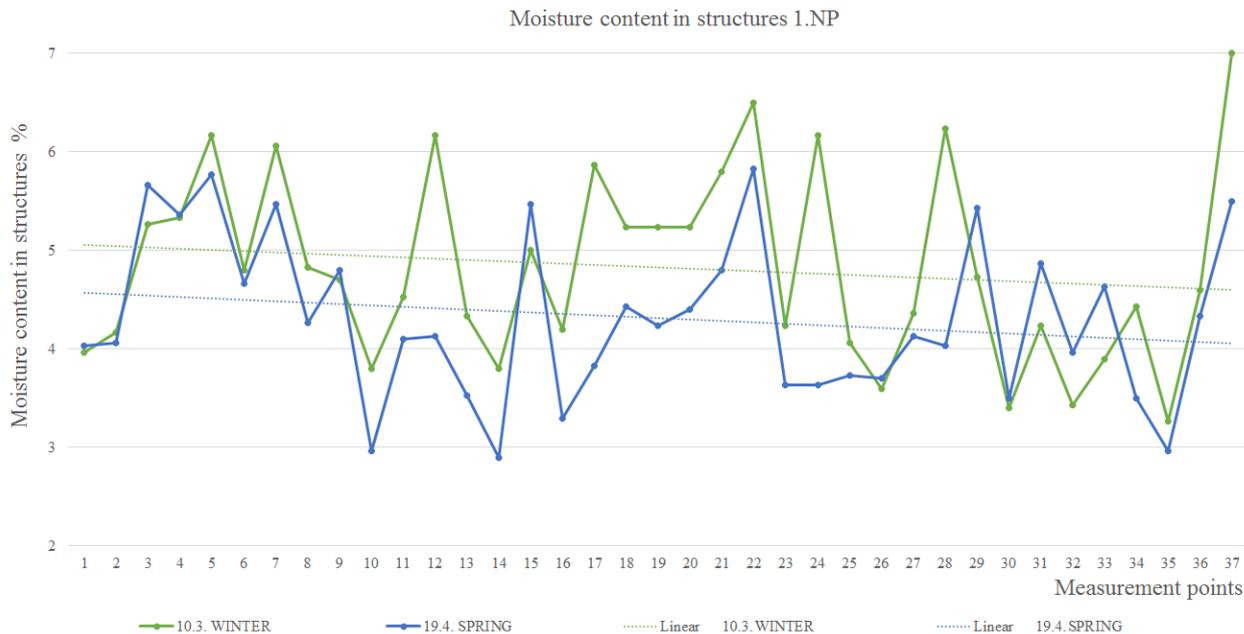
The obtained results indicated a slightly increased level of moisture in the structures in the whole bunker. The lowest value of moisture was 1.9%, while the highest was 7.6% (in percentage by weight). All results are listed in the first floor and underground floor drawings. The results from spring and winter were compared, because, in winter, the bunker was covered by snow. The linear trend of the results displays that the measurement made in winter exhibits higher values than the measurement made in spring (Figure 8, Figure 9). The moisture content in the structures is not too high on average, but water visibly leaks in many places. The causes were studied during the following inspection.

FIGURE 8. Comparison of moisture contents in structures measured in winter and spring – the first (upper) floor.

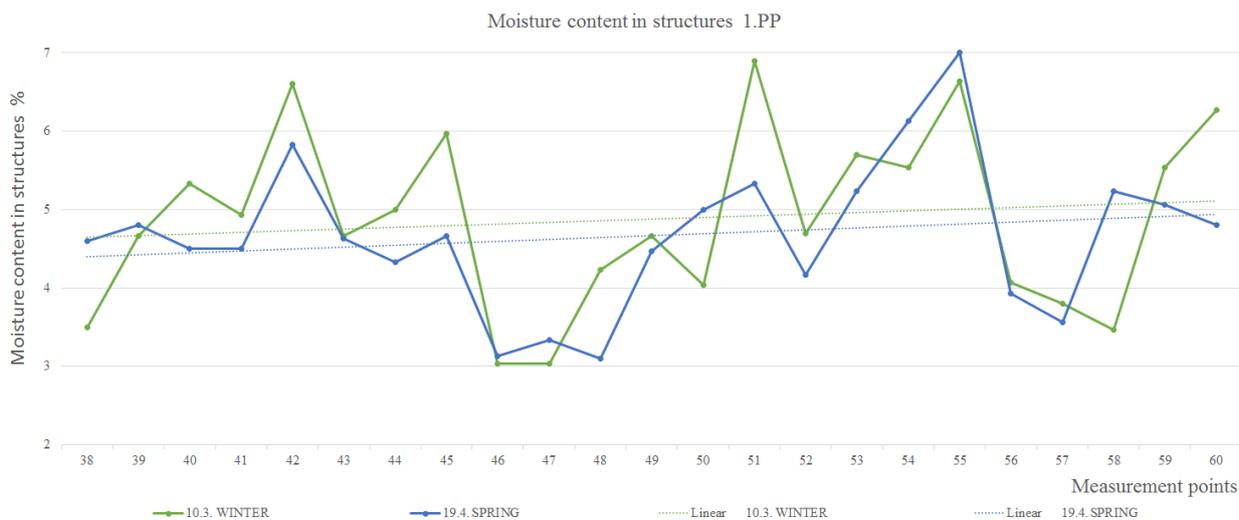
FIGURE 9. Comparison of moisture contents in structures measured in winter and spring – the underground (lower) floor.

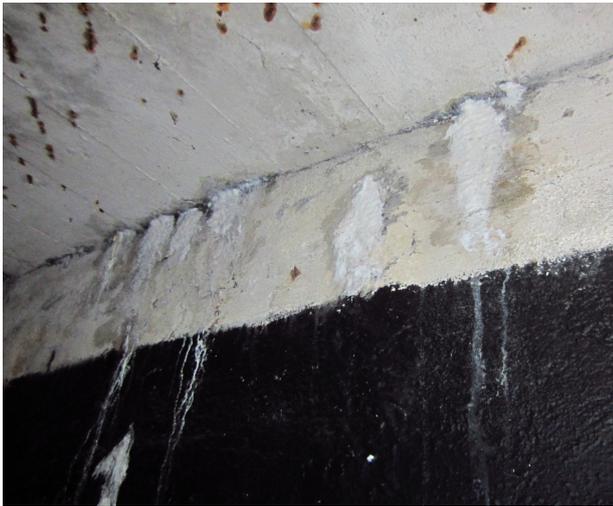
FIGURE 10. Surface efflorescence in the interior (bunker R-S-74).

A visual exhibition of the corrosion product is a typical efflorescence on the concrete surface originating from the leached $\text{Ca}(\text{OH})_2$ and its subsequent carbonation (Figure 10).

The results obtained after the thermogravimetric analysis and their comparison with the measurement on standard pure CaCO_3 exhibited a high similarity. The TG curves were analysed for specific temperature intervals by monitoring the weight loss. The average weight loss for the efflorescence samples was 41.2% in a range of 615 – 918 °C, which presents the area of the calcite decomposition [36]. The measured weight loss corresponds with the content of 93.85% of calcite in the studied efflorescence. The presence of calcite efflorescence caused by massive leaching of the binding components of the used concrete was confirmed.

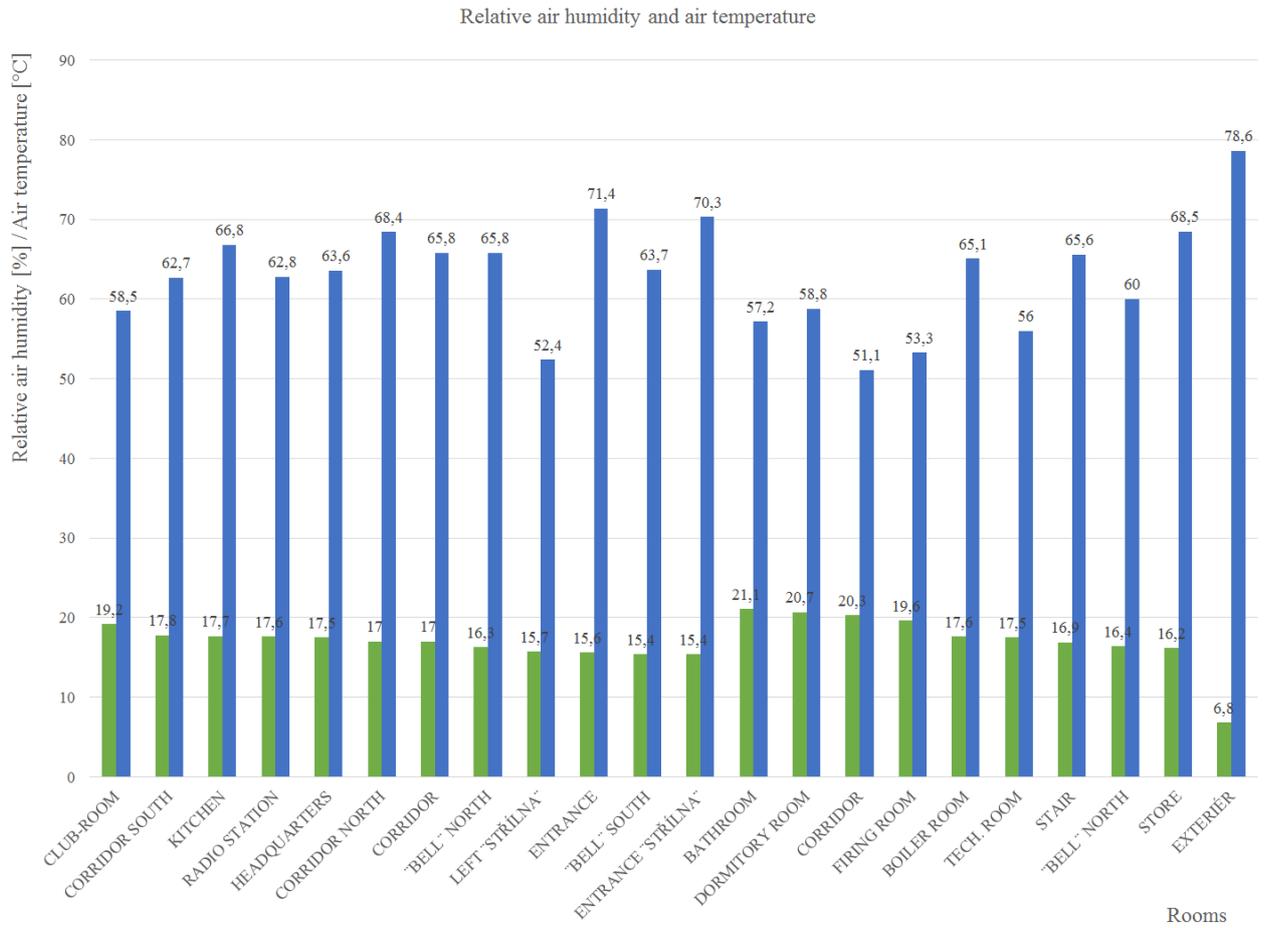
The results are displayed in the graph in Figure 11. The chart is divided into individual floors and sorted by the air temperature value. The room temperature is influenced by the usage and placement of local heating (panel radiators), which were additionally installed in the 1980s. The inhabitants (members of the club) stay for a longer term only in the following rooms: club-room, bathroom, dormitory and a room called “střílna”. These rooms should comply with

From air humidity and temperature values, the temperature dew point can be calculated. The condensation of air humidity is possible, if the surface temperature is less or equal to the dew point temperature. From the data, which are shown in Table 4, it is almost certain that there will be no condensation in the measured heated room. But in the unheated rooms, the situation could be different – there is a higher risk of surface condensation so the heating of these rooms and forced ventilation is recommended.

FIGURE 11. Graph of relative air humidity and air temperature measured in spring.

The air humidity measured in the rooms equipped with the heating was only slightly higher compared to the standard interior requirements. It was confirmed that the source of the moisture in the most damaged rooms was not condensed water on the walls. With a high probability, water seeps into the bunker from the exterior. The interior air quality in terms of carbon dioxide concentrations easily exceeds limits [37] and it is highly recommended to use a forced ventilation.

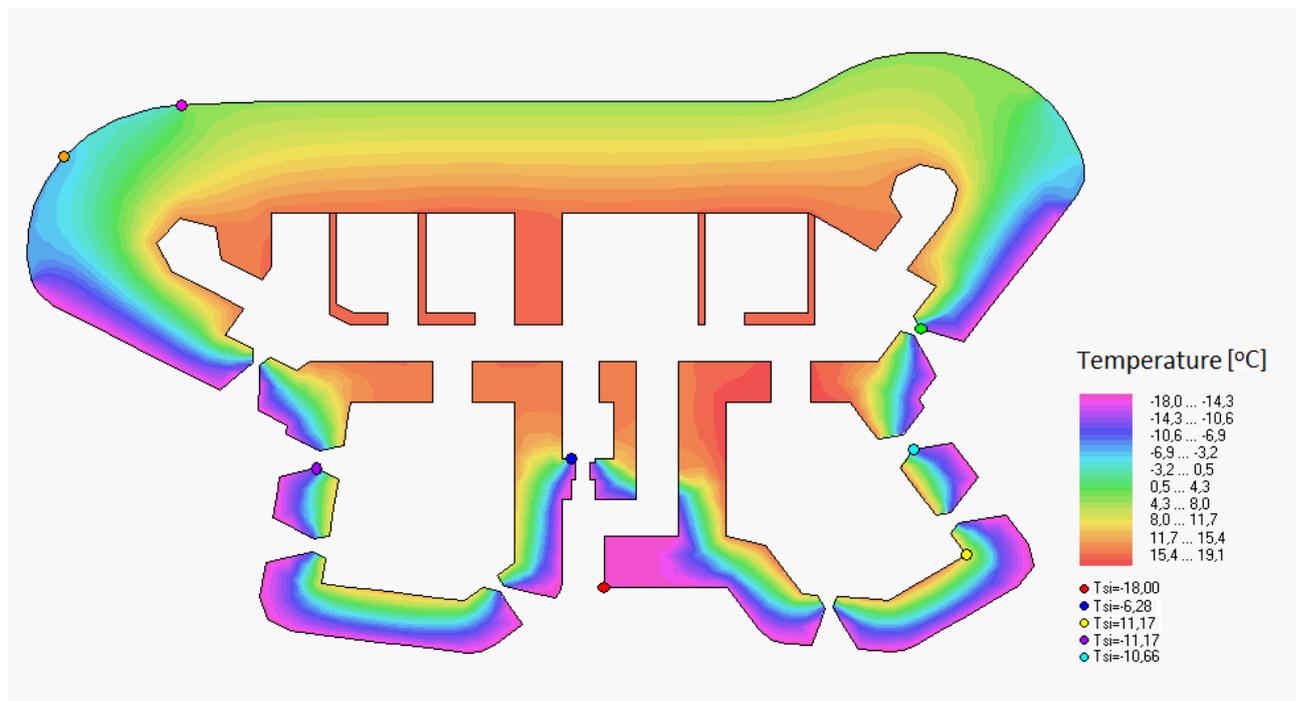
the requirements for thermal comfort. The measured temperatures in these rooms, which were between 19.2 - 21.1 °C, fulfil the criteria for a long-term stay. The thermal performance model of the building was created from the values of the measured air humidity and air temperature (Figure 12, Figure 13, Figure 14). This was made by the “Area 2017” software (Svoboda Software Ltd.). The temperature and moisture values used were based on a real measurement performed in February.

FIGURE 12. 2D thermal performance model of the first floor (Area 1717).

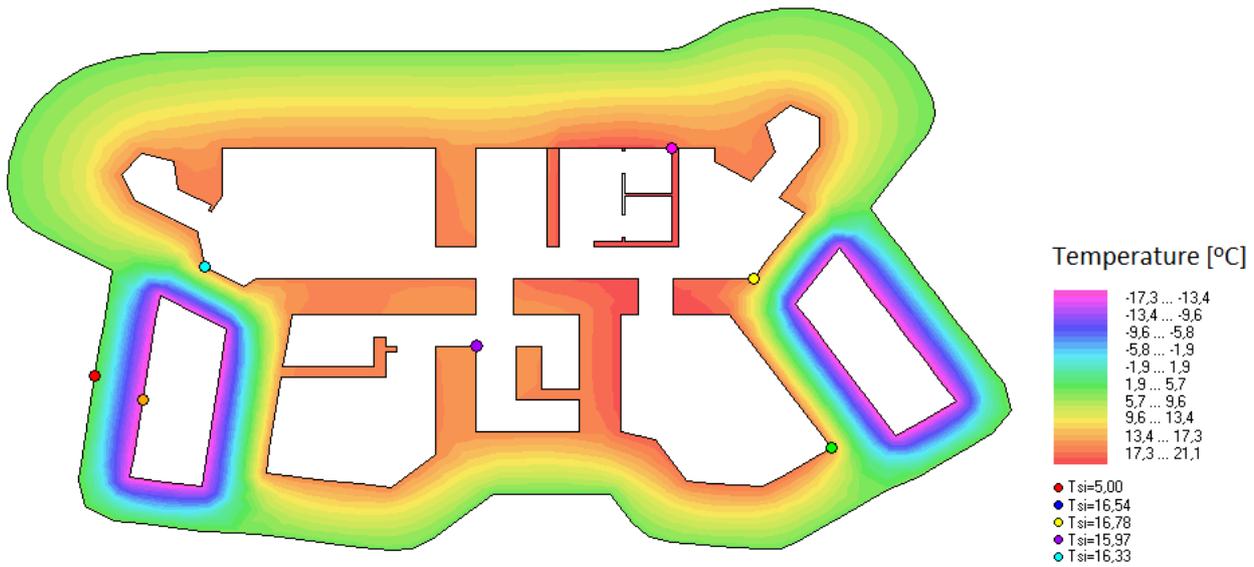
FIGURE 13. 2D thermal performance model of the underground floor (Area 2017).

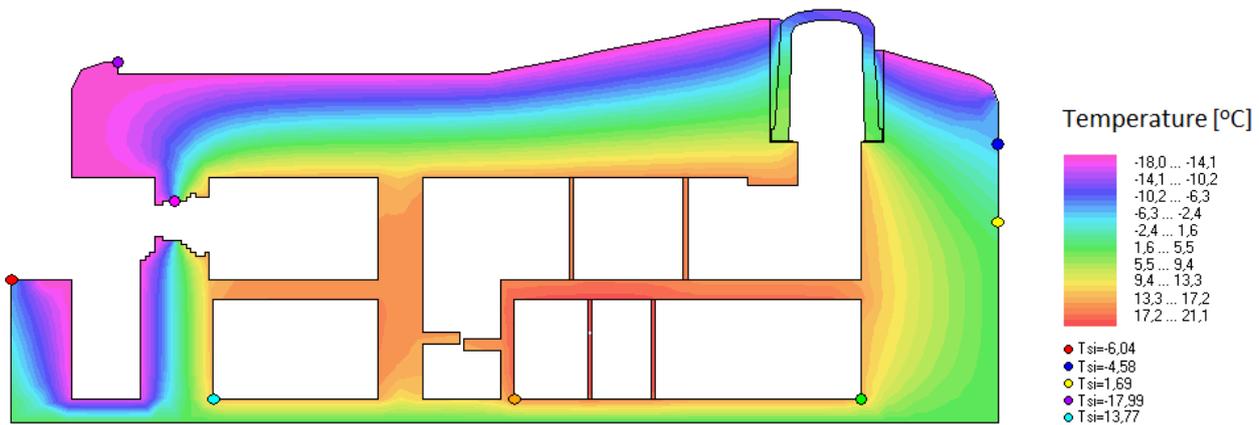
FIGURE 14. 2D thermal performance model of the cross-section (Area 2017).

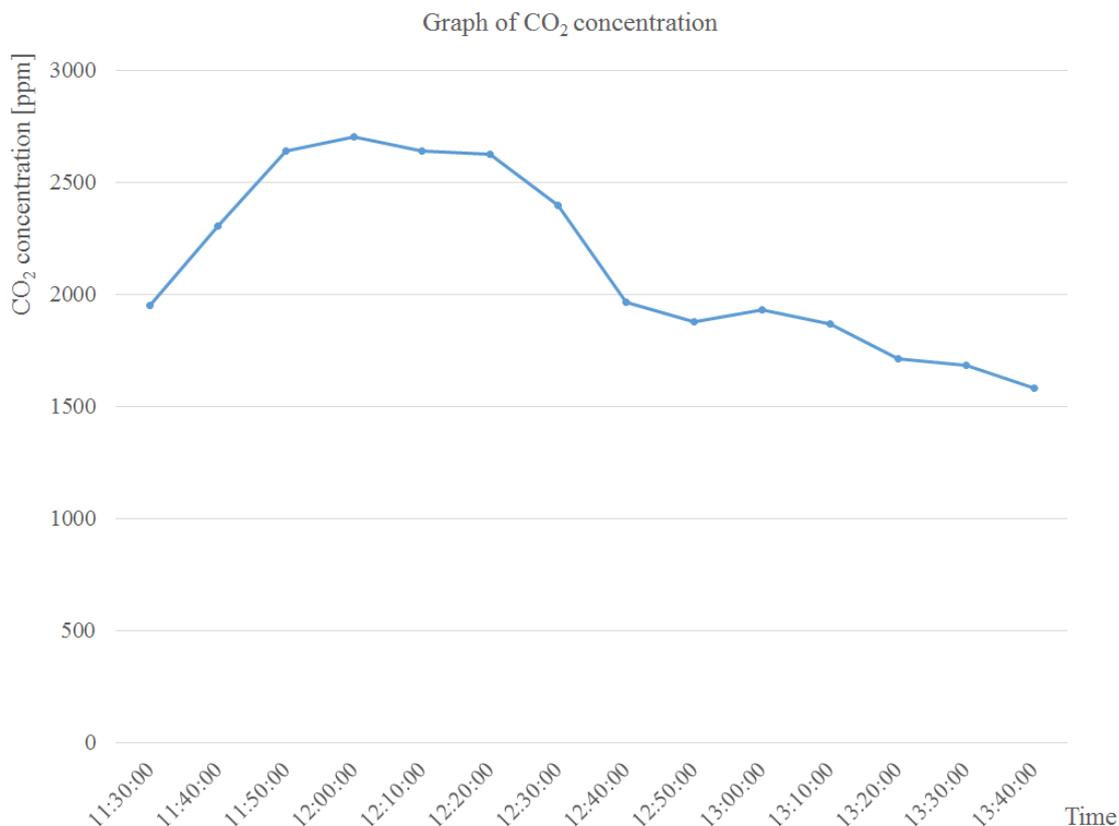
The dormitory room, where the measurement was performed, serves as the place where most of the people in the bunker sleep. The room with this purpose should be adequately ventilated and the CO_2 concentration should be less than 1500 ppm according to EN ISO 16000-26:2012 [37]. The whole room is windowless with a one entrance, has a volume of 43.5 m³ and usually serves as an accommodation for 6 to 10 people. Unfortunately, there was no possibility to measure the above data for a longer time and examine the CO_2 variability over day and night. The measurement was performed in February from 11:30 until 13:40 with a frequency of once per 10 minutes. The highest measured value reached 2703 ppm, which is by about 80% more than the value acceptable by EN ISO 16000-26:2012 [37]. During this measurement, there were no more than two people in the room. In the case of six or more people in the room, a higher concentration of CO_2 can be achieved - it could then have a harmful effect on their health.

Sometime after the start of the measurement, two people stayed in the room for a limited time. These minor changes in the room occupancy are easy to spot in the graph in Figure 15. The highest values were measured when people were present in the room. Due to the probe placement on the other side of the room, a devaluation by a direct exhalation on the CO_2 probe was not possible.

FIGURE 15. Measured values of carbon dioxide concentrations in the dormitory room.

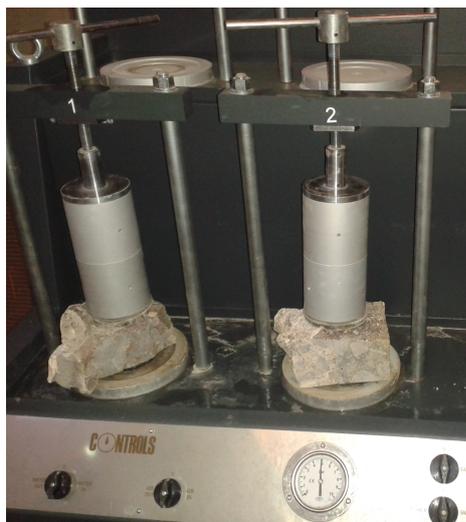
In this case, water had penetrated through each sample during the test (before the end of the time limit). The concrete samples were, therefore, permeable. A subsequent study of the fracture surface of the sample shows that the sample contains different parts with a different permeability (Figure 17).

FIGURE 16. Sample from the bunker R-S-73 under the water penetration test (EN 12390-8).

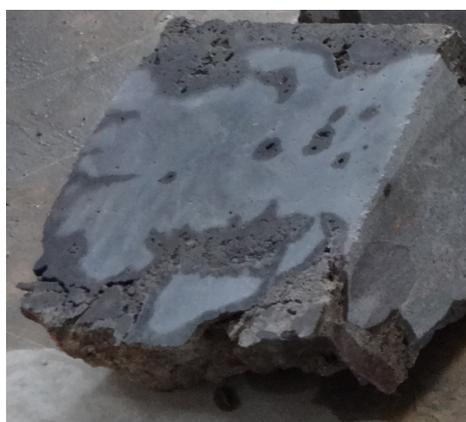
Based on the studies of fracture surfaces, it is evident that the concrete used for the construction of the historic bunker consists of high-quality (waterproof) and low-quality (permeable) parts. The observed inhomogeneity could be caused by poor workmanship – insufficient concrete compaction, a bad ratio of mixed components, or due to severe weather conditions during the construction – low temperatures, heavy snow,

strong wind. However, the frequent inhomogeneity in the concrete resulted in its high permeability, which was well manifested during the testing. The extracted samples exhibited massive seepage during the water penetration test (Figure 16). The inhomogeneity of the studied concrete is well visible in Figure 17.

FIGURE 17. Heterogeneous structure on the fracture surface of the sample.
