# CYCLIC RESPONSE OF RC BEAM-COLUMN JOINTS STRENGTHENED WITH TRANSVERSE STEEL BARS AND WITH C-FRP DIAGONAL TIES

**ABSTRACT.** The use of additional bars, internally placed through drill holes, in external beam-column connections subjected to cyclic loading, as shear reinforcement is experimentally investigated.

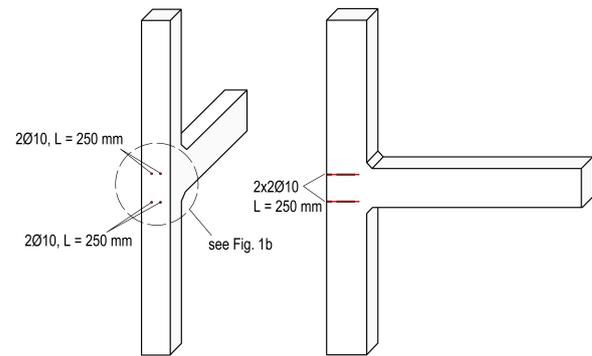
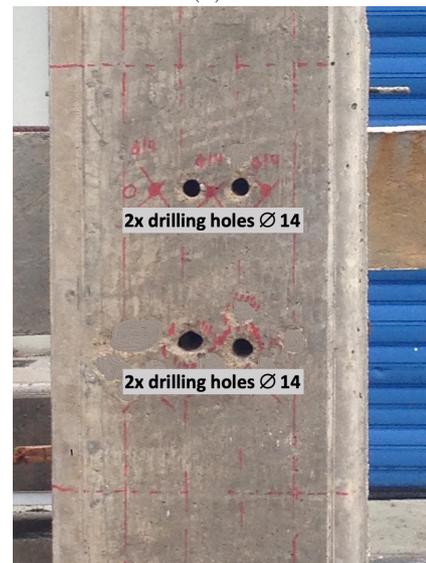
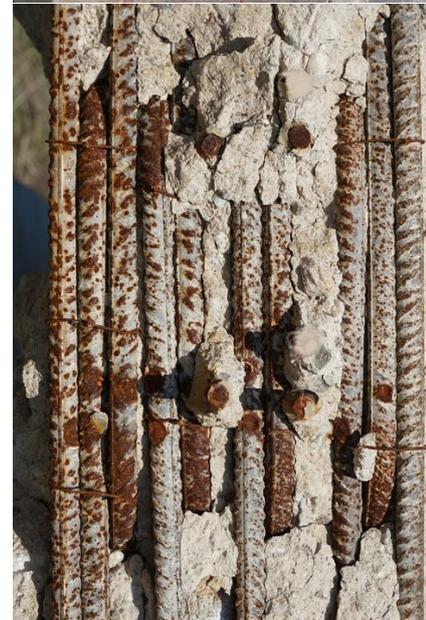
FIGURE 1. Reinforcement of additional bars for model JB0R.

(A).

(B).

Strengthening of the node of specimen JB0R has been performed prior to the tests. Holes  $\text{Ø}14 \text{ mm}$ ,  $L=250 \text{ mm}$  were drilled at  $0^\circ$  into the test specimen JB0R to be reinforced (Figure 1a and 1b). The drill

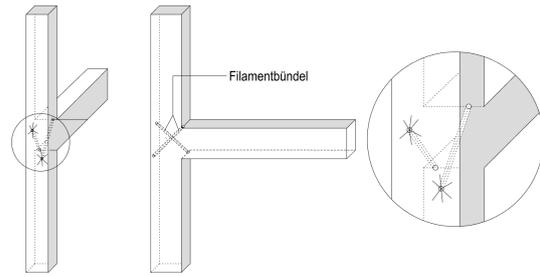
(A) . Strengthened specimen JB0VFX C-FRP rope.

After cyclic loading of the test specimen JB0V, the damage was caused in the nodal area (Figure 4a). Loose concrete parts were first removed. Then, the damaged area was shuttered and grouted with Sika Monotop-34. During this process, C-FRP rope bundles, diagonally impregnated with Sikadur-52, were tightly installed and fixed to improve the shear force bearing capacity. The C-FRP ropes are high-strength plastics that act as ropes and can transfer high tensile forces. Details on these materials can be found in Table 1. The damaged specimen JB0V has been repaired and strengthened with C-FRP ropes crossing the node diagonally (Figure 4a and 4b). The first rope has been placed starting from the bottom back of the node and wound towards the upper face of the existing beam; the second rope started from the top back of the node and wound towards the upper face of the existing beam (Figure 4). The fixed specimen was labelled as JB0VFX. It was then subjected to the identical cyclic loads on the test rig again. The performance of the two test specimens is evaluated and compared.

The final anchoring of the rope ends is done in a star shape in milled slots. The Sika Anchorfix-3+ is then placed in the slots and the C-FRP ropes impregnated with Sikadur-52 has been casted. The properties of the materials used are given in Table 1.

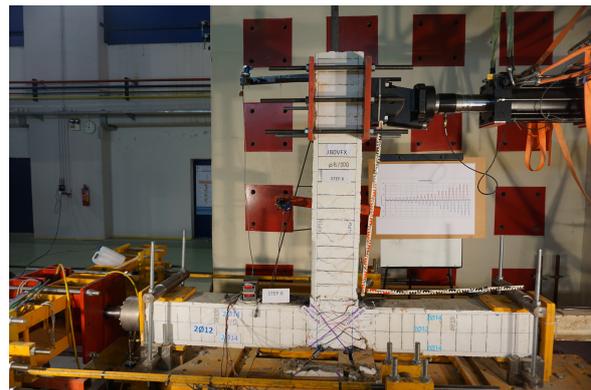
(B) . Reinforcement of additional bars for model JB0R.

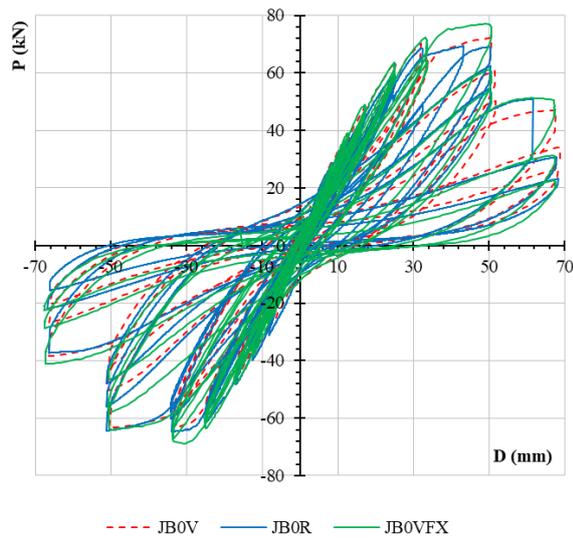
FIGURE 7. Force-displacement curves for all specimens.

In the diagram, the dashed red lines represent the test results of the unreinforced specimen (JB0V), while the solid blue and green lines represent the results of the subsequently reinforced specimens JB0R and JB0VFX.

The comparison of the test results shows that the applied reinforcement method using 2Ø10 round steel reinforcement at the top and bottom increases the load capacity by only about 6%. The reinforcement by C-FRP ropes shows a significant improvement. The

In order to determine the effectiveness of the applied reinforcement method, the load-bearing capacity of the unreinforced specimen JB0V is compared with the load-bearing capacity of the reinforced specimens JB0R and JB0VFX. The hysteresis loops of the respective specimens are shown in Figure 7 by means of a force-displacement curves.

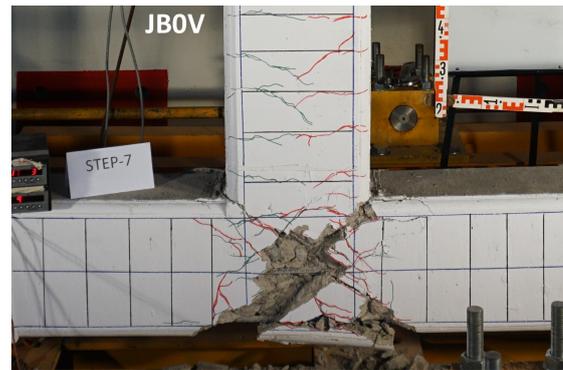
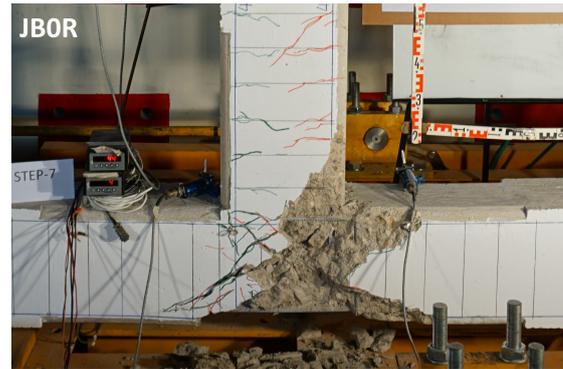
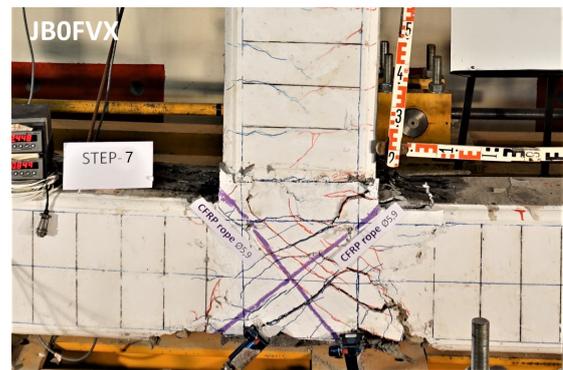
FIGURE 8.

(A) . Final damage mode, specimen JB0V.

(B) . Final damage mode, specimen JB0R.

(C) . Final damage mode, specimen JB0VFX.

damage patterns on the unreinforced specimen and the reinforced specimens after completion of the tests are compared in Figure 8. As can be seen, the damage pattern of both test specimens JB0V and JB0R is almost identical.

When reinforced with C-FRP ropes, the behaviour of the specimen JB0VFX is much more benign, the spalling of the concrete is greatly reduced, which is due to the fact that the rope reinforcement shows its effectiveness. This is also mainly due to the better anchorage of the C-FRP ropes adjacent to the highly stressed intersection. Thus, the overall damage pattern is significantly improved. The envelopes of the hysteresis loops for a full test run with 3 cyclic repetitions per loading level are shown in Figure 9a, 9b and 9c for all specimens, for all 3 cycles (seven steps per cycle).

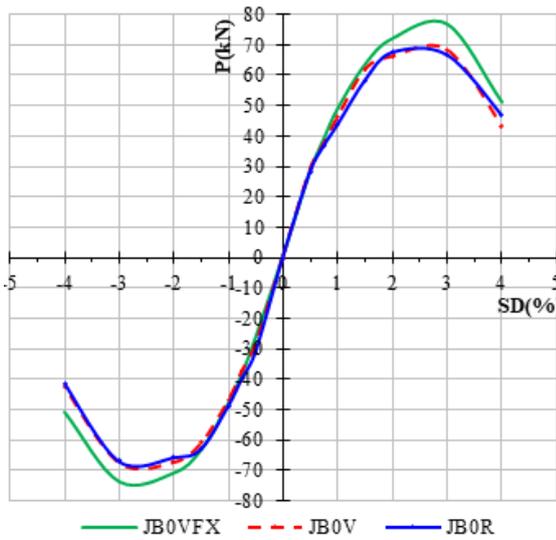
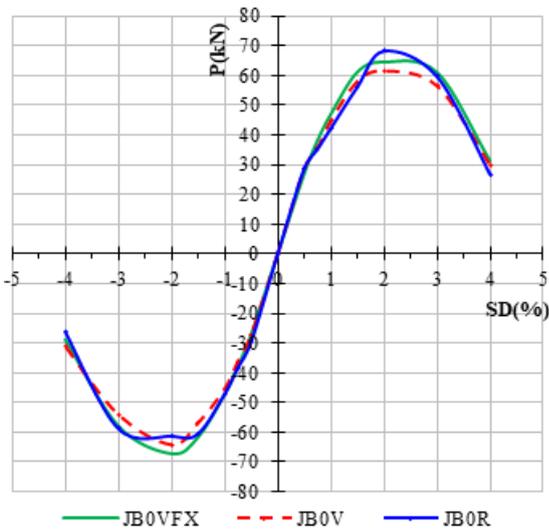
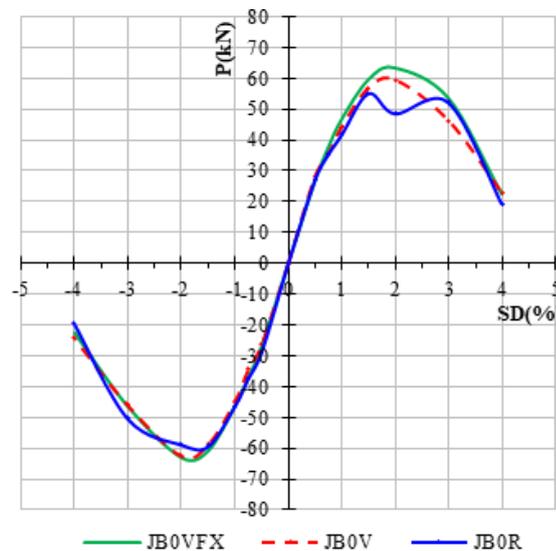
FIGURE 9.

(A) . Envelope curves of maximum loads at 1<sup>st</sup> loading cycles.

(B) . Envelopes of maximum loads at 2<sup>nd</sup> loading cycles.

(C) . Envelopes of maximum loads at 3<sup>rd</sup> loading cycles.

In the diagrams, the test load ( $P$ ) required for the selected deformation is plotted against the relative displacement ( $SD$  – story drift). For the sake of better representability, only values up to a load level 7 with  $SD = 4\%$  and a displacement of  $\pm 68$  mm are plotted. In addition, Figure 10 shows the change in stiffness regarding to load levels. The dashed red line corresponds to the unreinforced specimen JB0V, the solid blue line to the reinforced specimen JB0R and the solid green line to the reinforced specimen JB0VF.

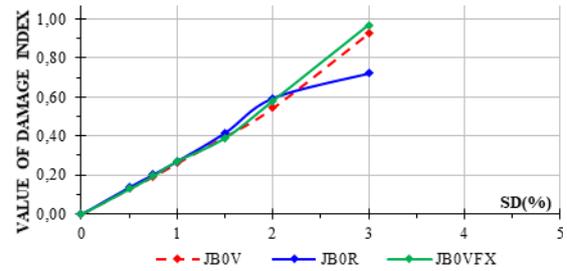
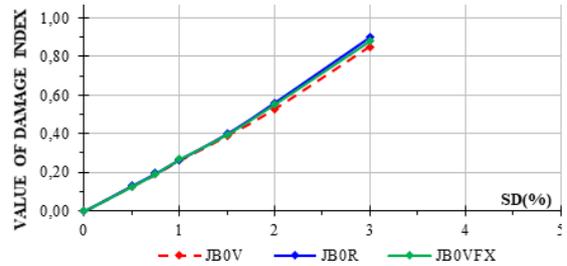
FIGURE 10.

(A) . Damage index values for the 1<sup>st</sup> cycles of the loading steps.

(B) . Damage index values for the 3<sup>rd</sup> cycles of the loading steps.

The values of  $\delta_M$ ,  $M_y$ , and  $dE$  of this model were obtained from the test results, while the value of  $\delta_u$  was estimated using an empirical formula for calculating ultimate drift according to Eurocode 8 (EN 1998-1). Extensive tests have shown that for the quantitative estimation of the coefficient  $\beta$ , a value between 0.3 and 1.2 and a mean value of about 0.15 can be applied, as indicated by Cosenza et al. (1993). It should be noted that the value  $\beta = 0.15$  correlates very well with the results of other damage models and that this value has, therefore, been adopted very frequently by other researchers. The stiffness degradation of the specimens is presented in Figure 11. The values of the damage indices thus calculated on the basis of the model described above are given for the three specimens tested in Figure 10a and 10b, for all specimens, after 1 and 3 loading cycles, respectively.

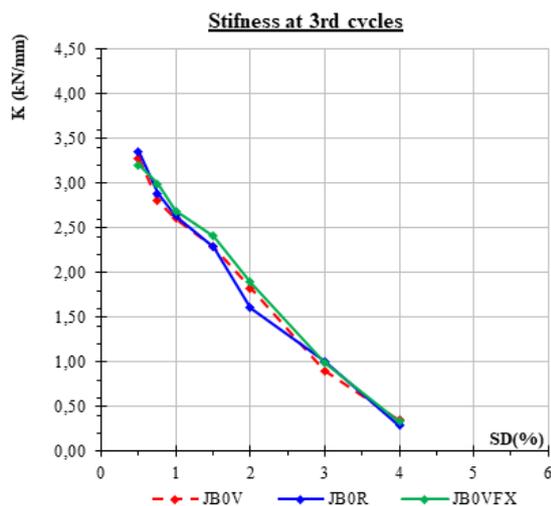
FIGURE 11. Stiffness degradation to load level.

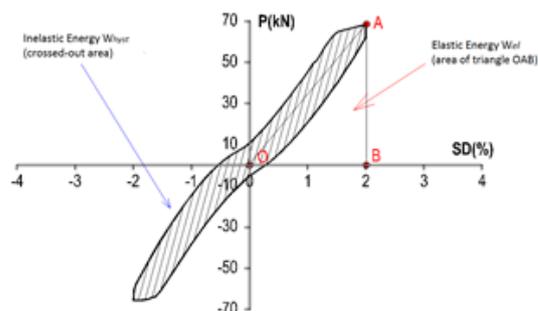
Hysteresis inelastic energy:  $W_{hyst} = 1077,24 \text{ kNmm}$   
 Maximum elastic energy:  $W_{el} = 1173,0 \text{ kNmm}$   
 Hysteresis damp. ratio:  $\zeta_{eq} = \frac{1}{4\pi} \cdot \frac{W_{hyst}}{W_{el}} = 0.073$

FIGURE 12. Hysteresis loop of the 1<sup>st</sup> loading cycle of the 5<sup>th</sup> loading step of the specimen JB0R.

under cyclic loading. Depending on the node formation in the area of the column/beam, the curve can vary accordingly. The hatched (crossed-out) area exemplarily represents the inelastic energy ( $W_{hyst}$ ) dissipated in the 1st loading interval of the 5th load level of specimen JB0R due to plastic deformations in the node. Obviously, the greater the ductility and thus the plastic deformation capacity of the materials, the greater is the integral of the hatched area, i.e., the energy enclosed by a hysteresis loop, and consequently the greater is the dissipated energy and thus the equivalent damping. The maximum elastic strain energy ( $W_{el}$ ), which corresponds to the depicted degree of deformation, is equal to the area of the triangle OAB.

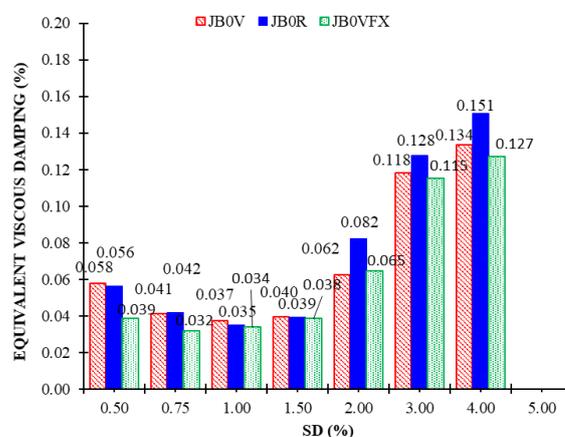
FIGURE 13. Equivalent viscous damping, per loading level, for all 3 tested specimens.

The dissipated energy of the three tests is captured in terms of equivalent viscous damping (Figure 13). Viscous damping of unreinforced and reinforced specimens is compared. The representation includes the first load cycle of all load steps of an overall test (again up to  $SD = 4\%$ ).
