# ASSESSMENT OF STRUCTURES REPEATEDLY EXPOSED TO THERMAL LOADING AND EXTINGUISHING WATER: A CASE STUDY OF A FIREFIGHTING TRAINING FACILITY

**ABSTRACT.** When designing a new structure or assessing an existing one, the risk of fire and its effect on the structure must be considered. Structures are usually assessed for fire resistance at the design stage – i.e. before the possible exposure to fire. If structure is exposed to fire during its service life, a post-fire assessment must be conducted in order to evaluate whether the structure is still safe and reliable for use. The post-fire assessment is conducted quite regularly; however, the assessment is usually conducted for structures exposed to fire only once. This paper presents an interesting and unique case study of a post-fire structural analysis of a firefighting training facility exposed to cyclic fire loading and the effect of extinguishing water. The main conclusion of the study is that though means of protection are recommended, the structure still has a sufficient load-bearing capacity and can continue being used as a firefighting training facility in the future. Aside from the specific conclusions for the investigated st

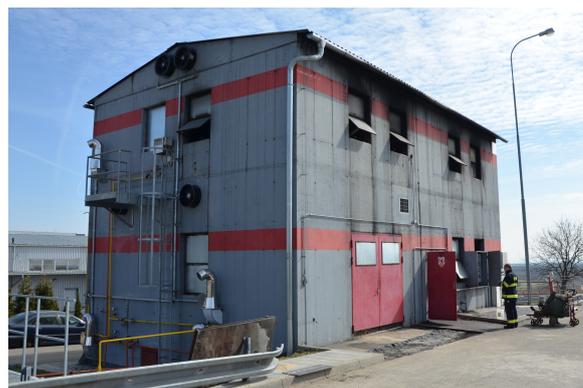
FIGURE 1. The analysed building.

The analysed building, see Figure 1, is being used as a training facility for firefighter trainees to experience fire-fighting before fighting real-scale fires. For such purposes, several gas burners producing flames, smoke, and high temperatures are installed inside the building. Although very high temperatures are reached during the trainings (up to  $1100^{\circ}\text{C}$  – according to the thermal power of each burner), the trainings last no more than 3 minutes. The main purpose of the trainings is to simulate conditions similar to those in real fire, which enables the trainees to practice movement and orientation in a smoky space, exposure to high temperatures, evacuation of occupants, or fire fighting. The fire fighting is performed by extinguishing water or other extinguishing media. The structure is thus not only affected by repeating thermal exposure due to the cyclic fire loading but also by the effect of the extinguishing media.

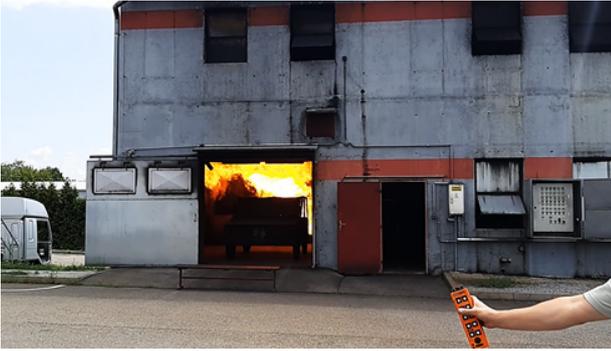
The fire training is demonstrated in Figures 2 and 3. The burners have a specific set-up, as they are partially covered by metal sheets to cluster and direct the flames, hot air, and smoke flow as shown in Figure 3. The gas burners are placed on the first and the second floors. On the underground floor, no burner is installed and hence, this floor is not analysed in detail in this paper. Five burners are installed in total. During a single fire training, only one burner is always active. The locations of the burners are shown in Figure 4.

FIGURE 2. Initiation of a gas burner during the training.

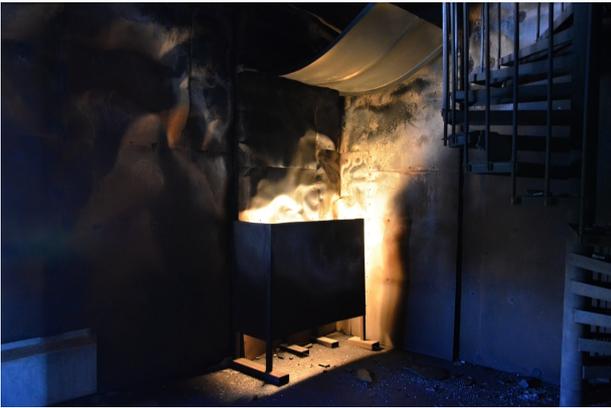
FIGURE 3. A gas burner partially covered by metal sheets.

- Burners are equipped with shielding plates which direct the flow of the hot gasses, as shown in Figure 3, and these plates are also simulated in the model.

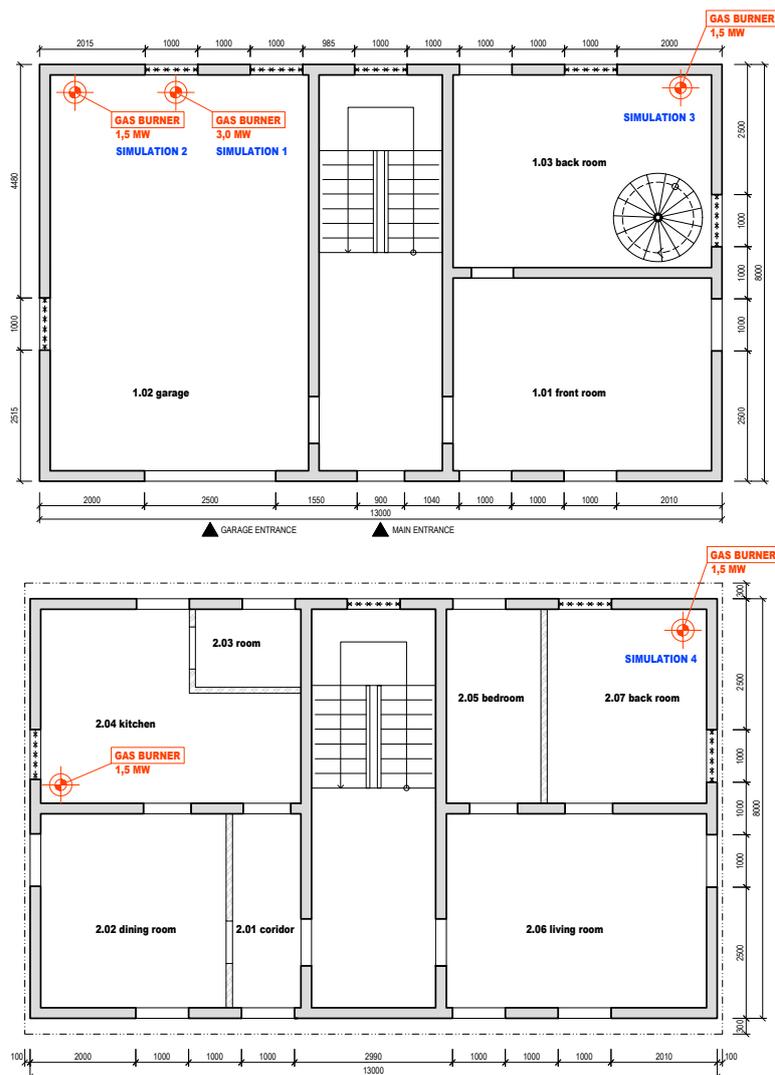
As only one gas burner is active during a fire training, four different simulations were performed, see

Figure 4. The fifth simulation with the gas burner on the left side of the second floor was not conducted since it was assumed that the results of such a simulation would be similar to the fourth simulation as the gas burners have the same thermal power and similar (corner) position. As an output of the fire simulations, temperature evolutions were obtained using the gas temperature thermocouples implemented in the model. The thermocouples are placed in the vicinity of potentially most affected structural members in a grid of  $0.5\text{ m} \times 0.5\text{ m}$ , see Figure 6.

- Only one burner is active during a fire training.
- Doors and gates are assumed as fully opened (both indoors and outdoors).
- Windows covered with metal sheet (highlighted by dashed lines with  $\times$  markers in the building layouts, see Figure 4), are omitted in the model.

- Fire simulation time is 10 minutes in order to include the temperature evolution after the fire training is finished (3 minutes).
- The area of each burner is  $0.2\text{ m} \times 0.2\text{ m}$ . Each burner starts in  $t = 0.1\text{ s}$  with maximum released energy. Four simulations were conducted, each varying the position and the power of the burner. The power of the burner is either 1.5 MW or 3.0 MW, see Figure 4.

FIGURE 4. The locations and the power of the gas burners on the first floor (top) and on the second floor (bottom).

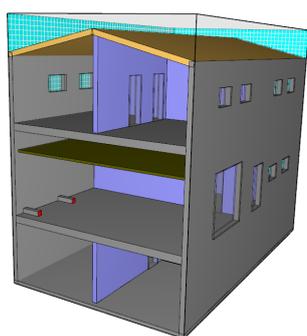
FIGURE 5. Overall visualization of the analysed building created using the Pyrosim software [19] (side wall is invisible).

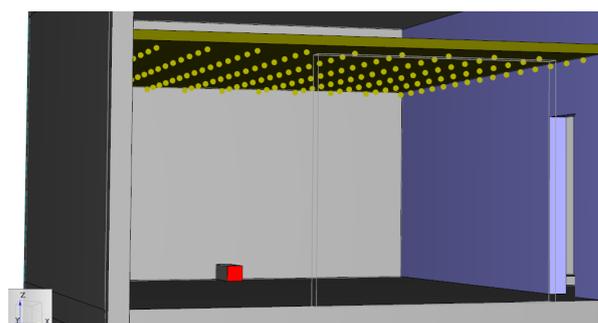
FIGURE 6. Visualisation of the thermocouples created using the Pyrosim software [19] (room 1.02; front wall is invisible).

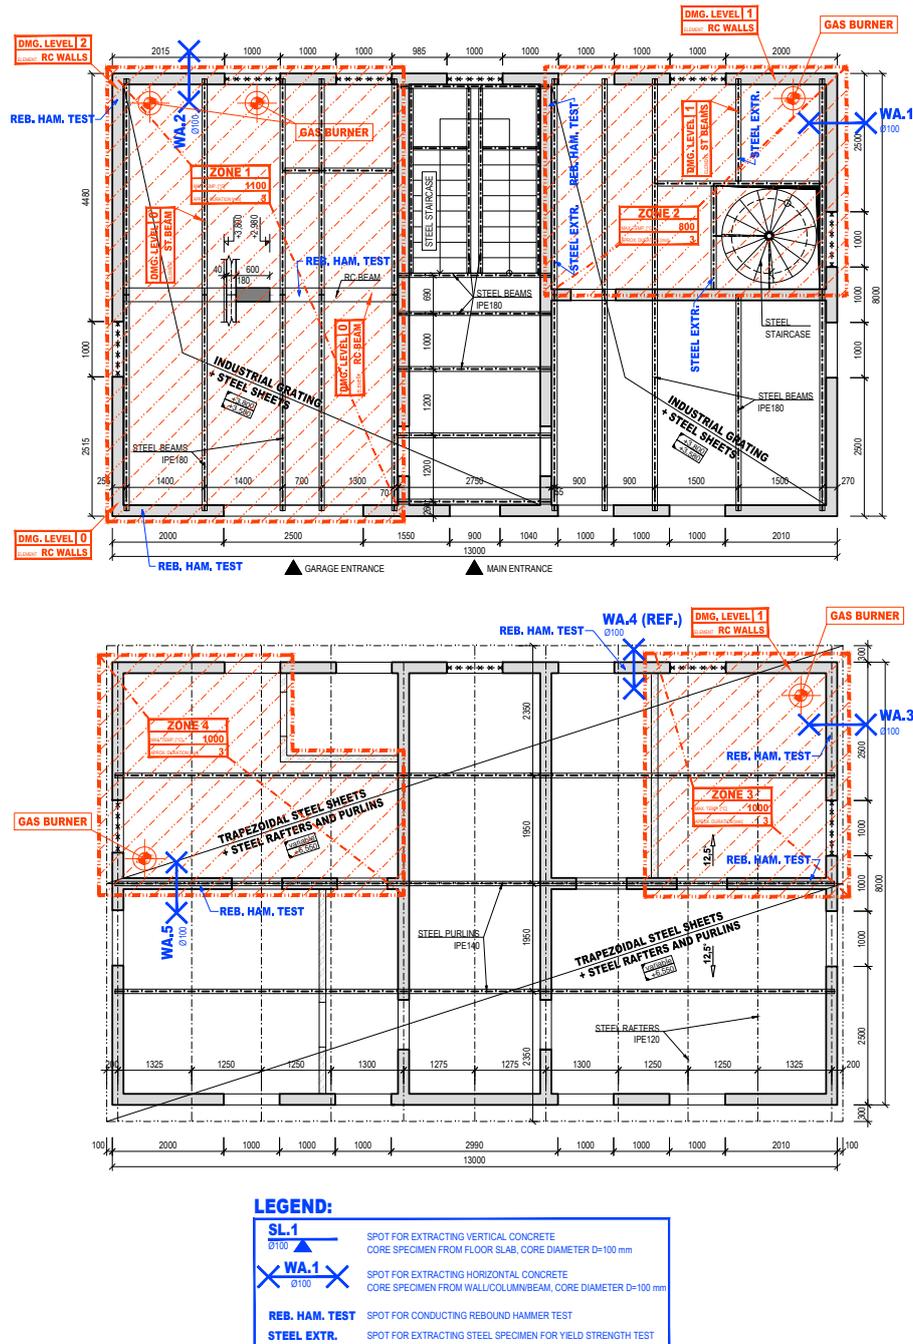
FIGURE 7. Layouts of the first floor (top) and the second floor (middle) with the information regarding the structural diagnostics; legend of the symbols used in the layouts (bottom).

All information regarding the structural diagnostics is summarised in building layouts, see Figure 7. Areas and structural members affected by the fire trainings were identified and drawn into the layouts. These areas were marked as ZONE 1 to ZONE 4. Maximum fire temperatures for each zone obtained by the aforementioned fire simulations as well as the duration of the fire are also given in the plans (for ZONE 4, the same temperature as for ZONE 3 was assumed). Individual structural elements were classified into damage classes according to their damage level determined by the visual inspection. The damage classification is done in accordance with the technical report pro-

posed by the Concrete society [22]. This technical report deals with the classification of concrete structures only, steel structures are not included. However, for the analysed building, the classification of steel elements was done analogically, i.e. Class 0 refers to *non-damaged element* while Class 4 refers to *totally damaged element*. The positions of the in-situ material tests and material samples extraction are given in the layouts as well.

To assess the surface deterioration of concrete (surface hardness reduction) in the space for fire trainings, a rebound hammer test was conducted, which is a method suitable for such purposes with only few limitations [23]. The results of a rebound hammer test usually assess the state of material degradation of an approximately 20–30 mm thick surface layer [24]. The rebound hammer test is illustrated in Figure 10. Rebound hammer tests were performed in selected places of the RC slab and walls on the underground floor and on the surfaces of beams and walls on the aboveground floors, see Figure 7.

Places for extracting concrete samples by core drilling were determined as described in the previous Sections, see Figure 7.

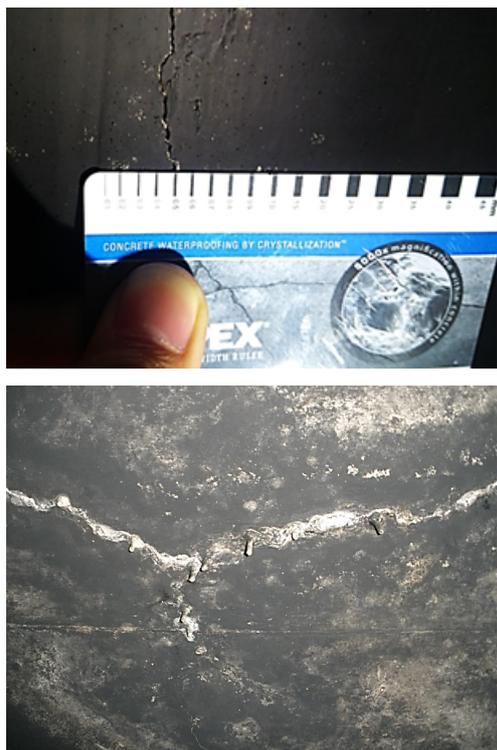
On the basis of the visual inspection, it can be stated that RC structures do not exhibit significant damage nor extensive deflections. No places with a spalled cover layer were found, the reinforcement was

FIGURE 8. Flexural cracks with a width of 0.4–0.5 mm found on the bottom face of the RC slab above the underground floor (top) with observed leakage of fire-extinguishing water (bottom).

not exposed anywhere. Also, no buckled or ruptured rebars were found. Related to the fire trainings, sooted places on the structure were observed in the places where the hot airflow is directed to. Sooted places were also found in the vicinity of the opened windows, out of which the hot air leaves the building during the fire trainings. No surface crazing was found except for a few places above the windows. On the underground floor, flexural cracks with a width of 0.4–0.5 mm were found on the bottom face of an RC slab, see Figure 8. This defect causes a leak of the fire-extinguishing water when fire trainings are conducted on the floors above.

The RC slab above the underground floor was assessed at ULS and SLS by assuming the initial material properties of concrete and steel reinforcement since the slab was not directly exposed to high temperatures. The calculations proved that the slab satisfies both the ULS and SLS criteria. However, for the SLS – crack control, the calculated effective crack width is close to the limit crack width. This is in accordance with the findings of visual inspection (see Section 4.1 and Figure 8) whereby flexural cracks with

a width of 0.4–0.5 mm were found on the bottom face of the RC slab. This defect causes a leakage of the fire-extinguishing water when fire trainings are conducted on the floors above. From a long-term point of view, the presence of water and air near the reinforcement can cause its corrosion. A corrosion of reinforcement gradually lowers load-bearing capacity and durability of the structure. To resolve this problem, refurbishment measures were recommended – to improve the drainage system in the building and to repair waterproofing in floor layers.

- repaint the steel structural members,
- repair the parts of the structural members where the material samples for destructive tests were extracted,
- improve the drainage system in the building and repair waterproofing in the floor layers (especially the ground floor),
- supplement the longitudinal beam going along the opening for the staircase with an additional IPE180 profile.

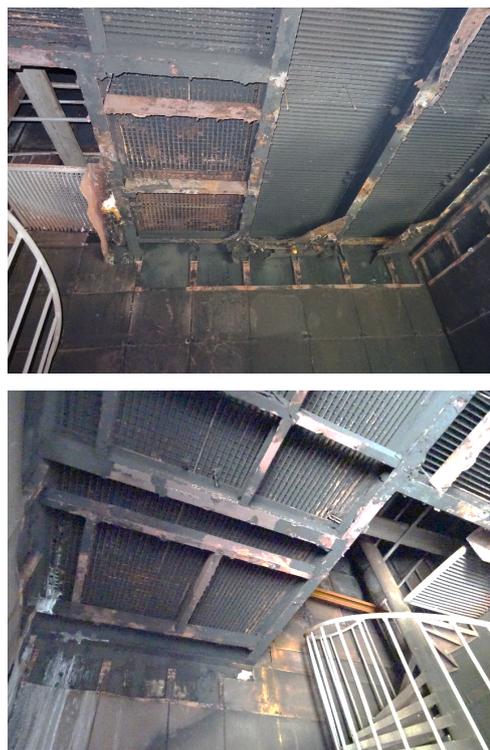
FIGURE 9. Steel beams above the first floor near the spiral staircase, ZONE 2.

Steel structural elements of the floor/roof system above the first and second floors are in a very good condition since no evidence of corrosion, extensive deflections, buckling, nor distortion was found. This is probably due to the effective system of ventilated soffit. However, there is one exception – the soffit in the room with a spiral staircase in the first floor (ZONE 2) which was not ventilated. Therefore, some hot air may have accumulated in the space above the soffit, even though its majority flew to the second floor through the staircase opening due to the stack effect. Steel beams in this location are much more sooted and corroded, see Figure 9. However, no excessive deflections nor buckling were found. A detailed inspection of the beams in non-ventilated soffit revealed that the observed incoherent and sooted layers are a heat-damaged paint layer and fused pieces of soffit sheets.

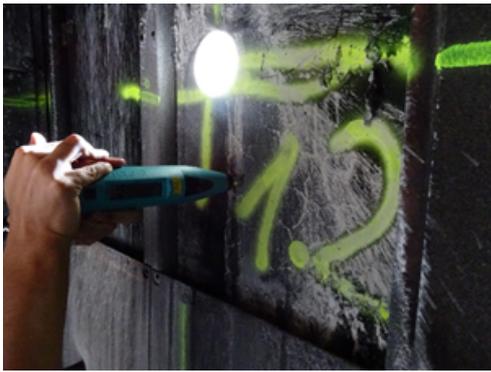
The diameter of the samples was 100 mm; the drill hole is visible in Figure 10 above the rebound hammer. The samples were tested in laboratory hydraulic press

FIGURE 10. Rebound hammer test.

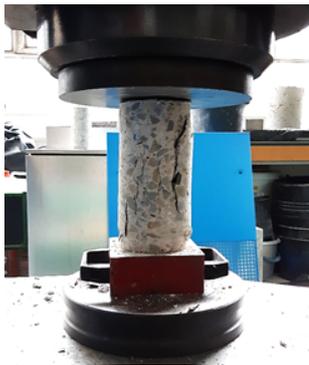
FIGURE 11. Concrete core destructive compressive strength test.

to obtain concrete compressive strength, see Figure 11.

The samples obtained by core drilling consisted of a damaged concrete cover and an undamaged concrete core. During the compressive strength test, the whole specimen was tested. Thus, the obtained compressive strength is an average value representing the whole concrete sample including both its undamaged concrete core as well as its damaged concrete cover.

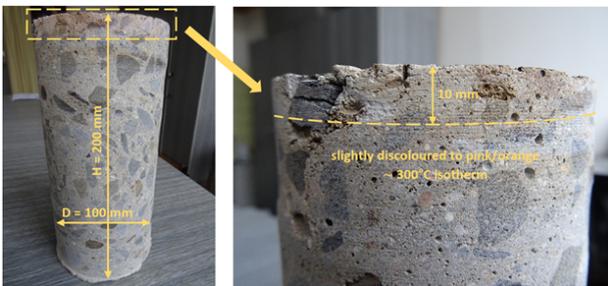
FIGURE 12. Concrete sample from ZONE 1 (WA.2) – estimation of approximate damage depth using colorimetry method.

The depth of the damaged concrete cover was assessed using the colorimetry method, see [26]. Using this method, the depth of the damaged concrete cover was identified to be approximately 10 mm, see Figure 12.

depth of the damaged concrete is also approximately 10 mm – see the discoloured layer of the specimen in Figure 12.

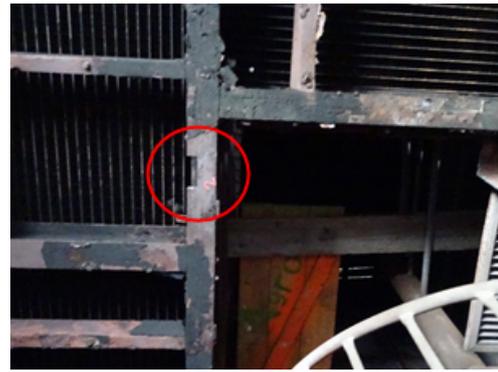
Also, places for extracting steel samples out of steel elements in ZONE 2 were determined (4 samples from the bottom flange of I-beams and 4 pieces of supple-

FIGURE 13. Steel sample cut out of floor beam in ZONE 2.

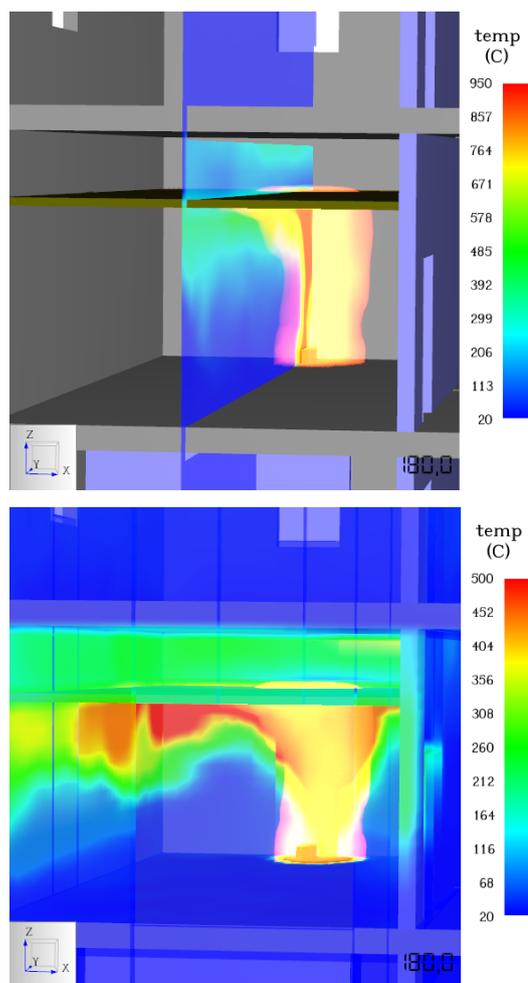
FIGURE 15. Simulation No. 1,  $t = 180$ s: gas temperatures (top); surface temperatures (bottom); front wall is invisible; visualised by the Pyrosim software [19].

The results from the first simulation (i.e. simulation No. 1) are shown in Figure 15. Moreover, in order to present a detailed description of the results, the

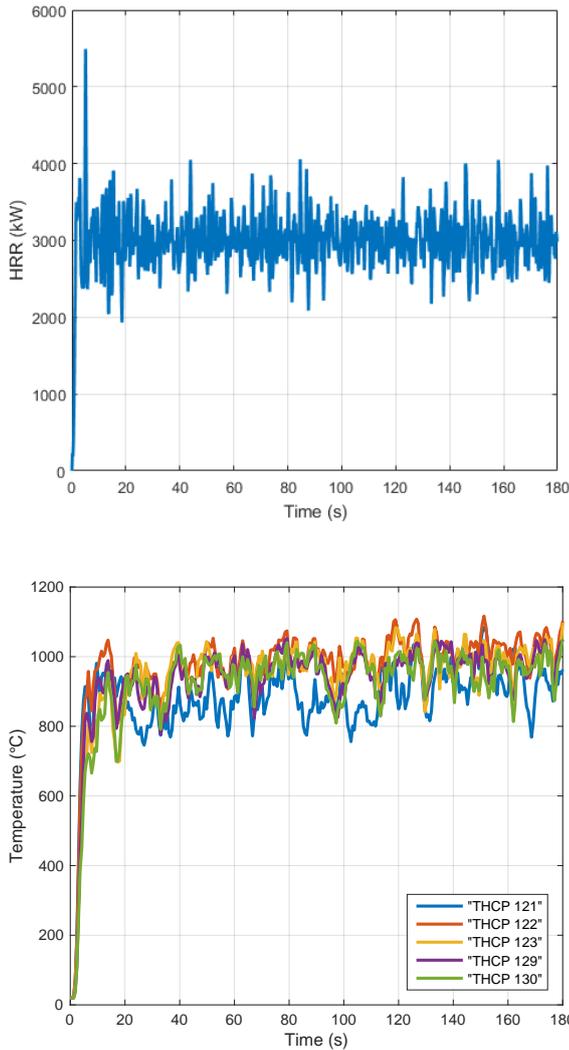
FIGURE 16. Simulation No. 1: heat release rate measured in FDS [2] (top); gas temperature evolution (in °C) measured by five thermocouples above the burner with the highest gas temperatures (bottom); visualised by the Pyrosim software [19] and the FMC software [31].

graphs of thermocouple temperatures and the heat release rate from the simulation No. 1 are shown in Figure 16. For a comparison, five thermocouples at various locations with the highest temperatures above the burner were chosen. In this simulation, a gas burner with the power of 3.0 MW was used, see Figures 4 and 16. As can be seen in Figure 16, the gas temperatures around the ceiling reached the maximum value of approximately 1 100 °C.

For determining the heat flux as a boundary condition for the thermal analysis of the RC wall in ZONE 1, mean values of the gas temperatures presented in Figure 16 were used, see Figure 20. The gas-temperature evolutions given in Figure 16 show the highest gas temperatures above the burner in ZONE 1. The gas temperatures were measured by the thermocouples in the FDS model. The “mean-values” curve given in Figure 20 adequately represents the whole range of these maximum temperatures and hence, employing this curve for determining the boundary condition for the analysed wall can be considered to be a conservative approach.

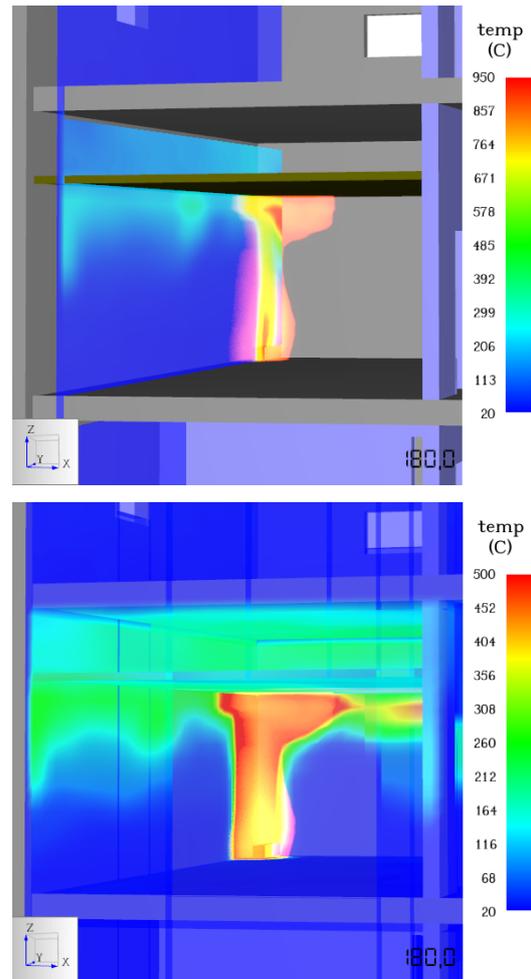
The results from the second simulation (i.e. simulation No. 2) are shown in Figure 17. In this simulation, a gas burner with the power of 1.5 MW was used, see Figure 4. In this simulation, the gas temperatures reached only approx. 800 °C, which is probably the result of the lower power (and lower value of the HRR) of the gas burner.

FIGURE 17. Simulation No. 2,  $t = 180$  s: gas temperatures (top); surface temperatures (bottom); front wall is invisible; visualised by the Pyrosim software [19].

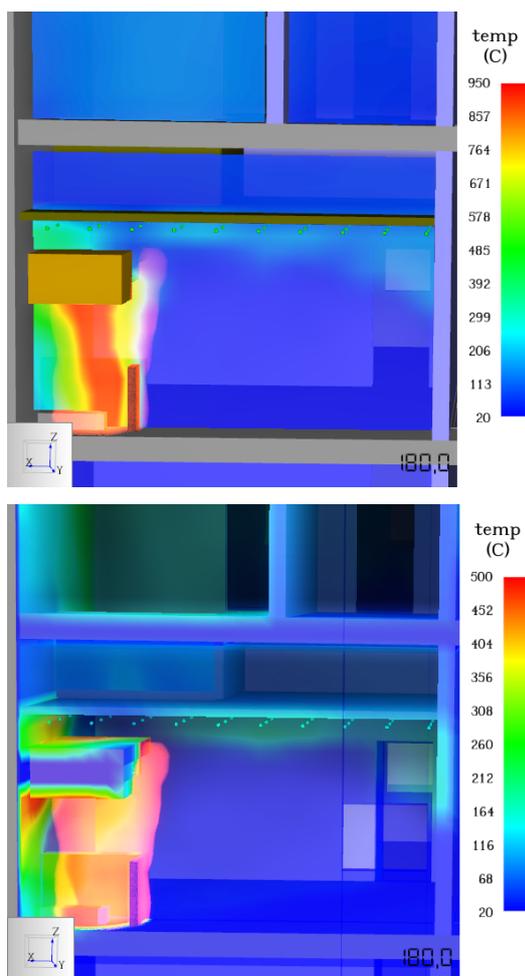
set to 1.5 MW, are shown in Figure 18. It can be seen that the hot gases go through the spiral staircase into the room 2.07, where the uncovered steel structures are exposed to high temperatures. The shielding plates, which direct the flow of the hot gasses, are placed around the burner. Hence, the hot gasses flow back to the side wall. The space above the ceiling of the room No. 1.03 is not force-ventilated, thus the high temperatures affect the ceiling structures. In simulation No. 3, the gas temperatures around the ceiling reach the maximum value of approximately 800 °C.

FIGURE 18. Simulation No. 3,  $t = 180$  s, gas temperatures (top); surface temperatures (bottom); back wall is invisible; visualised by the Pyrosim software [19].

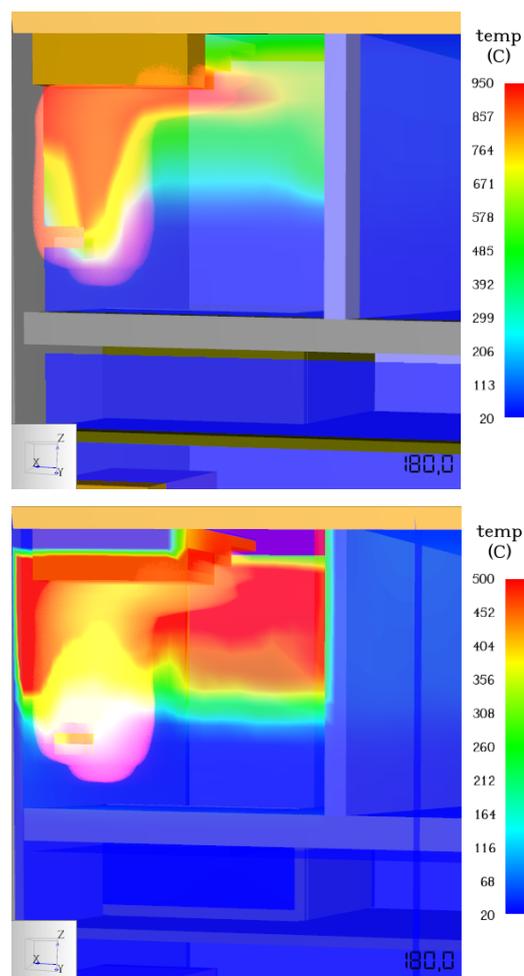
The burner with HRR of 1.5 MW for simulation No. 4 is placed in room 2.07, see Figure 4. The results are shown in Figure 19. In this case, the maximum gas temperatures reach approximately 1 000 °C and the shielding plates direct the flow of the hot gasses.

FIGURE 19. Simulation No. 4,  $t = 180$  s, gas temperatures (top); surface temperatures (bottom); back wall is invisible; visualised by the Pyrosim software [19].

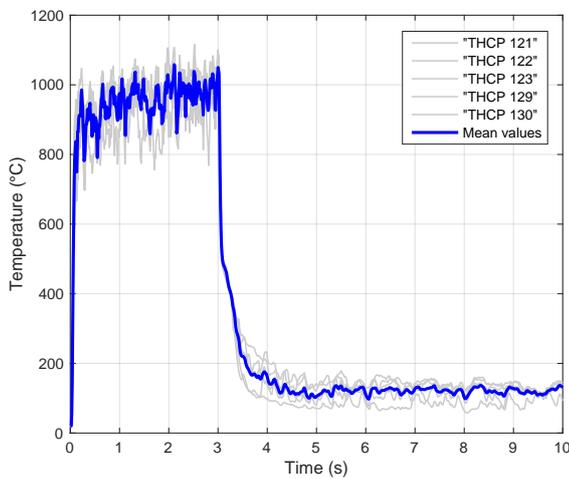
FIGURE 20. Temperature-time curve for ZONE 1 assumed for the heat transfer model boundary condition.

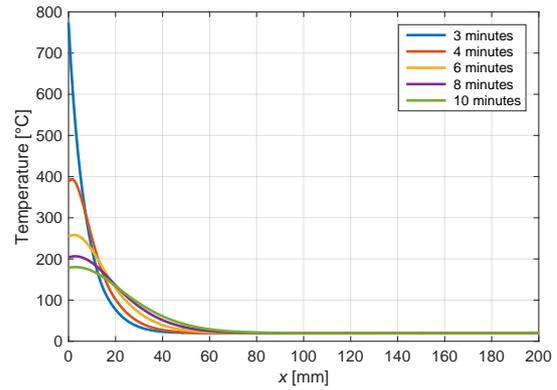
The results of the thermal analysis of the RC wall in ZONE 1, obtained using an in-house software TempAnalysis [28], are shown in Figure 21.

The results reveal that at the time when the fire training is terminated (i.e.  $t = 3$  min), the surface temperature of the RC wall reaches almost  $800^{\circ}\text{C}$ . This temperature causes a significant degradation of concrete; however, since the exposure time was short (i.e.  $t = 3$  min), only small part (few millimetres) of the concrete cover is heated up to this temperature and most of the inner concrete remains unheated. As can be seen in Figure 21, with increasing time, the maximal temperatures in concrete decrease rapidly.

The temperature distributions presented in Figure 21 show that only a 10 mm surface layer is heated to temperatures higher than  $300^{\circ}\text{C}$ . Based on this finding, it is expected that the reduction of mechanical properties takes place only in this surface layer. This presumption is validated by the aforementioned indicative colorimetry analysis which indicated that the

FIGURE 21. Temperature profiles of the analysed wall in ZONE 1.

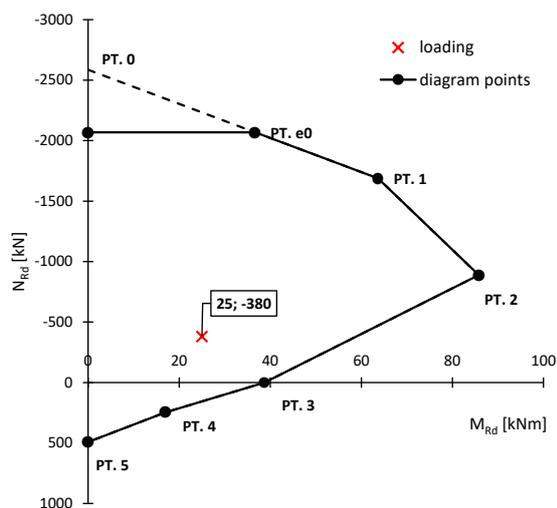
The concrete compressive strength was lowered by three concrete strength classes (from C30/37 to C16/20). The load-bearing capacity was estimated using N-M diagram, see Figure 22. Since the post-fire situation is related to the ordinary ULS situation at a normal temperature, all loading and material safety factor values used in the calculation were assumed as for normal temperature calculations. The calculation reveals that the point representing loading lies inside the diagram with a sufficient reserve in load-bearing capacity, see Figure 22.

FIGURE 22. N-M diagram of load-bearing RC wall in ZONE 1 proving sufficient residual load-bearing capacity.

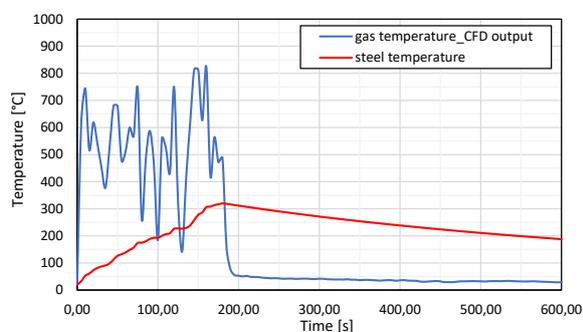
FIGURE 23. Comparison of gas temperatures of the space and surface temperature of the analysed steel beam in ZONE 2.

The corresponding temperature-time curve is presented in Figure 23 together with the results of the thermal analysis of the beam performed using the incremental method.

The results reveal that the temperature of the steel beams located in ZONE 2 reached approximately 350 °C. This value does not reduce the yield strength, either in the hot or residual state (e.g. [34, 35]), and thus, the steel preserves its initial yield strength. The results of destructive material tests also confirmed that no significant reduction of yield strength took place. Although the temperature around 350 °C can slightly reduce other mechanical properties of steel (e.g. the elastic modulus or the proportional limit) in the hot state – see EN 1993-1-2 [29], these changes are supposed to be reversible and can be omitted in the residual state – see e.g. [34, 35]. Hence, the mechanical properties of steel are assumed to be not affected

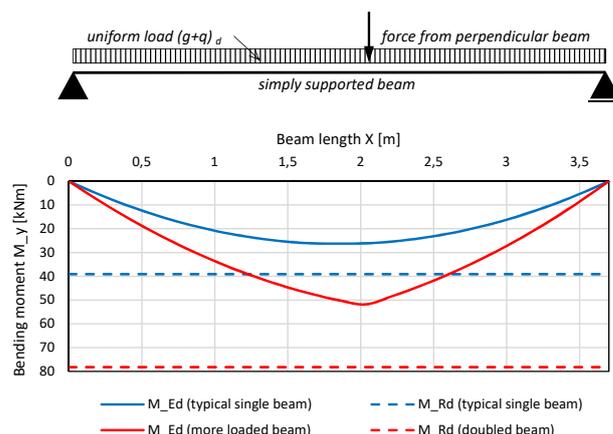
FIGURE 24. Diagram of bending moment along floor steel beam in ZONE 2.
