FIRE RESISTANCE FOR THIN-WEBBED CONCRETE AND MASONRY ELEMENTS

György L. Balázs, Éva Lublóy

Department of Construction Materials and Technologies, Budapest University of Techn. and Economics, Hungary

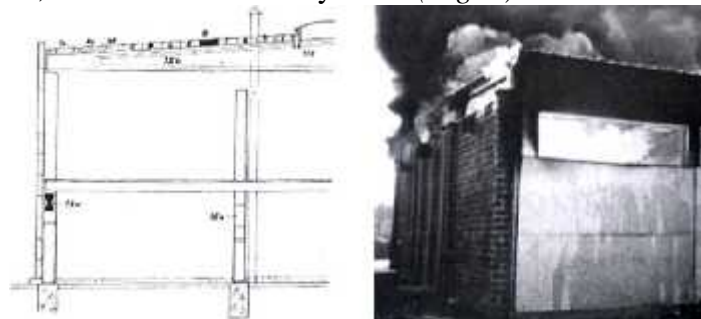
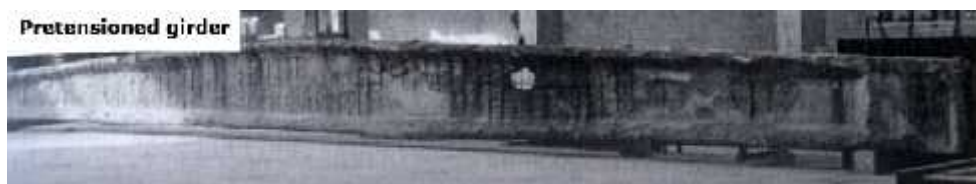
The structure of building

b) The fire test

c) The fire damaged girder

Fig. 1 Sub-assembly of a high-rise building after a 2h fire test (Annerel and Taerwe, 2009)

The concrete of the presented roof girder had an ordinary mix with calcareous pebbles and gravel for coarse and medium aggregates, and river sand for fine aggregates. The top flange was heavily damaged over most of the span, as shown by one strand, that is visible (the cover was gone) and by the longitudinal cracks, that are located at about 100 mm from the extrados (top face).

Several stirrups are also visible, after the explosion of the cover, that was lost roughly over the entire span. Spalling depths of up to 80 mm were measured (Annerel and Taerwe, 2009).

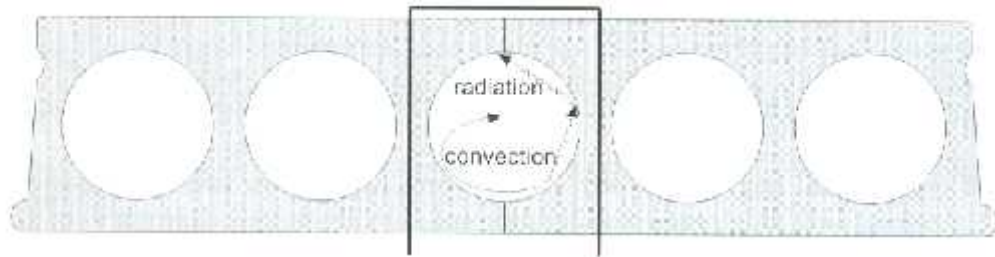
Fig. 2 The hollow-core slab is an example for a concrete member with longitudinal internal holes (Fellinger, 2004)

In case of hollow-core slabs the voids make the heat transfer rather complex and modelling the heat transfer is difficult as heat is transmitted from the bottom surface to the top surface of the voids via radiation and convection (Fig. 2).

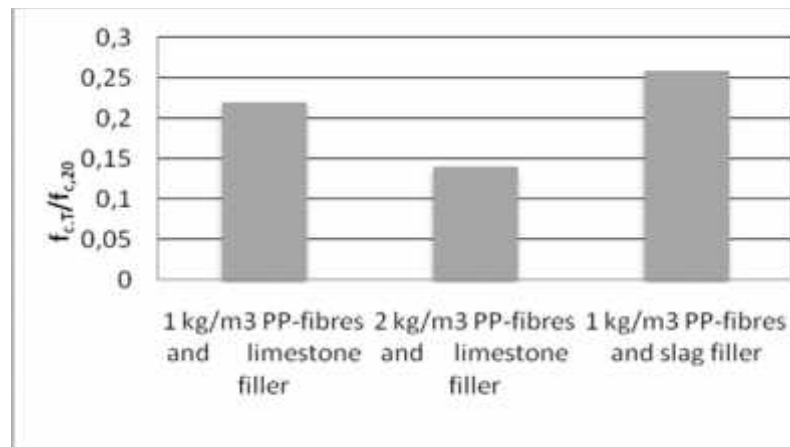
Fig. 3 Normalized values of the residual compressive strength after heating up to 800 °C (each point is the average of 3 measurements). The compressive strength at 20 °C (no heating) has been used as normalizing factor

The tests on concrete samples were carried at the Department of Construction Materials and Engineering Geology of Budapest University of Technology and Economics. The cube samples (side = 150 mm) were kept for 2 hours at 600 °C or 800 °C, and later were cooled down to room temperature. We have observed the highest relative residual compressive strength by changing the filling material from limestone to slag and including also 1 kg/m³ polypropylene fibres, subjected to 800 °C (*Fig. 3*).

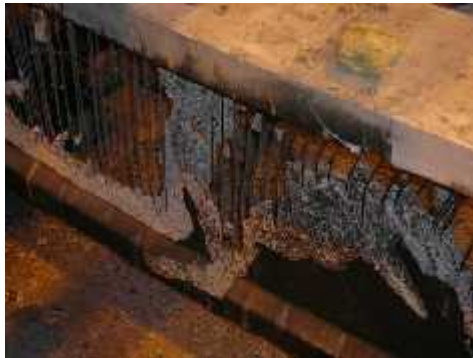
Fig. 4 Beam No. 1 (ref. Mix 1)
after failure due to web destruction

Beam No. 1 (Mix 1 = reference mix) failed in 12 minutes after the complete spalling of the concrete of the web (*Fig. 4*).

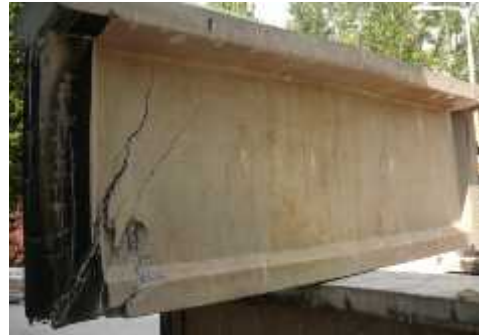
Fig.5 Beam No. 3 (Mix 4)
after the web failure in shear

Beam No. 3 (Mix 4 including 1 kg/m³ polypropylene fibres and a slag-based filler) failed in 71 minutes in shear (no spalling of the web, *Fig. 5*).

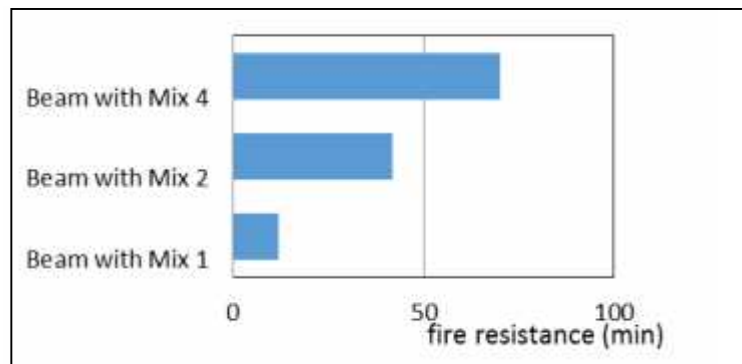
Fig. 6 Fire resistance of the three beam specimens tested in this project

The test results in terms of fire resistance are presented in Fig. 6, where the improvement due to the combined effects of slag-based filler and pp fibres is remarkable indeed (Balázs, Lubl6y, Mezei, 2010).

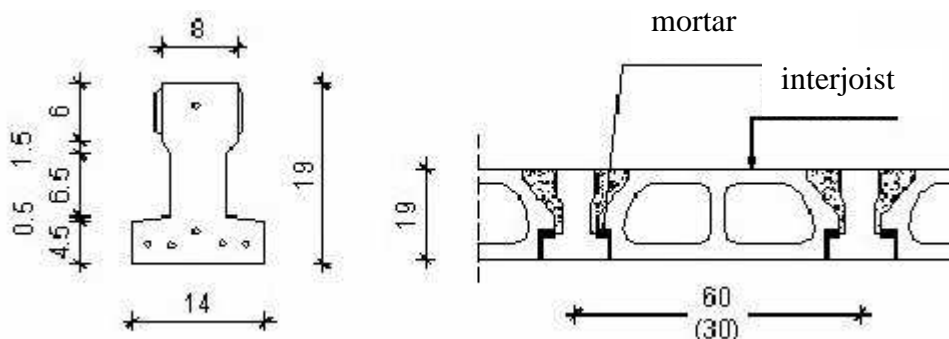
Fig. 7 The girder-slab system with concrete interjoists (<http://dutker.hu>) (sizes in cm)

A family house went up in flames on 1. April 2010. The slab consisted of pretensioned E type girders and concrete interjoists were made without reinforcement (Fig. 7). The axis-distance of E type girders were 60 cm. The type of girders were E7-54. The height of interjoists was 19 cm. The type of interjoists were EB 60/19. The span of girders were 5.40 m.

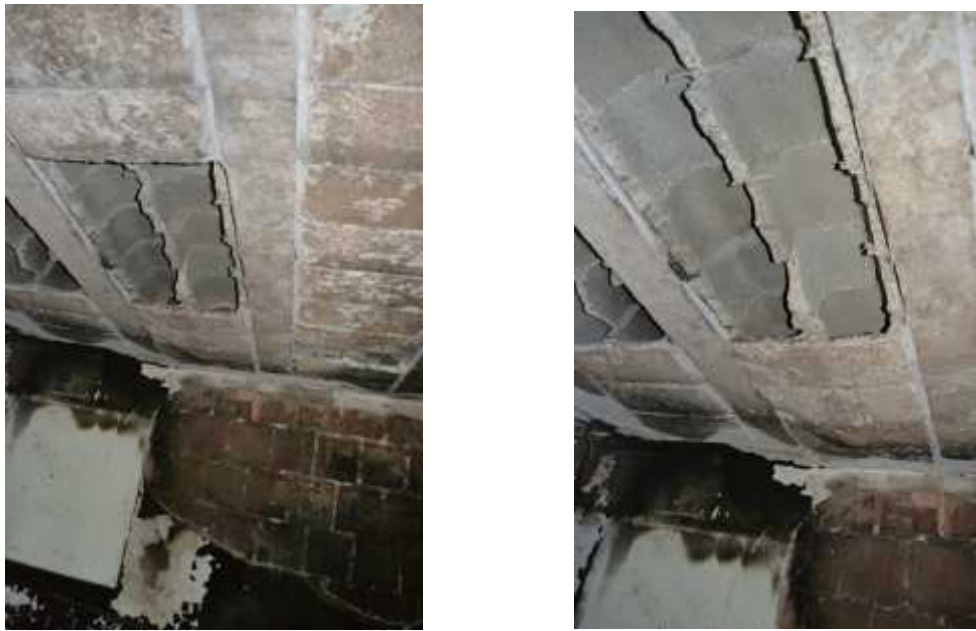
Fig. 8 The fire damaged girder-slab with concrete interjoists

Due to the fire the slab was damaged (Fig. 8). Some of the pretensioned E-girders were cracked. The concrete became red-coloured, indicating that the maximum temperature was about 500 °C. The bottom parts of concrete interjoists fall down (Fig. 9).

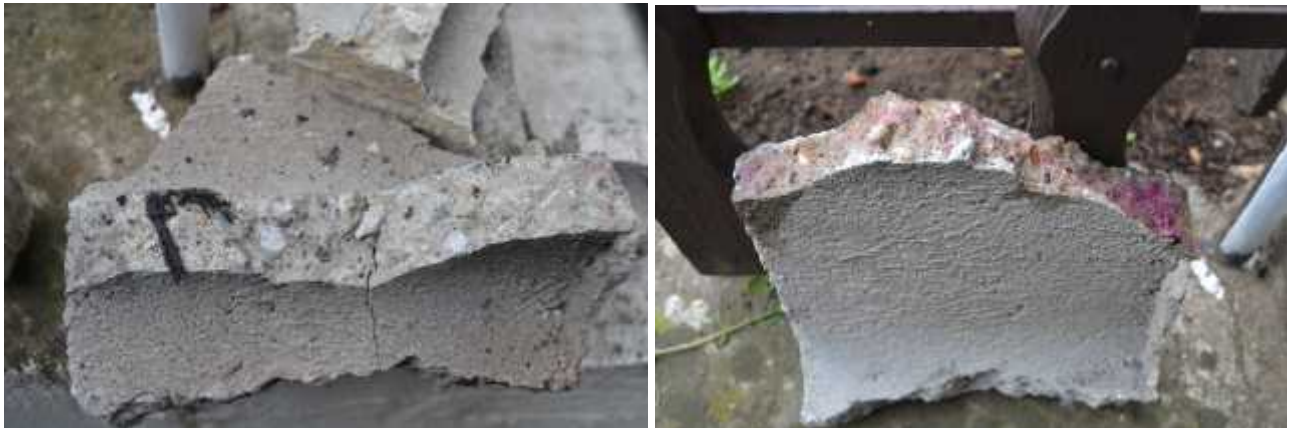
Fig 9. The fire damaged concrete interjoists

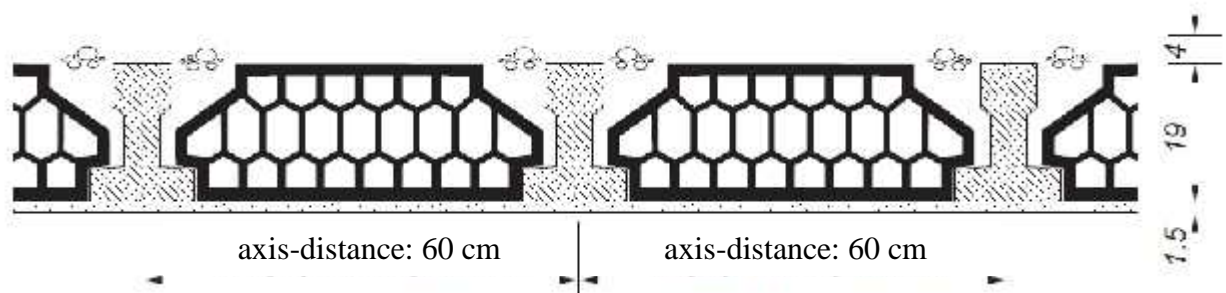
Fig. 10 The girder-slab system with brick interjoists (<http://down.archicentrum.hu>)

A family house went up in flames on 13. July 2013. The slab consisted of pretensioned E type girders and brick interjoists (*Fig. 10*). The axis-distance of E type girders were 25 cm. The type of girders were E7-48. The height of interjoists were 25 cm. The type of interjoists were FB 60. The span of girders were 4.8 m or 5.40 m.

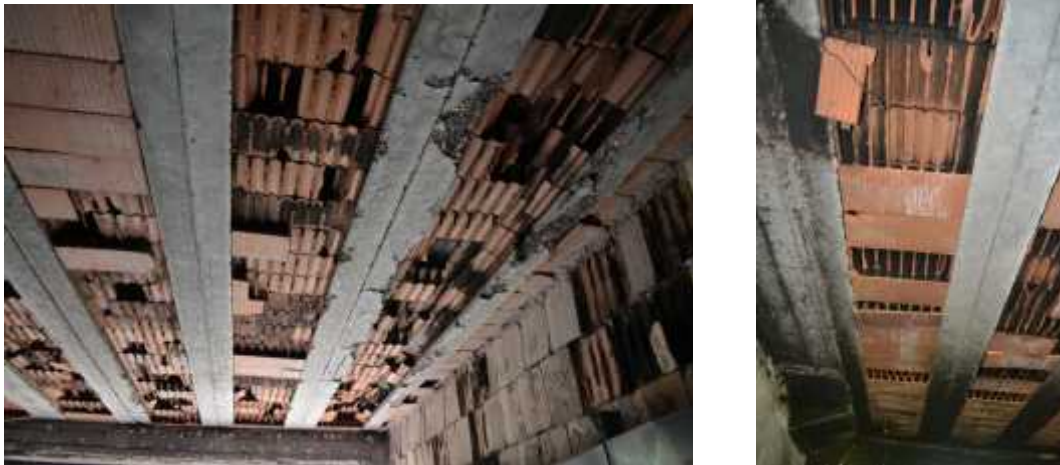
Fig. 11 The fire damaged girder-slab with brick interjoints

Due to the fire the slab were damaged (*Fig. 11*). The concrete cover of the pretensioned E type girders were spalled. The concrete were white-coloured and strongly cracked indicating that the temperature reached about 800 °C. The bottom parts of brick interjoints fall down (*Fig. 11*).
