THE BEHAVIOUR OF SPECIAL OSB BOARDS UNDER FIRE CONDITIONS

The influence of OSB board's fire coating on the fire resistance of light timber frame assemblies

Petr Kuklík, Magdaléna Charvátová

Czech Technical University in Prague, Czech Republic

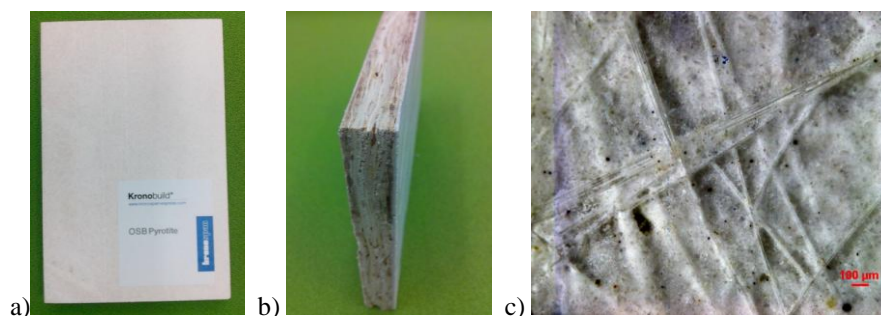
Fig. 1 The OSB board specimen with a fire resistant coating: a) side with a coating, b) OSB board in section, c) fire protection coating – microscopic picture, at 40x magnification

The timber industry has developed a lot of new types of wood-based materials for buildings in recent years. By their composition or surface treatment, these new products contribute to fire resistance. There are a lot of requirements for timber structures in terms of fire safety in the Czech Republic. The paper is focused on the behaviour of an OSB board with a fire protection coating. The coating consists of a cement-based mixture of magnesium oxide, reinforced by fibreglass with a thickness of 1.7 (± 0.3) mm. For the OSB board, see Fig. 1, according to EN 1995-1-2, the calculation for fire paints and coatings is not possible. There is a conservative approach in the case of calculating the contribution to the fire resistance of a wooden construction using this type of boards, where the surface layers are neglected.

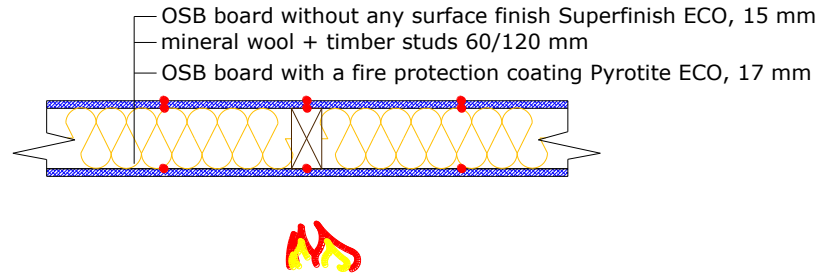
One OSB board (according to EN 300, OSB 3) with a fire resistant coating was used on the fire exposed side (board thickness of 15 mm + coating 1.7 mm (± 0.3)), while an OSB board without any surface finish (15 mm) was used on the fire unexposed side. The gaps between the timbers studs were completely filled by rock wool. In Fig. 2, the composition of the test specimen can be seen. There were 20 pieces of thermocouples used inside the specimen for measuring temperature.

Fig. 2 The composition of the test specimen

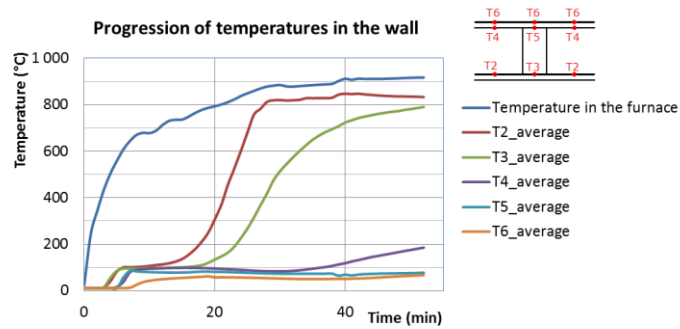
Fig. 3 The measured temperature of thermocouples during the fire test (average values)

The fire test was terminated in the 53rd minute due to a large deflection wall outside the furnace, and weak leakage of gray smoke was observed from the joints between the boards in the upper half of the specimen. There was a risk of the construction's collapse. The development of temperatures (average values) in each layer can be seen in the graph, Fig. 3, including the temperature on the unexposed side.

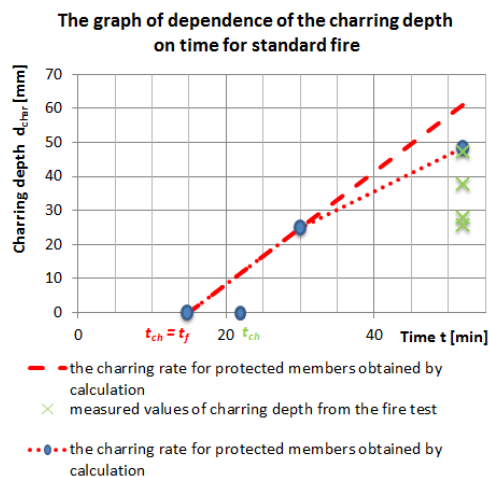
The graph (Fig. 4) displays the dependence of the charring depth on time. The red line shows calculated values obtained by EN 1995-1-2 (see chap. 2.1). The green colour represents the values obtained by the fire test - charring starting time of timber studs (t_{ch}), and the green point on the graph represents charring depth measured after the fire test (d_{char}). The red dashed line shows a constant charring rate (according to chap. 2.1, a), while the red dotted line shows the charring rate, which reduces charring after reaching a depth of 25 mm (calculated according to chap. 2.1, b).

Fig. 4 The graph of the charring depth dependence on time, comparison between calculation and the fire test

The calculation was performed for both fire tests by two methods using EN 1995-1-2. While the first method (see chapter 2.1 a), 3.1 a) is totally in accordance with Annex C (EN 1995-1-2), the second method (see chapter 2.1 b), 3.1 b) assumes reducing the charring rate after reaching a certain charring depth (Fig. 3.3, EN 1995-1-2). The second method compared with the first method is more accurate and gives better results as can be seen from Table 1. Therefore, it is assumed that the charring rate of these very subtle elements (load-bearing timber studs) also reduces after reaching a certain depth. After the fire protection falls off, a large increase in the charring rate occurs compared to an unprotected element (by up to 4 times in the second fire test) according to Annex C (EN 1995-1-2).

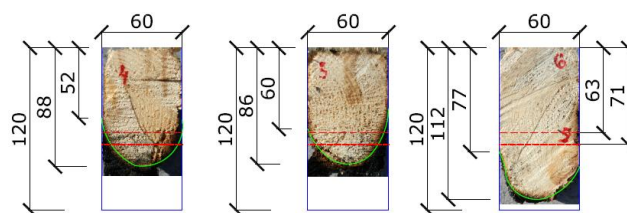
In Fig. 5, there are pictures of timber studs cut up after the fire test. It shows the comparison between the calculation (red line) and the real (green line) charring depth.

Fig. 5 Timber studs after the fire test; green line - real charring depth, red dashed line - calculation according to EN 1995-1-2 (2.1a), red dotted line - calculation according to EN 1995-1-2 (2.1b)

The start of charring of the timber stud was assumed in the 15th minute on the basis of calculated results. On the basis of temperatures measured inside the specimen during the fire test, the start of charring of timber studs was determined in the 23rd minute. Therefore, the difference between these starting charring times is 8 minutes. The fire coating likely contributes to the fire resistance of the structure. However, it is generally known that calculation methods are always on the safe side, therefore, conservative.

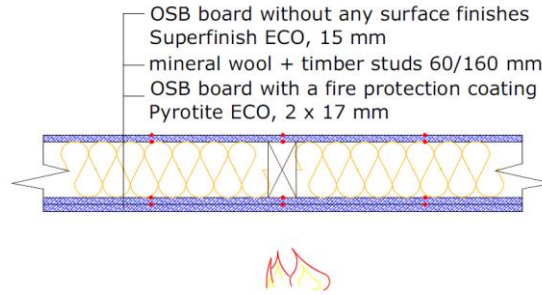
In the second fire test, two OSB boards (according to EN 300, OSB 3) with a fire resistant coating were used on the fire exposed side to increase the fire resistance (board thickness of 15 mm + coating 1.7 mm (± 0.3)). One OSB board without any surface finish (15 mm) was used on the fire unexposed side. The gaps between the timbers studs were completely filled by rock wool. In Fig. 6, the composition of the test specimen can be seen. There were 22 pieces of thermocouples used inside the specimen for measuring temperature.

Fig. 6 The composition of the test specimen

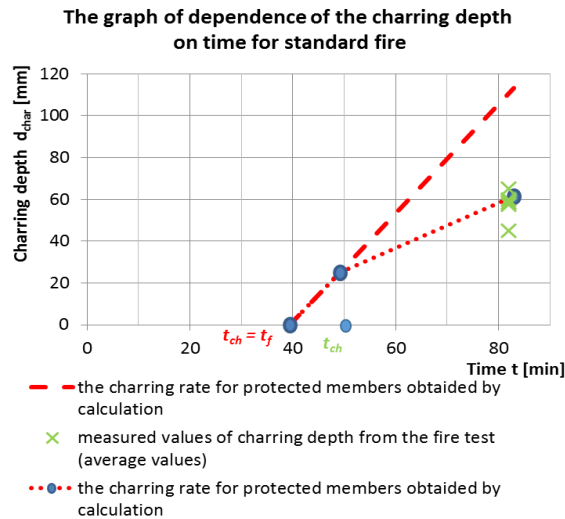
The graph (Fig. 7) displays the dependence of the charring depth on time. The red line shows calculated values obtained by EN 1995-1-2, see chap. 3.1. The green colour represents the values obtained by the fire test - charring starting time of timber studs (t_{ch}), and the green point on the graph represents charring depth measured after the fire test (d_{char}). The red dashed line shows a constant charring rate (according to chap. 3.1, a), while the red dotted line shows the charring rate, which reduces charring after reaching a depth of 25 mm (calculated according to chap. 3.1, b).

Fig. 7 The graph of the charring depth dependence on time, comparison between calculation and the fire test

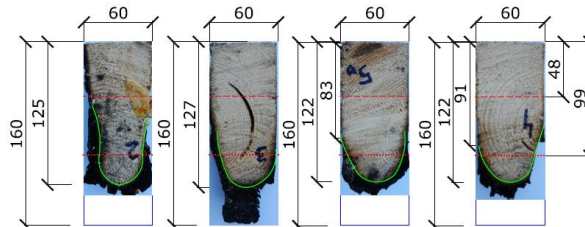
In Fig. 8, there are pictures of timber studs cut up after the fire test. It shows the comparison between the calculation (red line) and the real (green line) charring depth.

Fig. 8 Timber studs after the fire test; green line – real charring depth, red dashed line – calculation according to EN 1995-1-2 (3.1 a), red dotted line – calculation according to EN 1995-1-2 (3.1 b)
