## MAINTENANCE CASE STUDY OF PEDESTRIAN CABLE-STAYED BRIDGE WITH SPARSE CABLE SYSTEM

### ABSTRACT

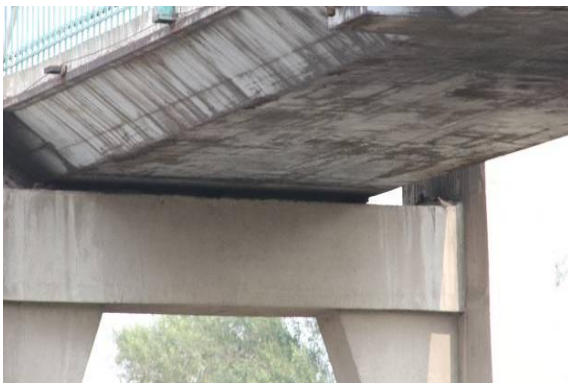
The bottom and sides of the uniform-section continuous steel box girder have extensive areas of rust paint peeling off and the steel plates are rusted. Water seepage occurs at the welding positions of the main girder, as shown in Figure 3.

*Fig. 3 - Rusting condition of steel main beam*

Due to the limitation of the technical conditions during construction, the steel cable is coated with PE pipe. In recent years, the protective layer of the cable has been aging, and the steel cable and anchor have been damaged and corroded in different degrees. In order to ensure the service performance of the bridge, the safety and durability of the bridge are improved, and the cable-stayed bridge is replaced.

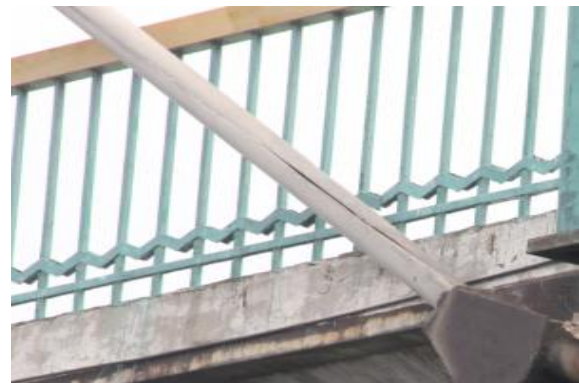
*Fig. 4 - Anchor head protective cover fallen off*

On both the north and south sides, there are 8 diagonal cables symmetrically distributed. Some of the cable anchor heads at the bottom have fallen off, exposing the anchor heads directly to the external environment. The simple PVC pipe covering of the bridge's cables has cracked to varying degrees, as shown in Figure 4.

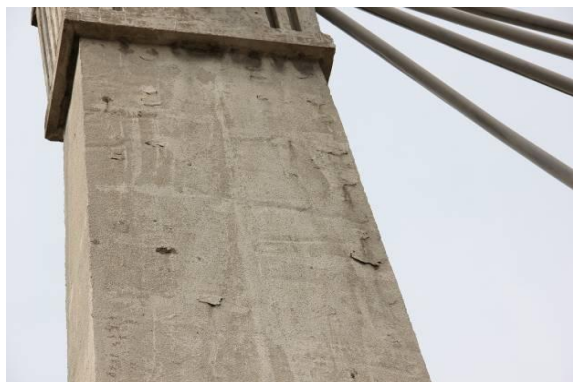
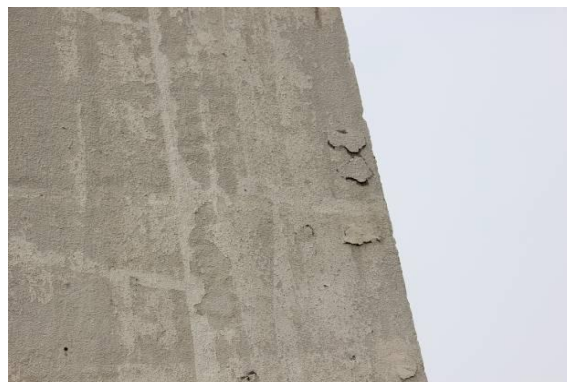
There are local concrete damage and exposed reinforcing bars with rusting phenomena on the surface of Sota, as shown in Figures 5 and 6.

Fig. 5 - Concrete Damage in Sota (1)

Fig. 6 - Concrete Damage in Sota (2)
