ANALYSIS OF HISTORIC (80+) CONCRETE STRUCTURE EXPOSED TO WEATHERING

The aim of the study was to analyze historic concrete structures from the 1930s and then to analyze the failures caused by water action on the structures. As part of the study, long-term moisture measurements were taken on a selected structure along with boundary conditions (temperature and relative humidity). By taking measurements at multiple locations on the structure using depth brush probes, it was confirmed that massive historic concrete structures exposed to external boundary conditions contain relatively high amounts of water (typically around 4%). This is mainly due to the large voids and porosity of the old concrete structure. The action of water in historic concrete structures leads to chemical reactions. Their products are chemical leachates which penetrate the surface of the structure. The analysis revealed that calcium is the dominant element, with measured values ranging from 92.42 % to 95.32 %. Although the structure studied is located in an agricultural area subjected to fertilization, the nitrate content was measured at only 0.031 %. Microscopic analysis confirmed potential calcium compounds recr

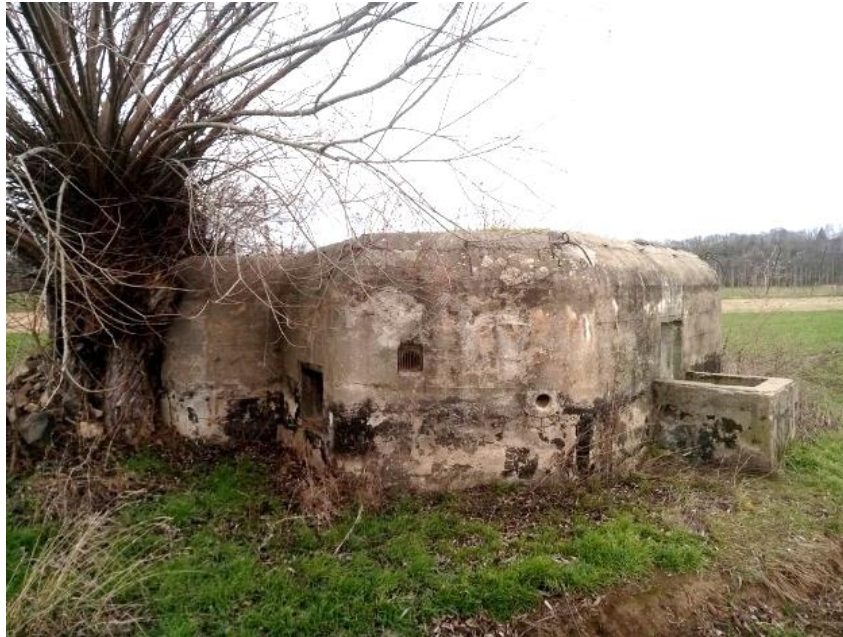
Fig. 1 – Object of light fortifications Model 37 in Czechia

Typical types of structures that have been exposed to weathering for long periods without any maintenance are reinforced concrete fortresses built in the 1930s across Europe (France, Germany, Czechoslovakia, Italy, UK, Switzerland, Yugoslavia, Belgium, Poland and other countries). In this study, objects of light fortifications Model 37, built between 1937 and 1938, were used to analyze the properties and behavior of historic concrete. One of these objects can be seen in Figure 1. Although these are fortification objects located in the territory of former Czechoslovakia, the research results can serve as a solid basis for further studies and remediations in other locations.

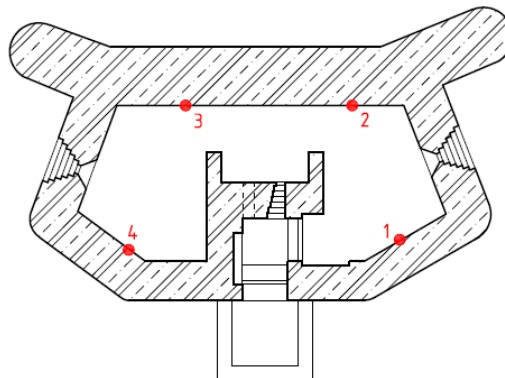
For the resistance moisture meter measurements, it was first necessary to drill holes in the interior of the structure into which brush probes were inserted. Figure 3 shows the location of four points in the building plan that were selected for these holes. At these points, holes were drilled at three height levels (0.1 m, 0.7 m and 1.3 m above the floor) to obtain the moisture profile of the structure at the measured point. Given the technological procedure, pairs of holes were drilled, each with a diameter of 8 mm, approximately 300 mm long and spaced 80-100 mm apart depending on the location of the reinforcement.

Fig. 3 – Diagram of moisture profile locations measured with resistance moisture meter

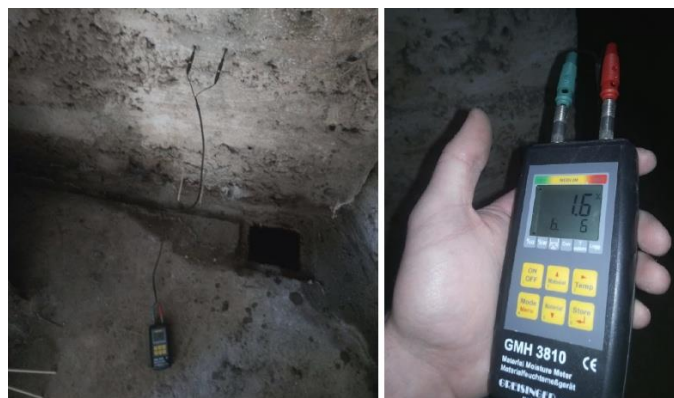
From October 25, 2019, to June 3, 2021, resistance moisture measurements in the structures were conducted at approximately weekly intervals to monitor the moisture behavior of the vertical structures over time (see Figure 4).

Fig. 4 – In-situ moisture measurement using electrical resistive hygrometer

The long-term analysis was used to determine the moisture behavior of the concrete structure during the model year. The moisture measured from September 2, 2019 to July 23, 2021 depends on the position of the structure (whether it was exposed or covered by an earth mound) and the boundary conditions (weathering). Moisture ranged from 3.5% to 4.6% at Point 1, 1.7% to 3.0% at Point 2, 3.0% to 4.5% at Point 3, and 3.5% to 5.0% at Point 4. Values with an extreme deviation indicate the effect of boundary conditions. The lowest humidity values were measured in winter, indicating water freezing in the structure and drier air. Extremely high moisture values were measured during autumn when the structures were exposed to heavy rainfall and during winter due to snow melt. Higher moisture on the exposed side of the structure is likely due to the retention effect of the earth embankment, which was constructed using stone fill.

The analysis further revealed that moisture levels within the height profile of the structure vary significantly. This suggests that the dominant source of water in the structure is not rising groundwater, but weathering water. Another cause of variability in the measured values is the porous and voided structure of the concrete structures caused by manual compaction during construction.

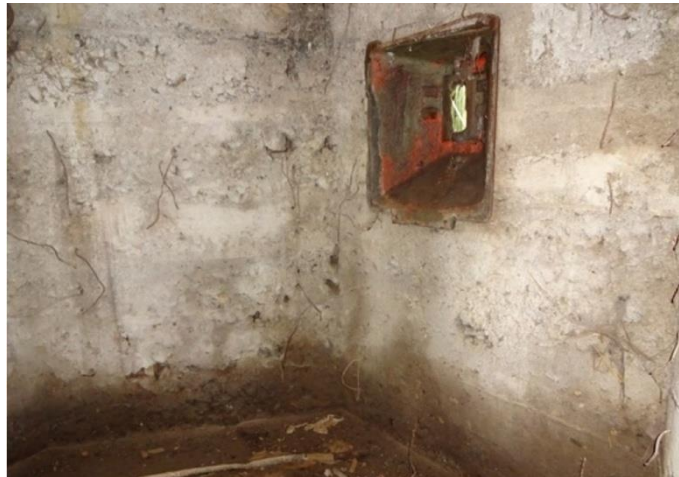
To obtain accurate results, due to the imperfections of the analyzed structure, calibration was performed by gravimetric laboratory examination of the collected damaged samples. Based on the values from in-situ moisture measurements and gravimetric laboratory examination, the calibration coefficient $K [-]$ was determined, which in this case has a value of 1.557. Moisture damage, as well as visible cavities and reinforcement corrosion in the concrete structure, can be seen in Figure 5 and Figure 6.

Fig. 5 – Moisture damage and visible cavities in the concrete structure

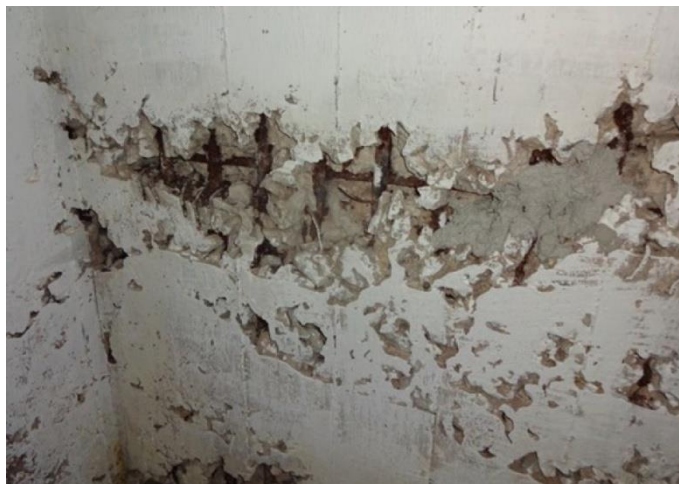
Fig. 6 – Visible cavities and reinforcement corrosion in the concrete structure

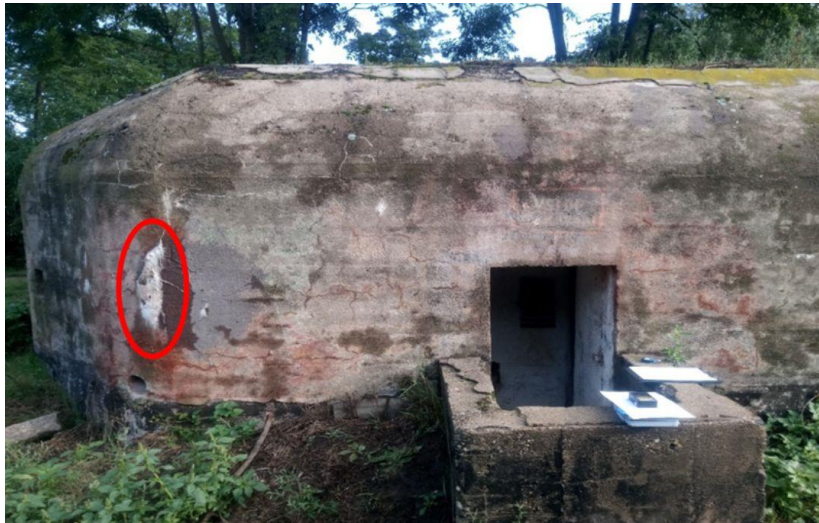
A laboratory measurement of the chemical content of the lime leachate sample (salinity measurement) was carried out. For salinity testing, the sample marked in Figure 7 was taken from fortification Model 37 (from 1937) number C-27/52a/A-140Z, located near the village of Mradice.

Fig. 7 – Location of leachate sample taken away from the object C27/56a/A-140Z near to Mradice

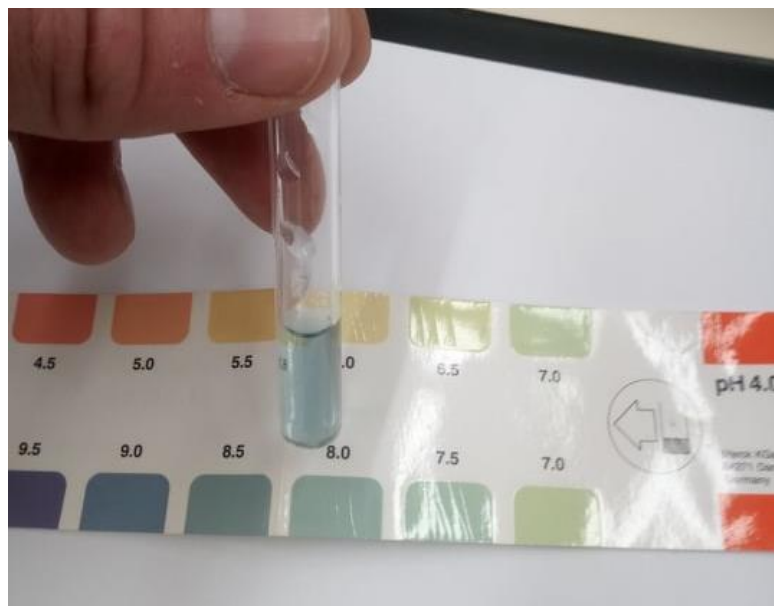
Qualitative analysis was used to preliminarily determine both the presence and approximate concentration of specific chemicals in the sample (mg/l). During the analysis, the test strips were immersed in the prepared solution, resulting in a change of their color (see Figure 8). These colors were compared with a calorimetric scale, which indicates the approximate concentration of salt in the sample. Using qualitative analysis, the solution was tested for the presence of nitrates. There was no color change after immersing the test strip in the solution. This indicates that there are no nitrates in the sample. This finding was later confirmed by quantitative analysis.

Fig. 8 – Calorimetric measurement of pH

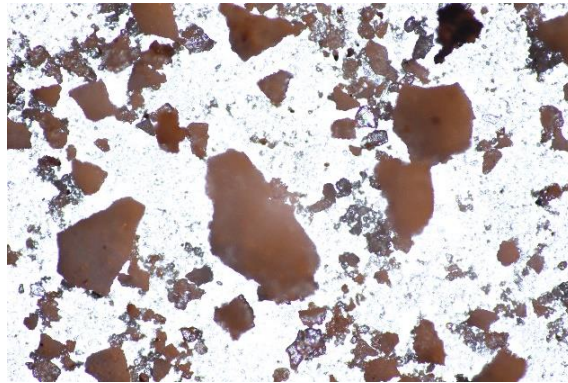
The sample collected was applied to a microscope slide, which was then labelled according to the corresponding sample. The slide with the prepared sample was then placed under a microscope. Figure 9 shows its structure before crystallization was examined. In the next step, the sample was exposed to a constant temperature of 60 °C for 14 days, during which the sample crystallized due to water evaporation, as shown in Figure 10. From the figures, it is clear that the solution contained a significant amount of dissolved substances. These substances crystallized after the evaporation of the solution.

Fig. 9 – The lime efflorescence sample S1 (before crystallization)

Microscopic analysis was performed on the samples intended for quantitative analysis. From the aforementioned procedure and figures, it is clear that the lime leachates can recrystallise, which has a significant impact on the remediation design, as lime leachates cannot be removed by dissolution. A suitable solution to eliminate the formation of lime leachate is likely to be the application of a crystalline waterproofing, which will create an impermeable zone in the structure at a depth of approximately 50 mm and prevent further spread of the calcite solution through the porous structure. Due to the structure of historical concrete structures, it is probably not possible to completely eliminate the formation of leachates throughout the structure, but it is possible to eliminate their presence on the surface. However, the question remains as to the effect of the leachates within the structure on the structure itself in terms of the pressures generated. This should be the subject of further study.

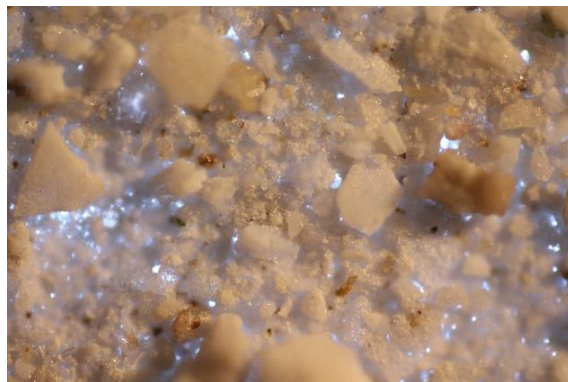
Fig. 10 – The lime efflorescence sample S1 (after crystallization)

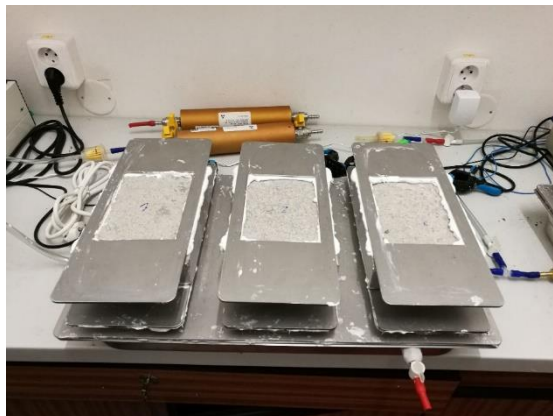
For laboratory purposes, three specimens were prepared (see Figure 11), with dimensions ranging from 37.0 mm to 39.3 mm. The effective area (the area through which radon diffuses into the accumulation chamber) of all specimens was $140 \cdot 10^{-4} \text{ m}^2$ (140 cm^2). A gravel fraction of 4/16 mm was used as aggregate.

Fig. 11 – Preparation of the samples for measurement

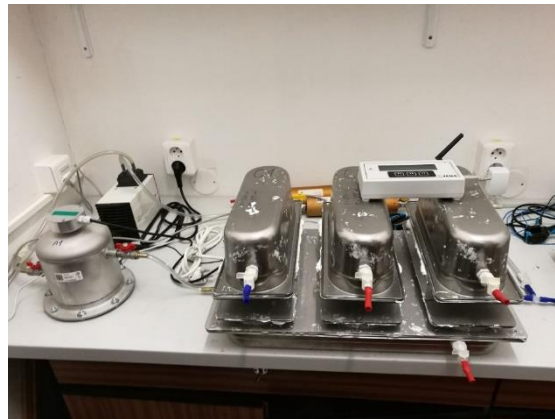
According to the test methodology A specified in ISO/TS 11665-13, samples of the tested material were placed between the source chamber and three accumulation chambers, as can be seen in Figure 12. Radon diffuses through the tested samples from the source chamber, which is connected to the RF 100 radon source, into the accumulation chambers. Radon concentrations on both sides of the samples are continuously measured by TSR-4 TERA detectors (in the accumulation chambers) and continuous ionization chambers (in the source chamber). The radon diffusion coefficient is determined from the time-dependent radon concentrations in the chambers, as shown in Figure 13. The calculation is based on an iterative numerical solution of the one-dimensional time-dependent radon diffusion equation. The final value of the radon diffusion coefficient is obtained when the solution has a minimal deviation from the measured radon concentration in the accumulation chamber [29, 30].

Fig. 12 – The samples ready for measurement

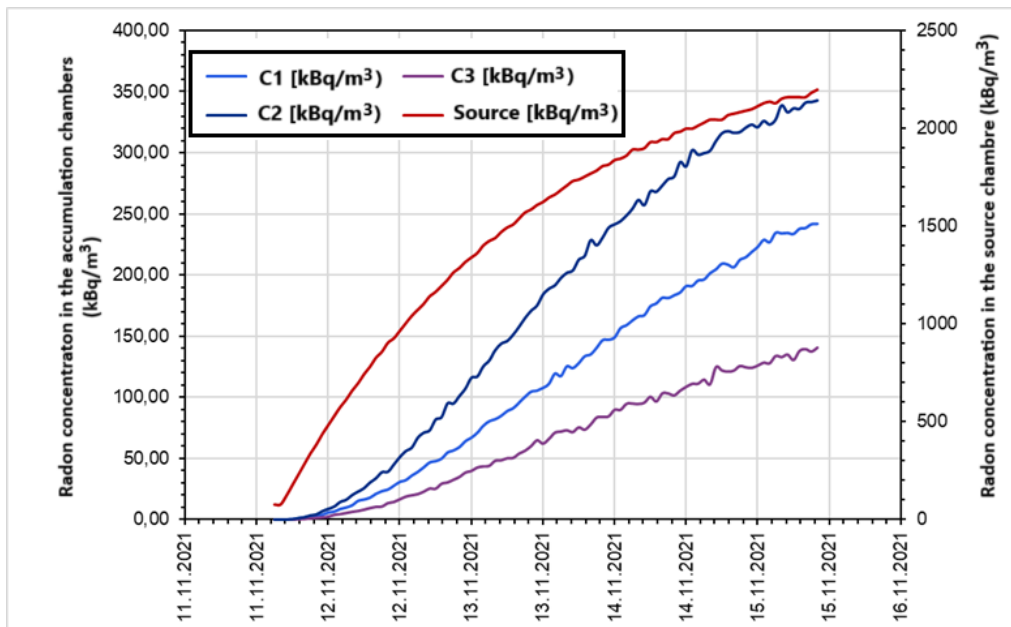
Fig. 13– The time course of radon concentration in the accumulation chambers and in the source chamber (output of the measuring system of radon concentration RM-2)

As part of the analysis, the diffusion permeability of the concrete was measured on three specimens. The following parameters were determined: average diffusion coefficient $D = 8,4 \cdot 10^{-9}$ (m^2/s), diffusion length $l = 63,2 \cdot 10^{-3}$ m and average radon resistance $R_{Rn} = 5.1$ (Ms/m) with the mentioned tolerances in Table 3.

Since the diffusion coefficient D and the diffusion length l are material constants, the radon resistance depends on the thickness. Thus, for concrete 0,5 m thick, the radon resistance is approximately 10 212 Ms/m. This is of course only valid if there are no cracks in the concrete structure.

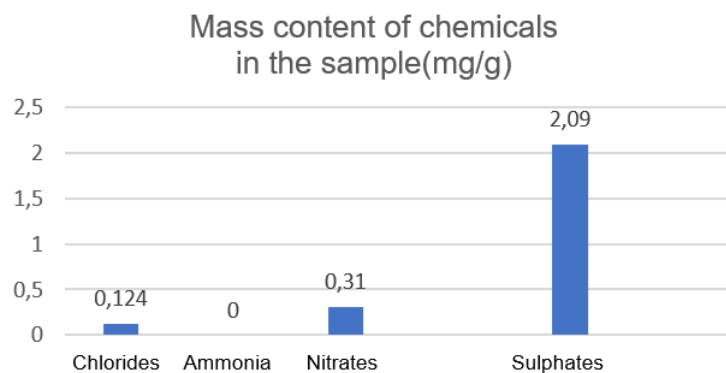
A sample of lime leachate, taken from the fortification near Mradice, was subjected to chemical analysis using both qualitative and quantitative analysis. The analysis determined that the chemical content in the lime leachate was low. The sample was found to contain 0.0124 % chloride, 0.031 % nitrate and 0.209 % sulphate. No ammonia was detected in the sample, as shown in Figure 14.

Fig. 14 – Photometric result of lime leachate of sample S1

Although the structure is situated in the middle of the field, the salinity classification of the measurements determined that the sample contained trace amounts of sulfate, nitrate, and chloride.
