# STUDY ON REINFORCEMENT OF FABRICATED HOLLOW SLAB BRIDGE BY POLYURETHANE-CEMENT COMPOSITE (PUC)

In this paper, a new polyurethane-cement composite (PUC) material is used to reinforce a 25-year hollow slab bridge. PUC material is composed of polyurethane and cement, which has good mechanical properties. After pouring PUC material at the bottom of the hollow slabs, the traffic can be restored in a short time. Ultimate bearing capacity was discussed based on the concrete structures. The bending failure mode of concrete reinforced T-beam bridges strengthened with PUC was controlled through PUC design strength. The main construction process was introduced, including concrete surface treatment, supporting template and pouring. To investigate the effectiveness of PUC in strengthening bridges, load tests were conducted before and after the reinforcement. The test results showed that PUC possibly removed the bridge load and increase the stiffness of the hollow slabs. The maximum carrying capacity and stiffness of the main girder were increased by about 20% and 28% after PUC material was poured. Meanwhile, the width of the cracks was reduced in different degrees.

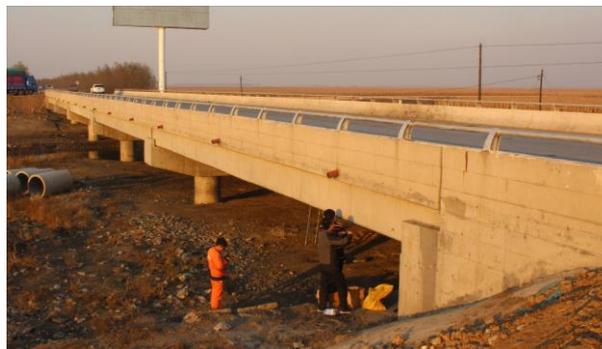
*Fig. 1 - Lateral view of Piao Fa Bridge*

Figure 1 shows a lateral view of Piao Fa Bridge. The bridge was built in 1995 and carries an average daily traffic of 800 vehicles. The bridge has 5 spans, each span being 20 meters of simply supported hollow slabs. Central supports consist of reinforced concrete bents, each supported by two circular columns. The total width is 12.0 m, and the width of the driveway is 11.0 m. The bridge has two lanes and carries one lane of traffic in each direction. The cross section of the superstructure consists of 9 hollow slabs with a width of 1.25m Figure 2.

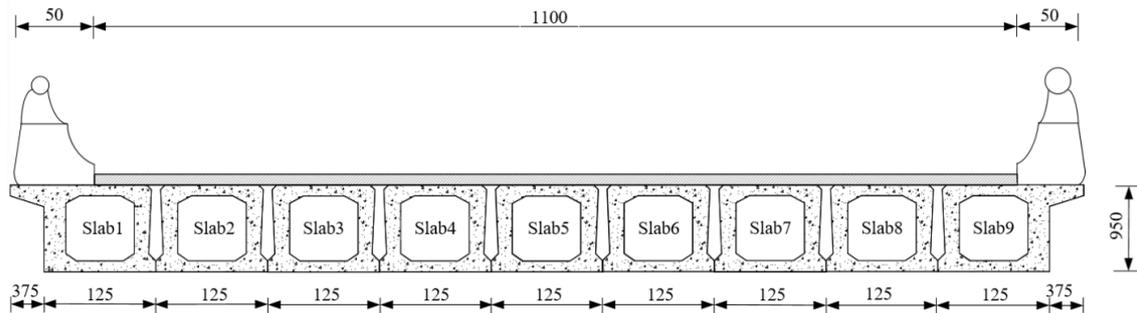
Fig. 2 - Cross-section of the bridge

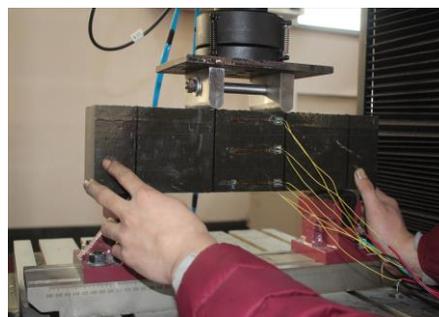
Fig. 3 - Bending test for PUC material

This project adopts polyurethane cement material with good mechanical properties with a density of  $1500\text{kg/m}^3$  to strengthen the hollow plate. The bending stress-strain curves of PUC with the same density are approximately the same. Bending test for PUC material is shown in Figure 3. The density of PUC mixed in the construction site was  $1,524\text{ kg/m}^3$ . The bending stress-strain curves of five groups of stirred PUC specimens at the construction site are shown in Figure 4. Ultimate strength ( $f_{Pu}$ ) was about 42.3MPa. Design strength ( $f_{Pd}$ ) was designed to be 3/4 of the ultimate strength, and the corresponding strain was 0.006 under the design strength. The minimum modulus of elasticity ( $E_{Pd}$ ) was 5MPa. Table 1 shows the properties of PUC.

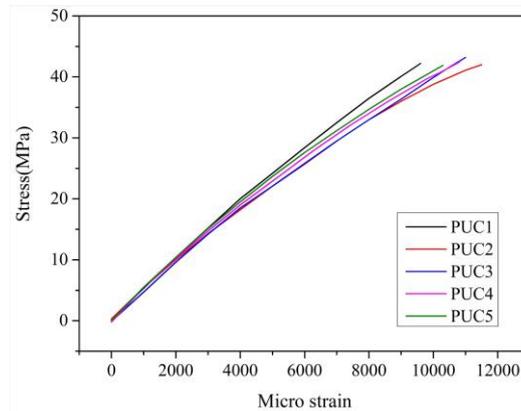
Fig. 4 - Blending stress–strain curve of the PUC

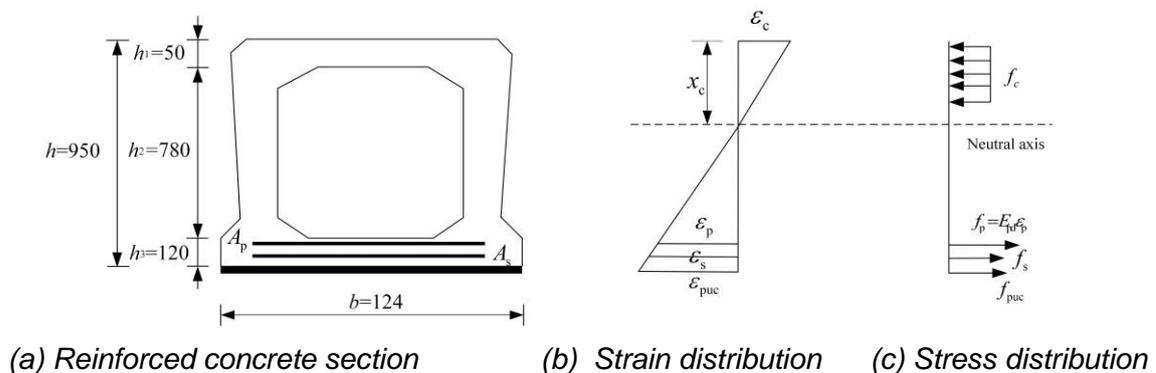
Fig. 5 - Internal strain and stress distribution for a hollow slab shape section

The service capacity of the inspected bridge is insufficient due to cracks, rain erosion and so on. Moreover, the owner of the bridge asked to complete the strengthening work with minimum interference to traffic. Therefore, the PUC material is designed to reinforce the hollow slab bridge. The hollow slab blending bearing capacity was analysed through the assumption that the plane section remained to be planar until failure. Blending bearing capacity was evaluated based on force equilibrium and strain compatibility until failure Figure 5.

material's design strength. Two kinds of failure modes exist for PUC -strengthened the prestressed hollow slab according to Fig. (5) and plane assumption.

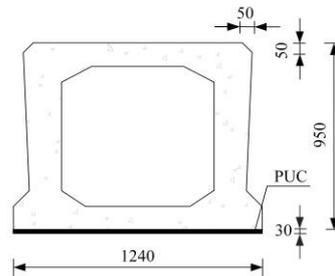
Fig. 6 - Hollow slab section strengthened with PUC material

The above mentioned analysis shows that the bearing capacity of the strengthened beam is controlled by the design strength of the PUC material. The flexural strength increased to 1543.7 kN.m through the pouring of the PUC material. The section of PUC is shown in Figure 6.

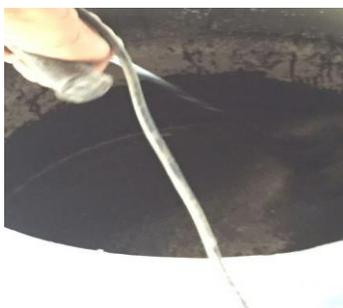
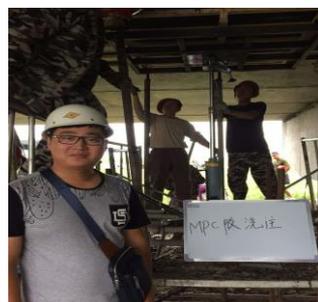
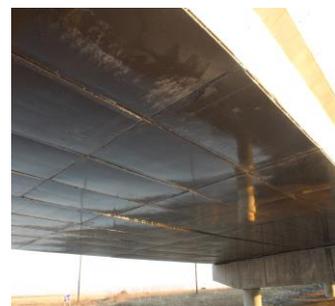
(a) Mixed the PUC material (b) Support formwork and PUC casting (c) Template removal  
Fig. 7 - The PUC material casting

In achieving a better bonding effect, sufficient time must be ensured to dry the concrete surface naturally. The construction templates were made depending on the design of the dimensions of the PUC material. The template was installed in the location specified Figure 8. The mixing ratio of the PUC components (polyol: polyisocyanate: cement) was 1:1:2 by weight. The mixed PUC material was poured into the templates. First, a water drill is used to form a round hole with a diameter of 40 mm at the hinge joint position. Then, at the deck location, the PUC material is dumped through the circular hole. The templates were removed after two hours Figure 7c.

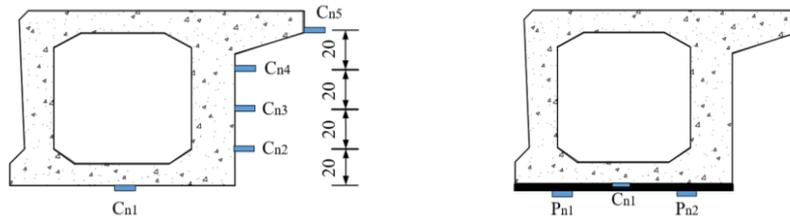
(a) Strain gages mounted on concrete

(b) Strain gages mounted on PUC

Fig. 9 - Locations of Strain Gages Mounted on the Slabs (n is the slab number)

Strain gages were placed and arranged at the bottom of the mid-span, as shown in Figure 9a. The letter n represents the hollow slab number, and the letter C represents the concrete strain gages. Strain gauges ( $C_{n1}$ ) were installed on the bottom of the hollow slab before strengthening, as the bottom of the hollow slabs was covered with PUC after strengthening. The strain gages of the PUC surface are shown in Figure 9b. The letter P represents the PUC strain gages. The gage  $P_{n2}$  and the gage  $C_{n1}$  were installed at the same horizontal position. The strains were collected at a rate of two readings per second.

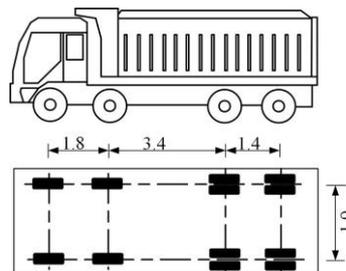
Fig. 10 - Load-test truck configuration

Before strengthening and two months after strengthening, load tests were performed to obtain the service ability of the bridge. These tests are repeated once a year, and they will continue over a period of three years. Three-axle trucks are used as live load. The details of the trucks are shown in Figure 10. The gross rail loads before and after strengthening are listed in Table 2. The bridge test was performed under four conditions. The two trucks were used at different locations for each condition and were assigned with unique letters A and B.

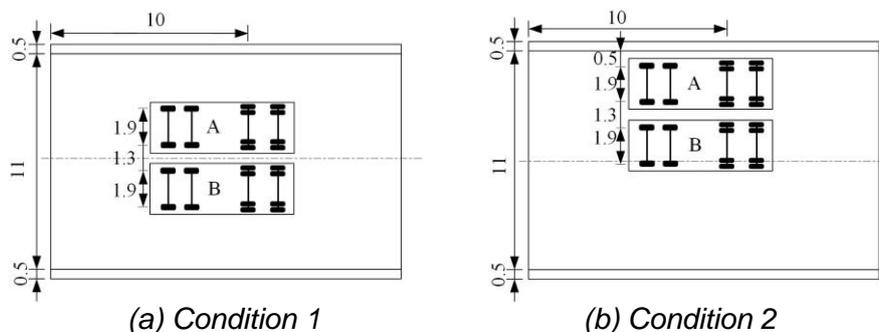
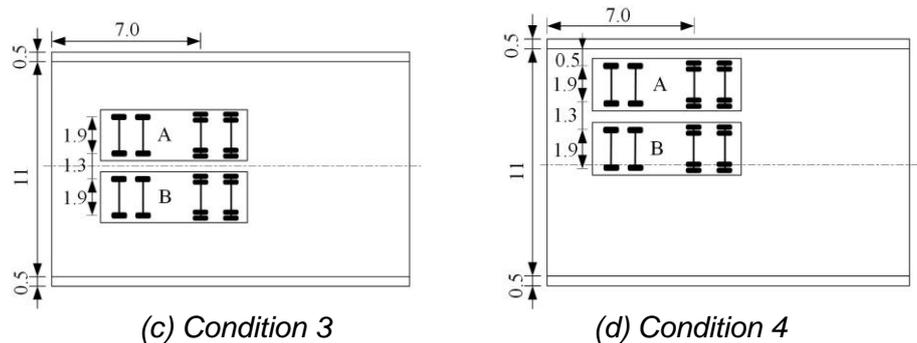
(a) Condition 1

(b) Condition 2

Fig. 11 - Distribution of load-test trucks on the bridge deck at different

The testing of each condition was sequenced as follows: Truck A, Truck A + B, Truck B. The four conditions are shown in Figure 11. For condition 1, the two trucks were symmetrical with the centre of the bridge, and the distance from the outside wheels to the pavement edge was 2.95 m. For condition 2, the two trucks deviated from the centre line of the bridge, and the distance from the outside wheels to the pavement edge was 0.5m. For both conditions 1 and conditions 2, the third axle of the vehicles are in the middle of the span. For condition 3, the two trucks were symmetrical with the centre of the bridge, and the distance from the outside wheels to the pavement edge was 2.95 m. For condition 4, the two trucks deviated from the centre line of the bridge, and the distance from the outside wheels to the pavement edge was 0.5m. For both conditions 3 and conditions 4, the four axles of the vehicles are in the middle of the span.

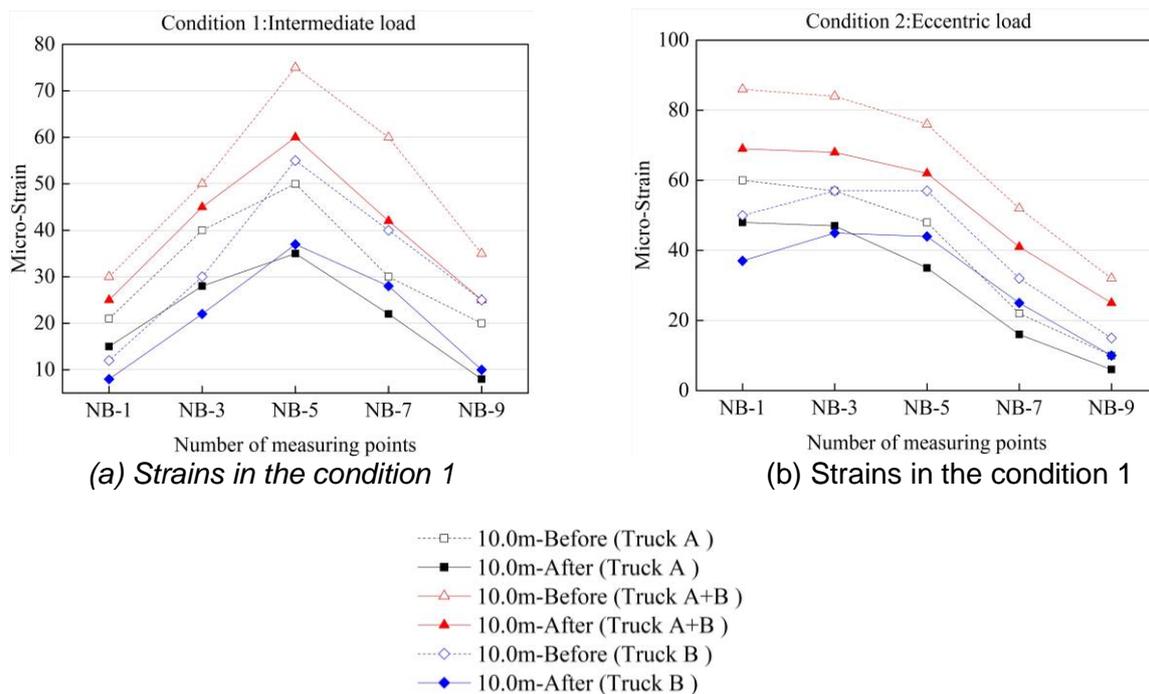
Fig. 12 - Recorded concrete strains of hollow slabs in condition 1 and condition 2

Figure 12 shows the concrete strain on the bottom concrete surface under live load in condition 1 before and after strengthening. The strain was the largest in the middle slab. The maximum strain of slab 5 were 75 microstrains for the two trucks (Trucks A + B) before strengthening because of the damage and the weak interaction between the slabs. After strengthening, the maximum strain of slab 5 were 60 microstrains for the two trucks (Trucks A + B). The maximum strains of hollow slab 3 were 50 microstrains and 45 microstrains before and after strengthening, respectively. The strain was reduced to about 5 microstrains. The maximum strains of slab 1 were 31 microstrains and 25 microstrains before and after strengthening, respectively. Therefore, the concrete strain can be reduced after the PUC material is poured. For condition 2, the concrete strains on the bottom concrete surface under live load before and after strengthening are shown in Figure 12. The strain of beam 1 was the largest for the two trucks (Trucks A + B) because the two trucks approached the side of the bridge. The maximum strain of beam 1 were 88 microstrains before strengthening, and the strain became 69 microstrains after strengthening. Before strengthening, the strains of beam 3 and beam 5 were 83 and 76 microstrains, respectively, and after strengthening, the strains were 68 and 63 microstrains, respectively. In comparing the strains before and after strengthening, the concrete strain is reduced to some degree.

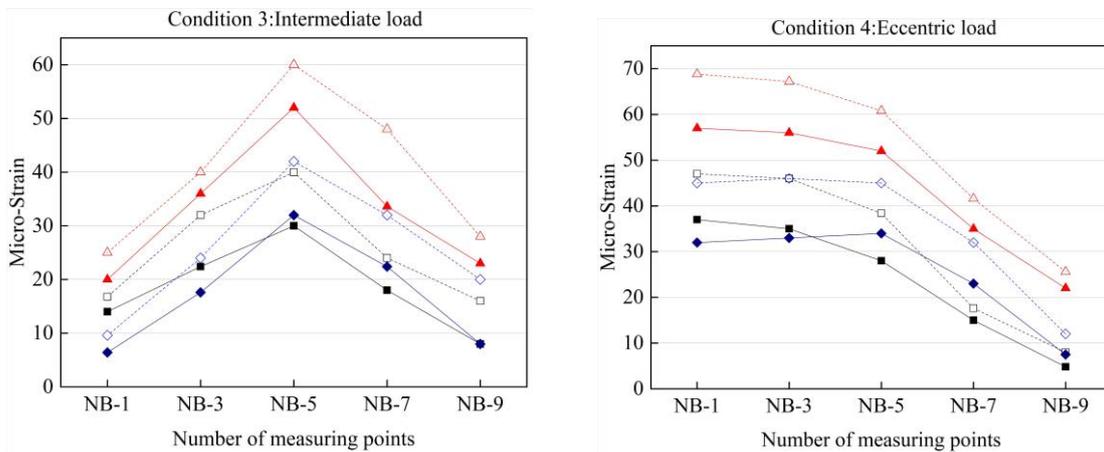
(a) Before strengthening

(b) After strengthening

Fig. 13 - Recorded concrete strains in condition 2

Figure 13 shows the concrete strain on the bottom concrete surface under live load in condition 3 before and after strengthening. The strain was the largest in the middle slab. The maximum strain of slab 5 was 60 microstrains for the two trucks (Trucks A + B) before strengthening because of the damage and the weak interaction between the slabs. After strengthening, the maximum strain of slab 5 was 52 microstrains for the two trucks (Trucks A + B). The maximum strains of hollow slab 3 were 40 microstrains and 36 microstrains before and after strengthening, respectively. The strain was reduced to about 4 microstrains. The maximum strains of slab 1 were 25 microstrains and 20 microstrains before and after strengthening, respectively. Therefore, the concrete strain can be reduced after the PUC material is poured. For condition 4, the concrete strains on the bottom concrete surface under live load before and after strengthening are shown in Figure 13. The strain of beam 1 was the largest for the two trucks (Trucks A + B) because the two trucks approached the side of the bridge. The maximum strain of beam 1 was 68 microstrains before strengthening, and the strain became 56 microstrains after strengthening. Before strengthening, the strains of beam 3 and beam 5 were 67 and 61 microstrains, respectively, and after strengthening, the strains were 56 and 52 microstrains, respectively. In comparing the strains before and after strengthening, the concrete strain is reduced to some degree.

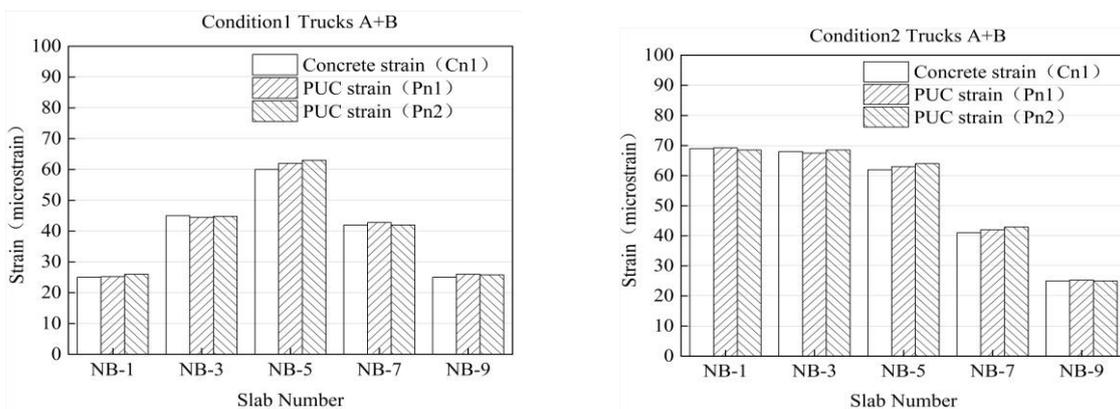
(a) Condition1 (Trucks A+B)

(b) Condition2 (Trucks A+B)

Fig. 14 - Concrete Strains and PUC Strains at Different Positions

The recorded strain values of gages C<sub>n1</sub>, P<sub>n2</sub> and P<sub>n1</sub> for the five slabs in condition 1 and condition 2 are shown in Figure 14. In comparing the recorded concrete strains (gage C<sub>n1</sub>) and PUC strains (gage P<sub>n1</sub> and gage P<sub>n2</sub>), the concrete strain values are close to the PUC strain values on the same horizontal height. Therefore, PUC strain compatibility is well at the live load. In comparing the PUC strains (gage P<sub>n1</sub> and gage P<sub>n2</sub>) with those recorded on the concrete (gage C<sub>n1</sub>), the PUC strains are approximately the same as that of concrete strains. Strain compatibility

leads to the higher PUC strain than the concrete strain because the bottom PUC is physically located below the bottom concrete in the beam section.

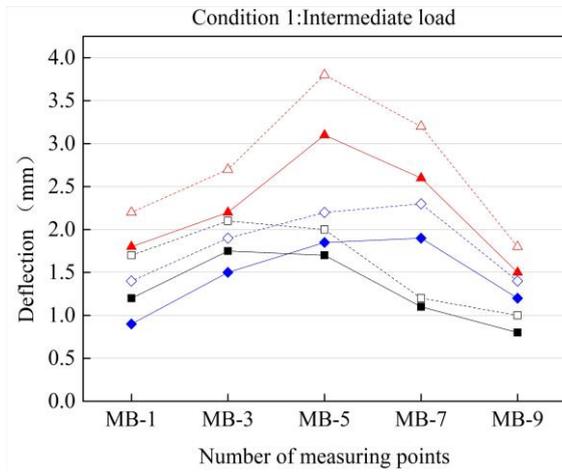
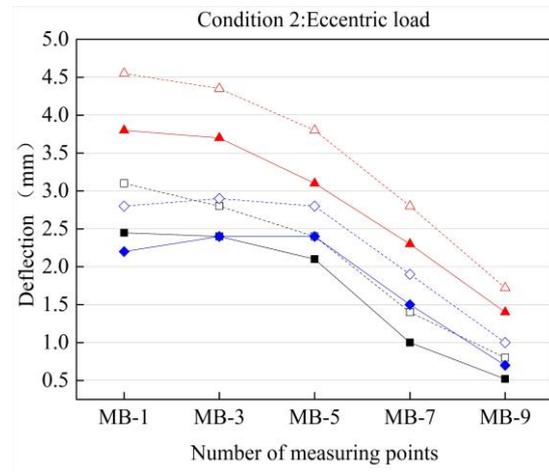
(a) Deflections in the condition 1

(b) Deflections in the condition 2

Fig. 15 - Measured deflection of hollow slabs in condition 1 and condition 2

Displacement meters were installed on the bottom of the hollow slabs to measure the midspan deflection in the different conditions. The midspan deflection of all the slabs before strengthening in condition 1 is shown in Figure 15a. The deflection of slab 5 was the maximum under the symmetrical loads. The maximum deflections were 3.9 mm and 2.8 mm for two trucks (Trucks A + B) before and after strengthening, respectively. The deflection was reduced by 3mm compared with that before reinforcement. The deflection for slab 1 and slab 5 were 1.5 mm and 2.7 mm before strengthening, respectively. The deflection for slab 1 and slab 5 were 1.1 mm and 2.2 mm after strengthening, respectively. Figure 15b shows the midspan deflection of all the slabs after strengthening in condition 2. The maximum deflections of slab 1 were 4.6mm before strengthening. After strengthening, the deflection was 3.8 mm for the two trucks (Trucks A + B). As expected, a certain decrease in deflection after the application of PUC reinforcement could be observed.

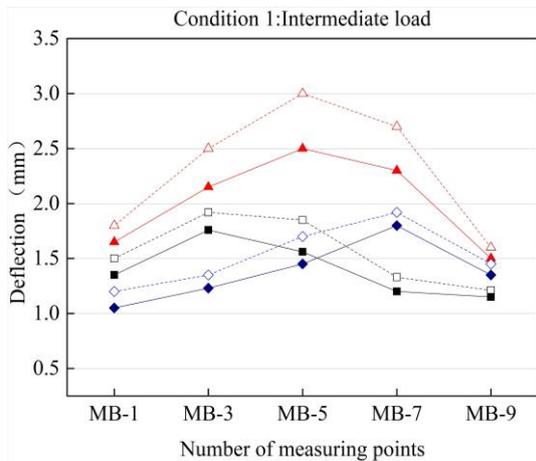
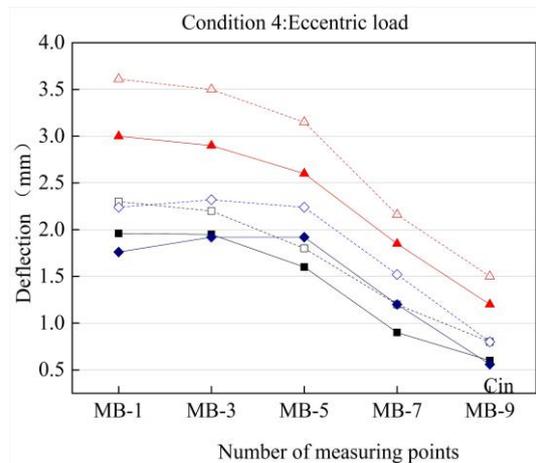
(a) Deflections in the condition 3

(b) Deflections in the condition 4

Fig. 16 - Measured deflection of hollow slabs in condition 1 and condition 2

Figure 16a and Figure 16b show the midspan deflection of all the beams before and after strengthening in condition 3 and condition 4, respectively. In condition 3, the deflections of slab 5 were 3.0 mm and 2.5 mm for the two trucks (Trucks A + B) before and after strengthening, respectively. The deflection decreased by about 0.5 mm after strengthening. Before strengthening, the deflections of slab 1 and slab 3 were 1.7 mm and 2.5mm, respectively. After strengthening, the deflections of slab 1 and slab 3 were 1.7 mm and 2.2 mm, respectively. In condition 4, the deflections of slab 1 were 3.7 mm and 3.0 mm for the two trucks (Trucks A + B) before and after strengthening, respectively. The deflection decreased by about 0.7 mm after strengthening. Before strengthening, the deflections of slab 3 and slab 5 were 3.5 mm and 3.2 mm, respectively. After strengthening, the deflections of slab 1 and slab 3 were 2.2 mm and 2.8 mm, respectively.

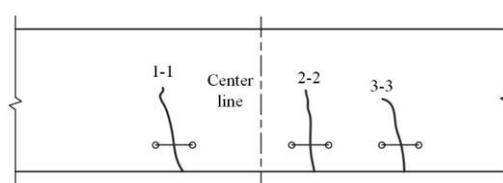
Fig. 17 - Schematic diagram of fracture observation

In the load test before retrofitting, the width of the cracks increased with the test load, but no new cracks appeared. These cracks had affected the durability of the bridge and would have further reduced the performance of the bridge if no actions were taken. In observing the development of the cracks after reinforcement, a crack (2-2 measure point) in the side slab for slab 9 was selected to be the observation crack of the load test. The width of the crack on the bottom concrete is 0.15mm before strengthening. The depth from the observation location to the bottom concrete surface was 10cm. The width of the crack at the observation location is 0.08mm. Its width was unchanged for one truck (Truck A), 0.01mm for two trucks (Trucks A + B) in condition 2 and closed when the trucks were moved from the deck. Furthermore, periodical inspections were conducted to observe the development of the crack. The crack was found to be stable.

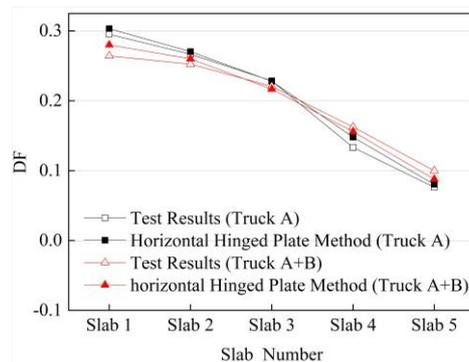
Fig. 18 - Live -load DFs calculated from test results and horizontal hinged plate method in condition 2

where  $\delta_i$  is the maximum static deflection in the  $i$  th slab, and  $i = 1 \sim 5$ . The deflection measurements shown in Figure 18 for Pia oFa Bridge in condition 2 were used to determine the live-load DFs according to Equation (7). From the horizontal hinged plate method [24], live-load DFs that can be compared with the measured DFs Figure 18 were provided. The slab 9 deflected by 2.5 mm for one truck (Truck A) in condition 2. The total deflection of all of the slabs was 8.5mm for a live-load DF of about 2.5/8.5 or 0.29. The live-load DF is 0.30 using the horizontal hinged plate method. The live-load DFs depend on slabs spacing, span, girder bending stiffness and girder torsional stiffness. The slab 9 deflected by 3.8 mm for the two trucks (Truck A + B) in condition 2. The total deflection of all of the girders was 14.3 mm for a live-load DF of about 3.8/14.3 or 0.27. The live-load DF is 0.28 using the horizontal hinged plate method. Thus, the horizontal hinged plate method is applicable for calculating the live-load DFs of T-beam bridges.
