EXAMINED AND ANALYSIS OF EMPIRICAL SEISMIC DAMAGE OF WORKSHOP BUILDING

Workshop Building, Empirical Seismic Damage Observation, Analysis of Typical Failure Characteristics, Failure Analysis, Seismic Damage of Components

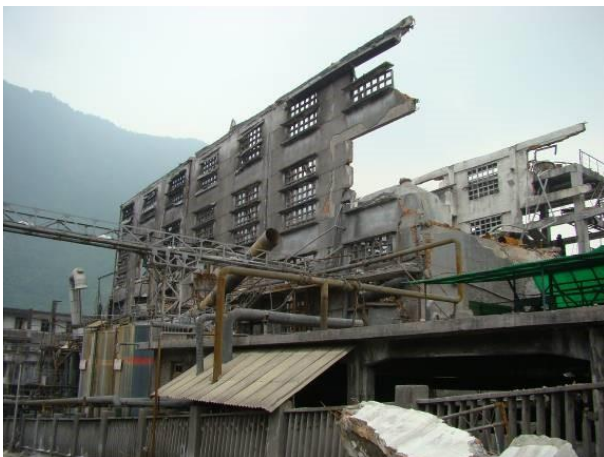
(a) Local collapse of RC industrial building

The investigation team found that in the high-intensity area, due to the relatively weak stiffness and strength at the connection between the precast beam and column, the beam was seriously displaced or even fell under the reciprocating action of ground motion, resulting in local collapse. In addition, individual brick plants experience an overall collapse in the multi-intensity region, owing to their brittle materials and weak vertical and horizontal constraints, as depicted in Figure 2. It should be considered to properly strengthen the connection between the crane beam and corbel, improve the integrity of longitudinal and transverse stressed members, and reasonably set diagonal bracing members to enhance lateral stiffness to coordinate the overall deformation of the structure. Structural members composed of multiple materials should be avoided, the lateral force resistance of the structure should be reasonably increased, and the seismic effect of the structure should be improved.

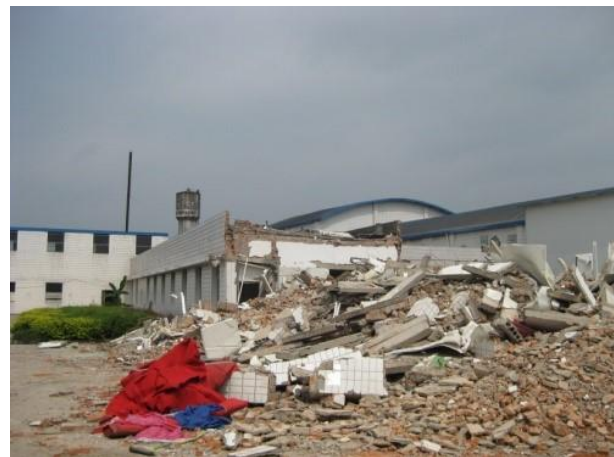
(b) Collapse of MS industrial building

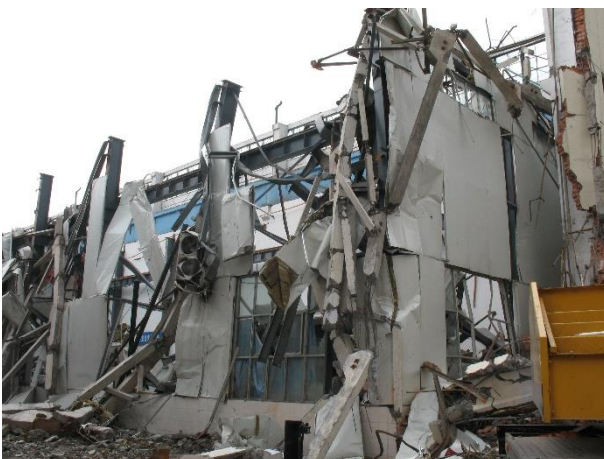
(c) Failure of steel structure industrial building

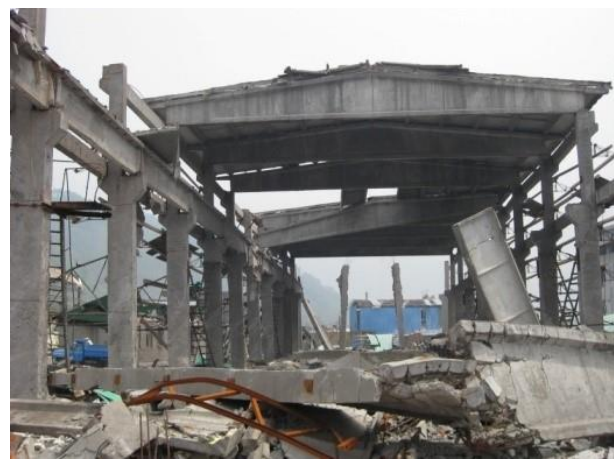
(d) Failure of roof slabs and beams in an industrial building

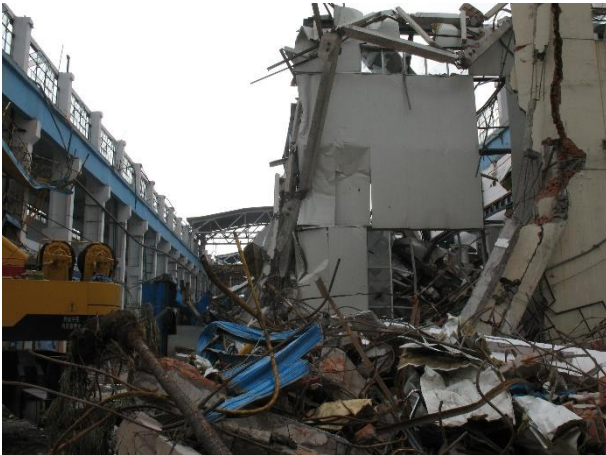
(e) Overall failure of MS and steel frame industrial building

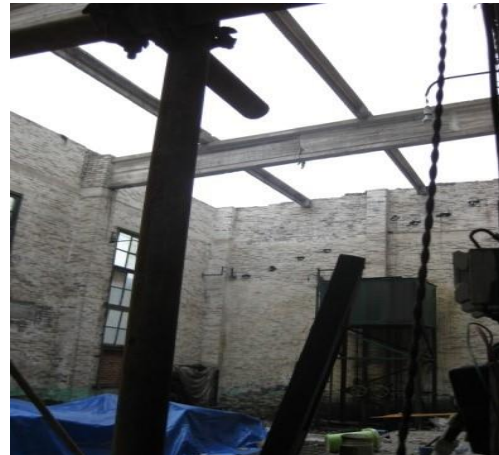
(f) Failure of upper transverse beam and plate of industrial building

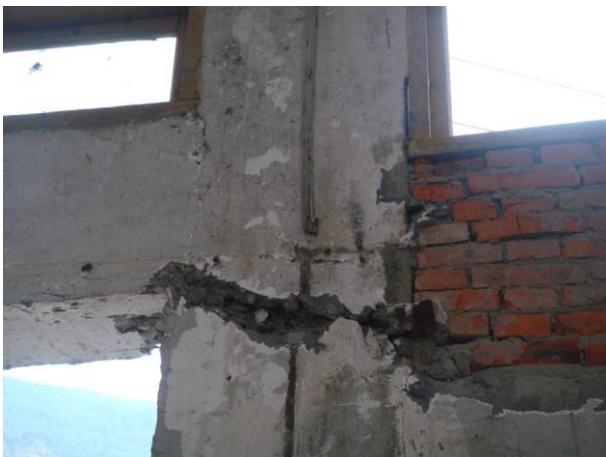
The seismic damage of the WB column was typical in the investigation work. The failure forms were: oblique and transverse cracking of the column (column head, column body, and column base), cracking of the concrete corbel root, cracking at the variable section, and cracking at the column beam joint, as illustrated in Figure 3. Owing to the column ends (top and bottom) being generally subjected to large horizontal earthquakes, a the large shear force was generated and led to shear failure. The failure of the column body was characterized by transverse cracking, local compression, and crisp crushing, resulting in a short column effect, and cracking failure was caused by the coupling effect of bending and tension. Shear or crushing cracking often occurs at the variable section of the concrete column (corbel). Because this position was at the variable section of the column, it caused sudden changes in stress and force transmission coupled with insufficient strength and stiffness, resulting in cracking failure.

(a) Cracking failure of the RC column head

accordance with the seismic design requirements to ensure that they have sufficient seismic capacity. Reasonably improve the ductility to reach the plastic state and still have a certain bearing capacity and deformation capacity when working. Properly control the section shape of a variable column and the ratio of the section area and linear stiffness of the upper and lower columns. The corbel should be subjected to strict seismic checking calculations of stiffness, strength, and ductility, and the lateral stiffness should be reasonably designed to avoid the increase in seismic force caused by too short a transverse period due to improper design.

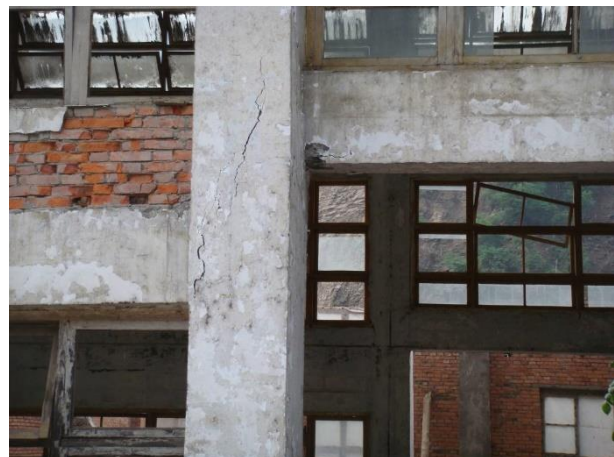
(b) Oblique cracking failure of RC frame column

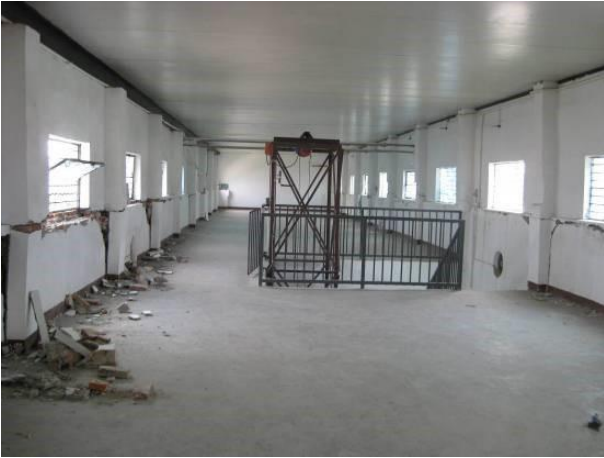
(c) Transverse cracking failure of the brick column

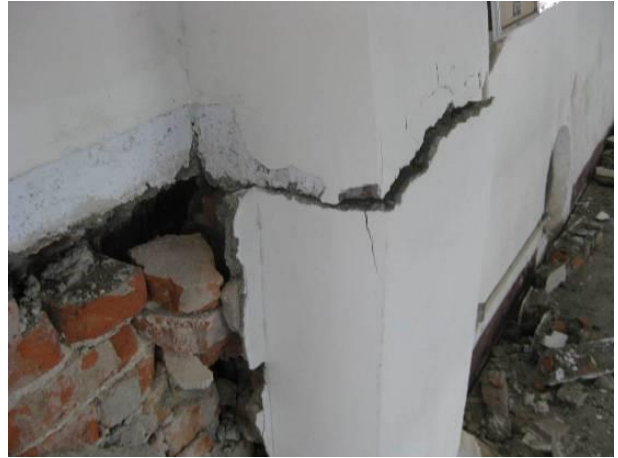
(d) Cracking failure of the lower part of the brick column

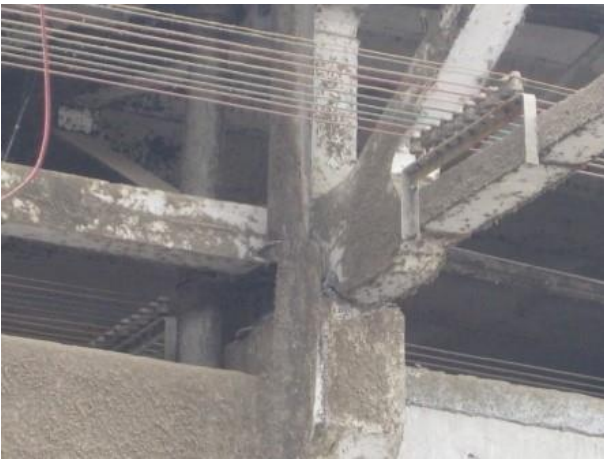
(e) Cracking and failure of corbel root

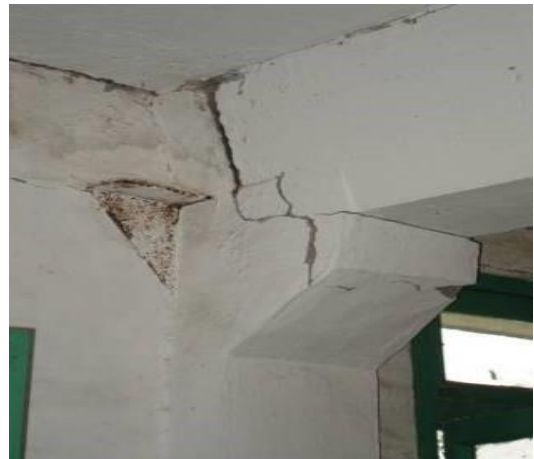
(f) Crushing cracking failure of corbel end

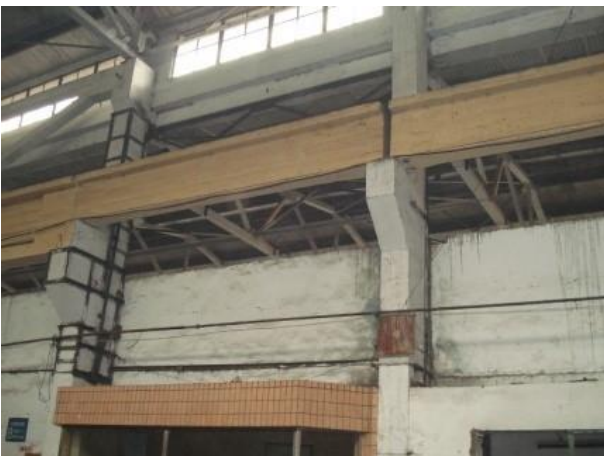
(g) Longitudinal displacement of crane beam

In addition, it was found in the investigation that some column and beam joints produce plastic hinges and crack damage. Individual crane beams cause the corresponding displacement due to insufficient longitudinal restraint. The columns of different materials should be checked in strict

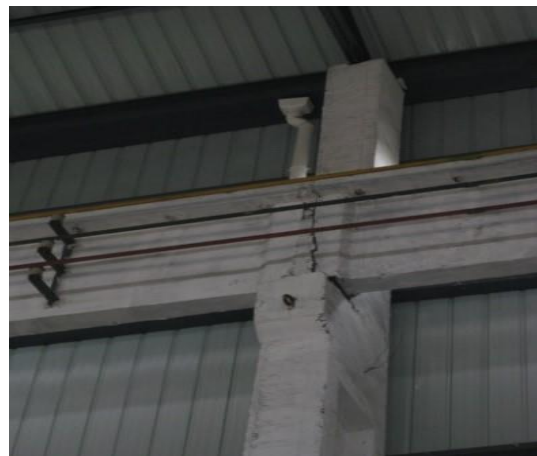
(h) Vertical cracking failure of crane beam

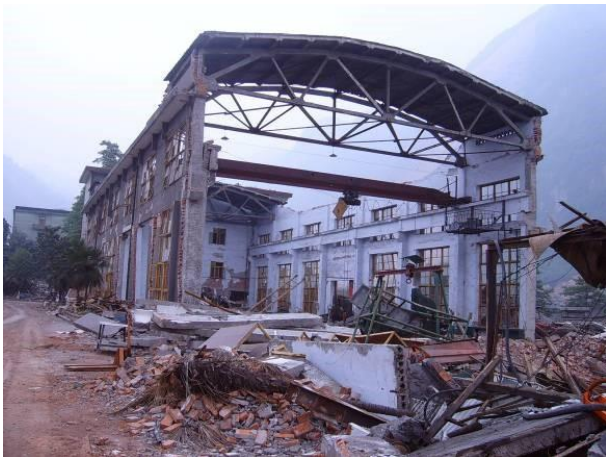
Walls are a vital enclosure component of WB, which can avoid the adverse impact of natural environmental factors on the structural system, ensure the normal use of WB, and play the role of enclosure and blocking space. According to the field investigation of empirical seismic damage, most of the retaining walls are self-supporting brick walls, with relatively small shear and bending resistance and insufficient seismic capacity. Under the reciprocating action of longitudinal ground motion, it is easy to produce a "whiplash effect," resulting in outward inclination of the top and local or overall collapse, as demonstrated in Figure 4.

(a) Failure of Maintenance wall (gable)

WB's stress system is a bent or frame structure system. The maintenance wall is a nonstructural member. It first fails with beams and columns, which protects the bearing capacity of the main structure to a certain extent, plays the role of "the first line of defense," and has positive seismic significance. The necessary design should be conducted in strict accordance with the code for seismic design of building structures, the essential description of the wall structure design, the seismic checking calculation of tie joints, the connection between the wall and structural members should be strengthened to coordinate its stiffness and mass distribution, and the seismic performance of the wall should be further included in the seismic checking calculation of WB.

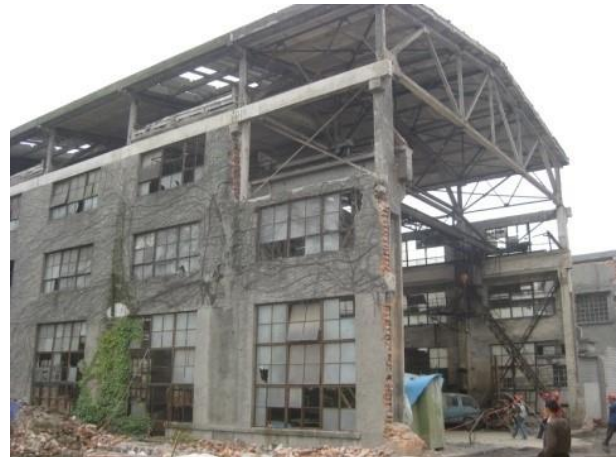
(b) Local collapse of building a wall of RC bent workshop

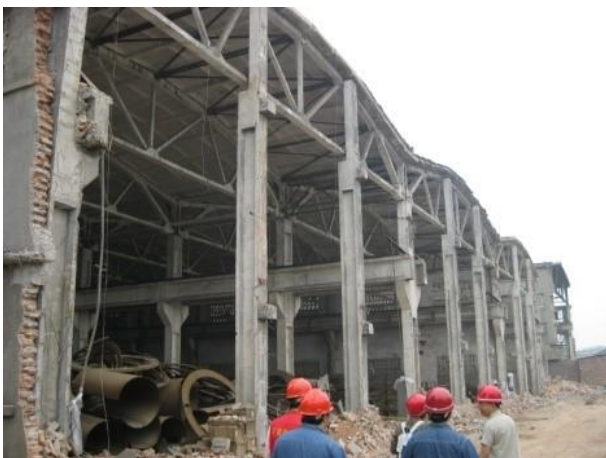
(c) Overall wall failure of maintenance wall

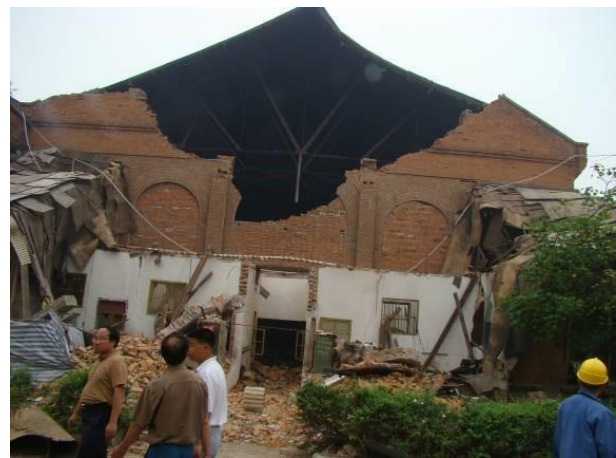
(d) Local collapse of maintenance wall

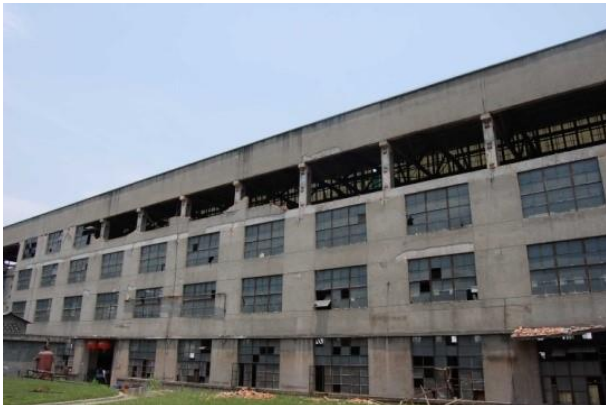
(e) Collapse of upper maintenance wall

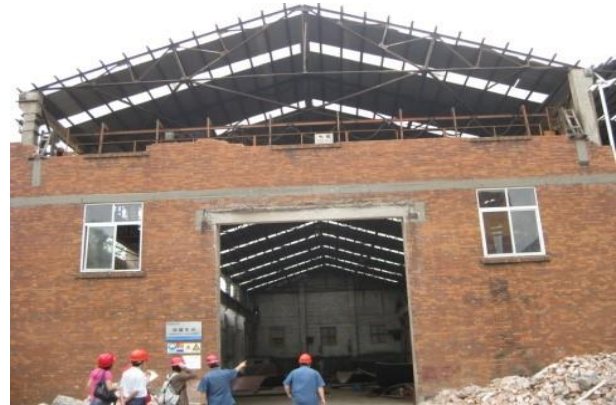
(f) Partial failure of upper maintenance wall

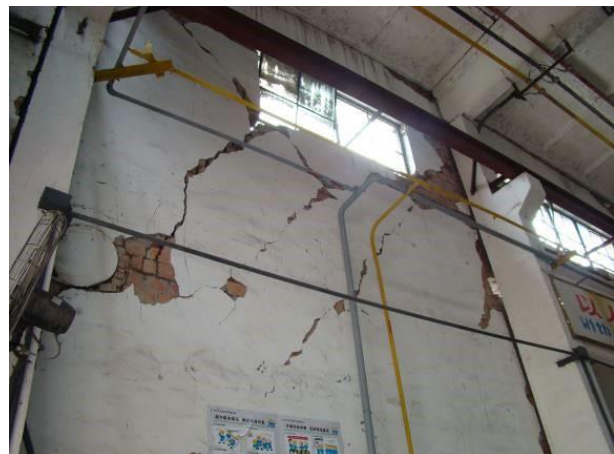
In the low and medium-intensity regions, some walls show transverse and oblique cracking failure, especially at the door and window openings caused by stress concentrations, as depicted in Figure 5.

(b) Oblique cracking of wall

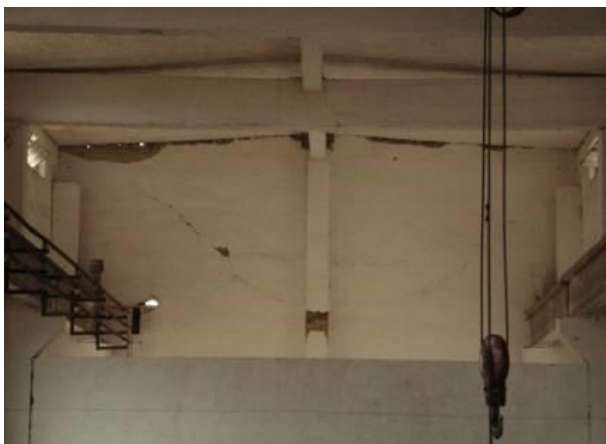
(c) Cracking of inner wall

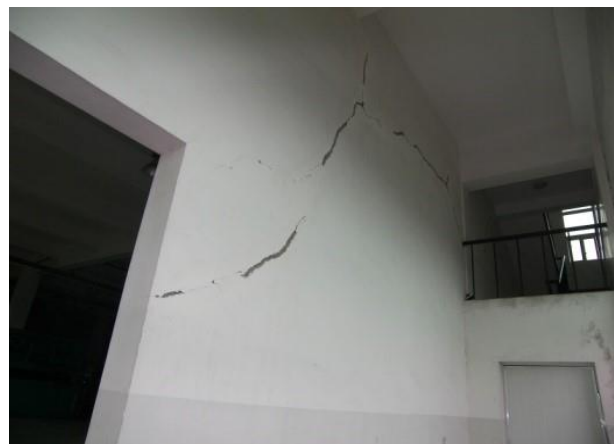
(d) Cracking and damage at the door opening

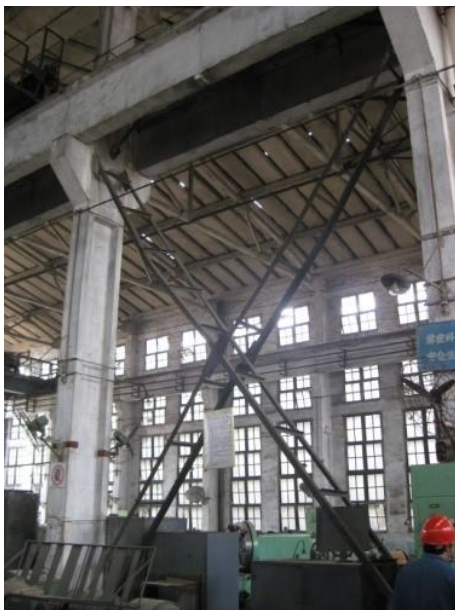
The practical setting of X-type and horizontal support and connection can improve the lateral stiffness of WB to a certain extent to improve its seismic performance. In the field seismic damage investigation, it is found that the yield of supporting and connecting members is relatively significant. When subjected to an earthquake, the roof truss and roof system produce a large horizontal inertial force, resulting in more considerable pressure and tension on the support members. In addition, the support system suffers buckling or failure due to insufficient stiffness and connection strength, as depicted in Figure 6.

(a) Buckling of X-brace

It is necessary to consider the essential aseismic checking of the X-type supporting system and appropriately increase its stiffness and lateral force resistance. Strengthen the joint strength between the vertical and horizontal connecting members and the main structure to have the same deformation coordination ability. However, the buckling or failure of the X-brace consumes part of the seismic capacity to a certain extent and has a certain protective effect on the main structural system.

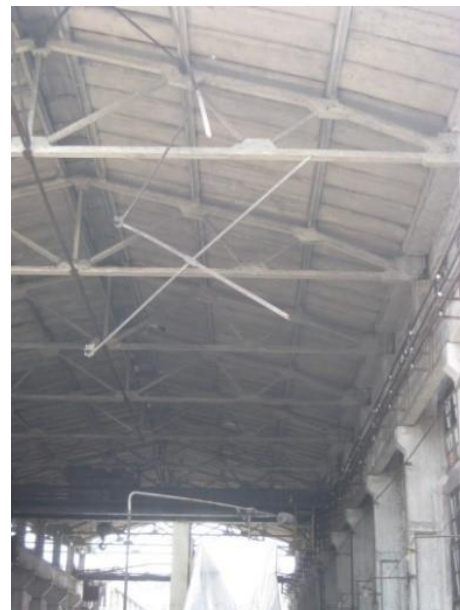
(b) Failure of horizontal contact

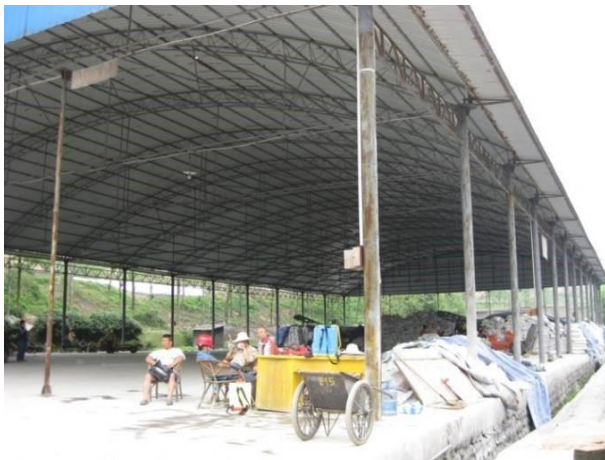
During the field investigation, it was found that a large amount of light steel structure WB and constrained brick WB after seismic design were basically intact, as illustrated in Figure 7. It is worth noting that even in the high-intensity regions, a certain number of light steel structures WB and brick WB after seismic design were still undamaged.

(a) Light steel workshop

The main reason was that the light steel structure has a strong overall deformation capacity, light material texture, and relatively small inertial force. After the seismic design, the brick WB has the seismic structural measures of ring beam and connecting column so that its seismic capacity can be further improved. In new construction or reinforcement projects, priority should be provided to the use of light steel structure WB and brick WB structure category with seismic design to ensure that the structural design and construction are performed in strict accordance with the seismic code.

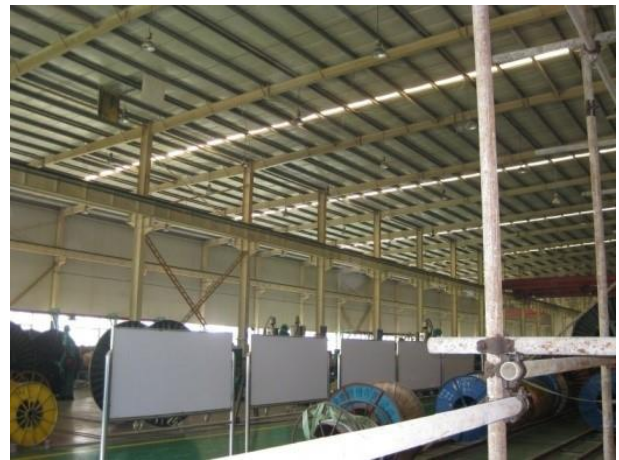
(b) Steel structure workshop

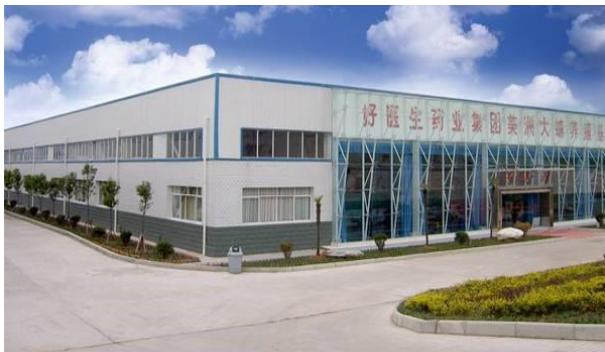
(c) Steel frame workshop

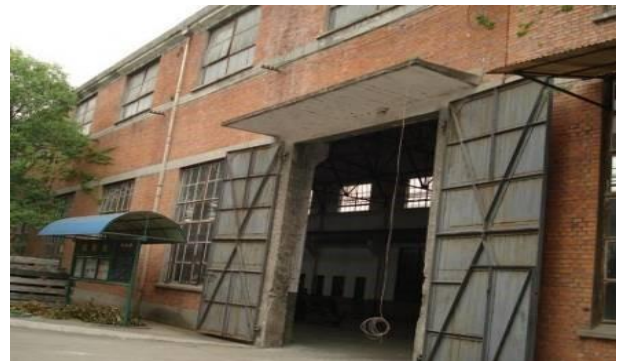
(d) Brick workshop with seismic design
