THE ROLE OF TECHNICAL AND NATURAL SCIENCES IN STONE MONUMENTS CARE

Stone monuments, Tool traces, Weathering, Hyperspectral analysis, Prague

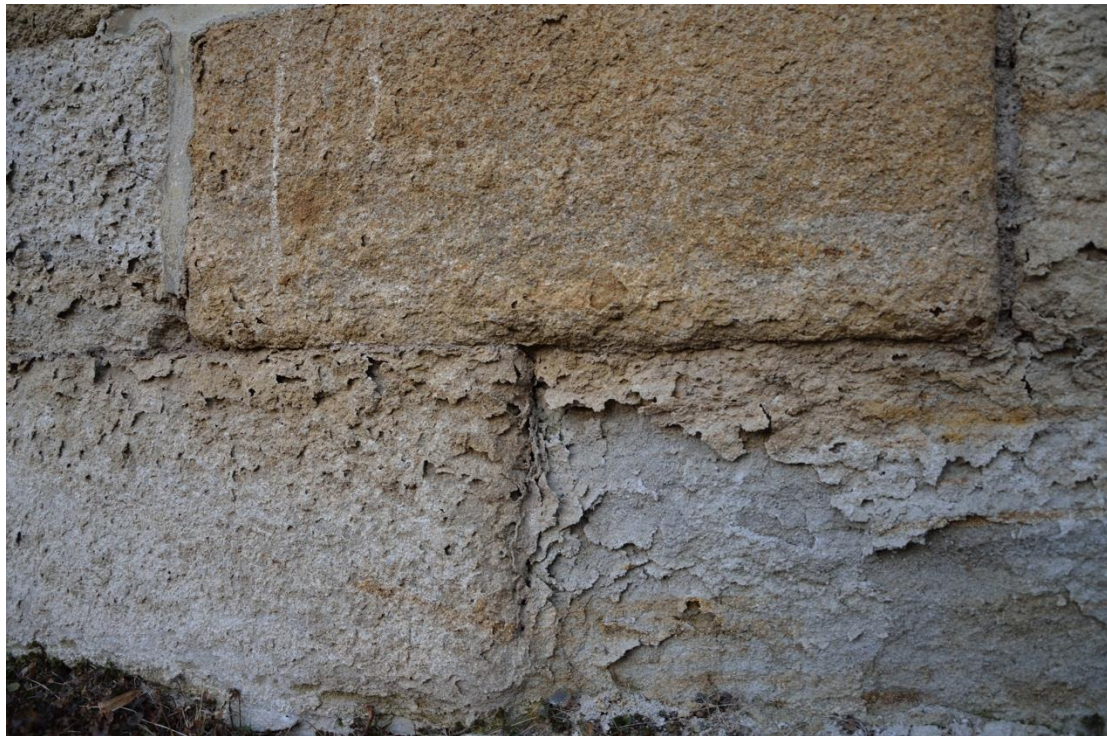
Fig. 1 – Blistering of sandstone surface with the subsequent surface scaling with strongly damaged tool traces, St. Jacob's Church, Srbeč.

As any other building material, stones undergo to weathering processes and so are damaged. They lose their original qualitative properties, such as uniaxial compressive strength and durability. The presence of water in liquid state with dissolved chemical compounds is the most important factor controlling the durability of natural stone. For example, the ice and salt crystallization may cause the pressures from tens to hundreds MPa [2], what usually exceeds tensile strength of most stones. The relationship between frost and salt weathering is discussed by e.g., Williams and Robinson [3]. The damage rate depends on the salt combination applied in the salt weathering process. Crystallizing salts in stone pore space create a set of several processes acting together. Physical processes play the most important part [2], which may be accompanied with chemical processes and action of organisms [4]. This process may cause surface crumbling or delamination [2] and the tool traces are therefore damaged as well (see Figure 1).

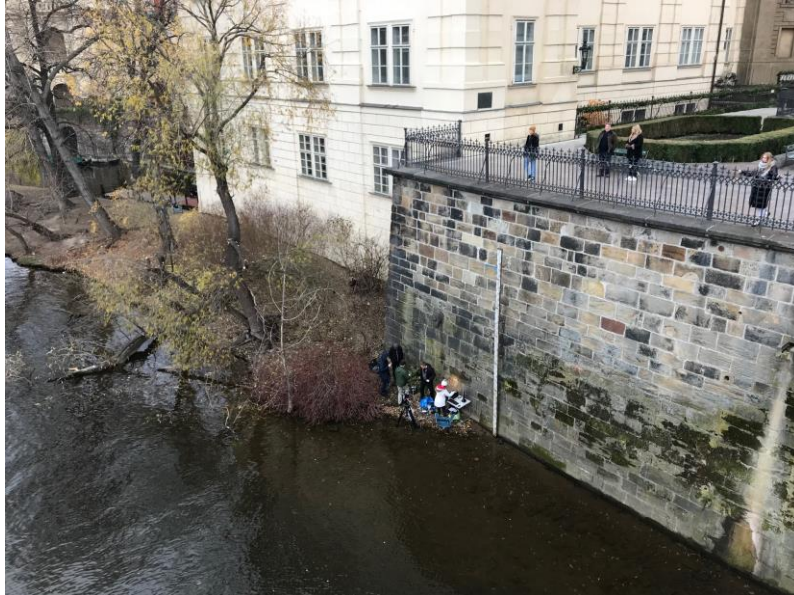
Fig. 2 – The location of a selected sandstone block in Křižovnické náměstí retaining masonry.

For the purpose of the survey a hyperspectral monitoring of processed stone surface was conducted which is negatively influenced by weathering action. We chose the stone block of the Křížovnické náměstí retaining masonry (Figure 2) which is dated back to 1848 [15]. Generally, this ashlar masonry is predominantly built from fine to middle grained sandstone which shows more or less surface degradation signs. The chosen stone block is of sufficient size and contains more degradation manifestations like presence of organisms (e.g. moss and lichen), signs of water freezing/thawing and also salt weathering action, as it is obvious in Figure 4. Moreover, the selection of this stone block is also very useful for studying and understanding a weathering processes synergy, which do not occur separately, but often together. Additionally, the studied stone block is

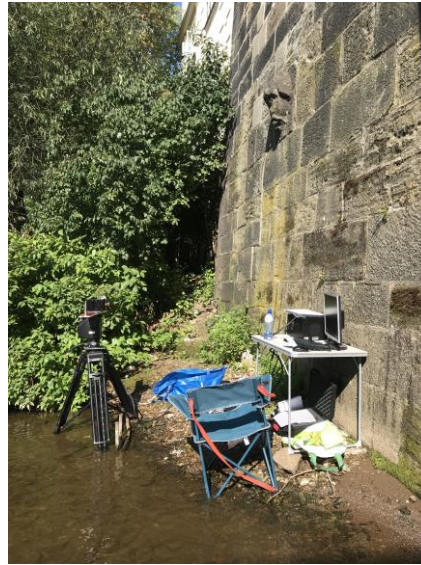
Fig. 3 – Measuring setup.

For the purpose of hyperspectral analysis, a unique portable hyperspectral imaging device consisting of a hyperspectral sensor, Pan&Tilt unit, tripod, illumination sources and a control unit was used. An A-series hyperspectral VNIR camera Hyperspec VNIR manufactured by Headwall Photonics Inc. [16] is used. Headwall Photonics' Hyperspec imaging spectrometer platform is built on a reflective concentric, f/2 optical design. The camera is lens-based, thus equipped with a C-Mount 35mm objective and 18mm long and 25/60um wide slit. The operational wavelength ranges between 400 to 1000 nm and the focal plane size is 1004 spatial and 810 spectral bands in this range. The setup (hyperspectral camera, Pan&Tilt unit and the illumination platform) has been placed on a strong tripod Callidus CINE 2000 to enable one to move the system and adjust the height of the camera. Special tripod head had to be created for the Pan&Tilt unit fitting. Control of the system is performed by the HDPU (Hyperspec Data Processing Unit) and using Hyperspec III. software developed by Headwall Photonics, Inc. Hyperspectral imaging data are commonly given in the form of a 3D data cube. The 3D data cube information resembles the reflectance spectrometer data – wavelength and a corresponding signal value. From this dataset, user can derive a spectral curve or to analyse and work with each band separately.

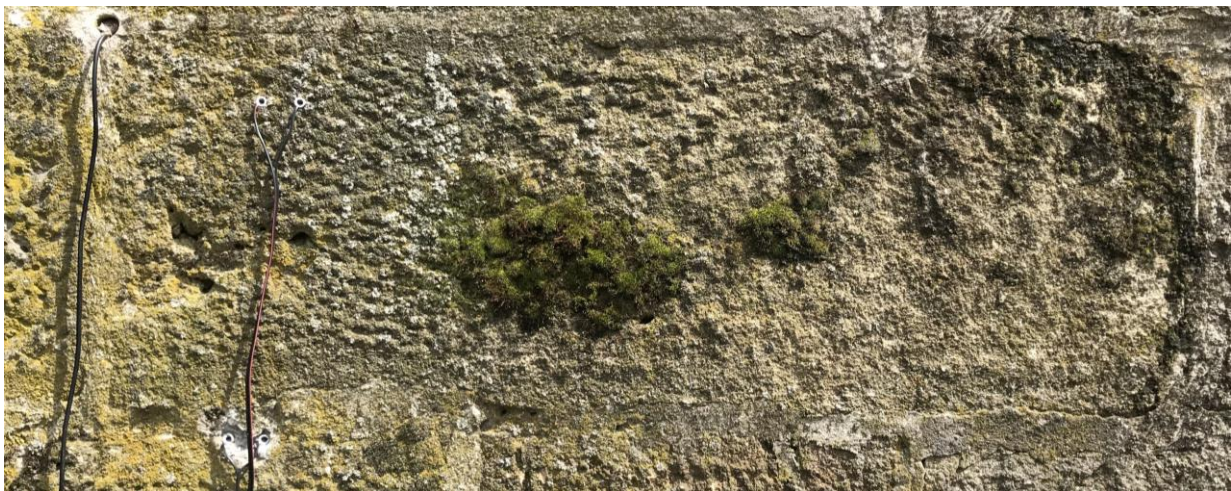
Fig. 4 – Area of interest photograph.

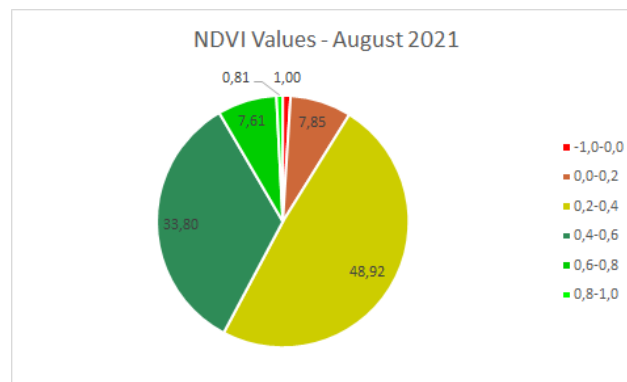
Fig. 5 - NDVI Values derived into 6 classes together with percentage of each class

Figures 5 and 7 show graphs with NDVI values and corresponding values with a scale step of 0,2. The first class (shown in red colour) covers negative NDVI values and therefore represents areas without any vegetation. Colours in resulting images (Figures 6 and 8) follow the graph legend. Mean spectral signatures of derived NDVI value classes are shown in Figure 9.

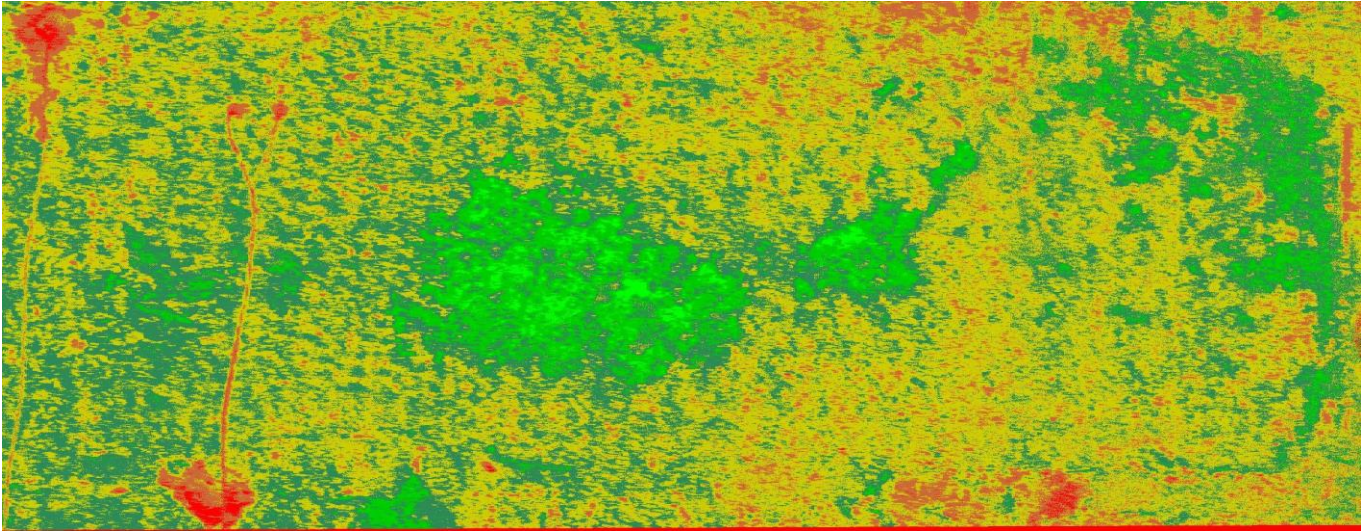
Fig. 6 – NDVI image with 6 classes, for legend see Figure GRAF August.

A specific historical sandstone sample was chosen for a temporal analysis. Significant changes can be found when summer (August) and autumn (November) measurement were compared (Figures 6 and 8). The NDVI value changes between the measurements are summarized in Table 2.

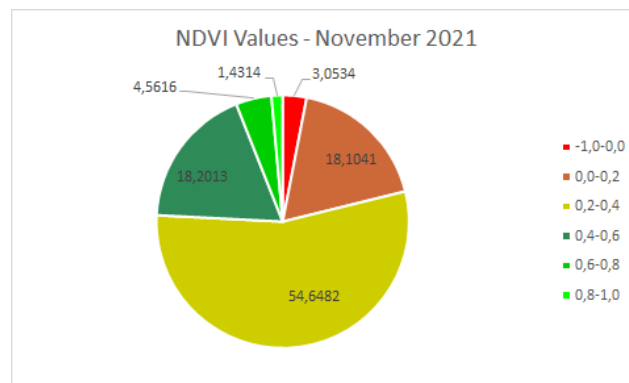
Fig. 7 – NDVI Values derived into 6 classes together with percentage of each class.

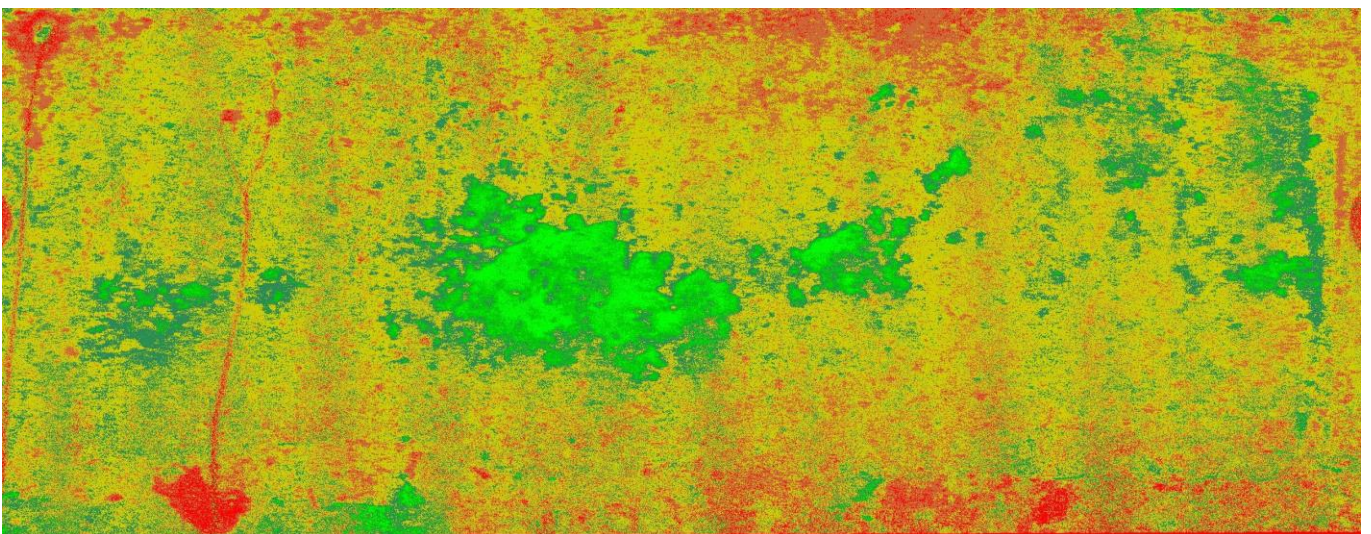
Fig. 8 – NDVI image with 6 classes, for legend see Figure GRAF November.

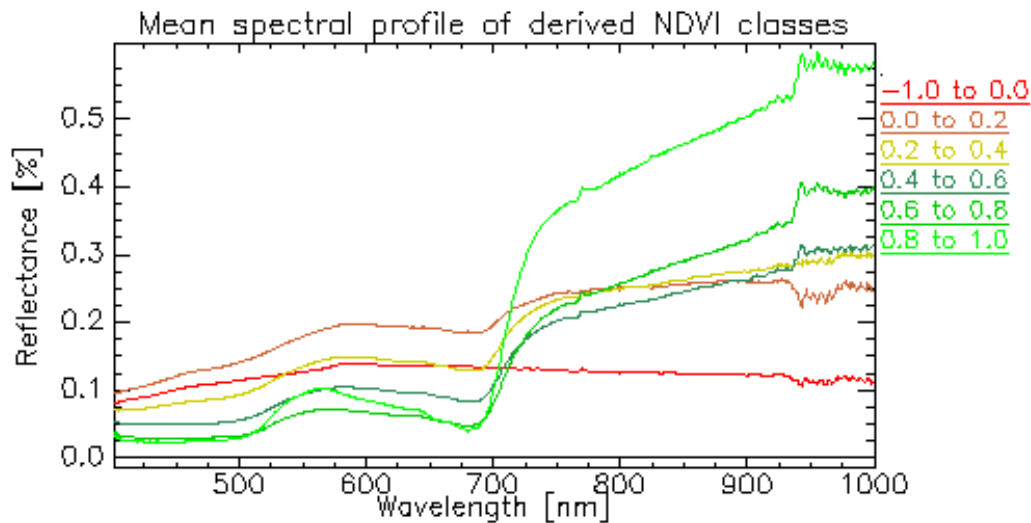
Fig. 9 - Mean spectral signatures of derived NDVI value classes.
