# SEISMIC DAMAGE FIELD OBSERVATION AND VULNERABILITY ANALYSIS OF MULTILAYER REINFORCED CONCRETE FRAME STRUCTURE

RC frame structure, Seismic damage field observation, Vulnerability analysis, Mean damage seismic index (MDSI), Seismic intensity

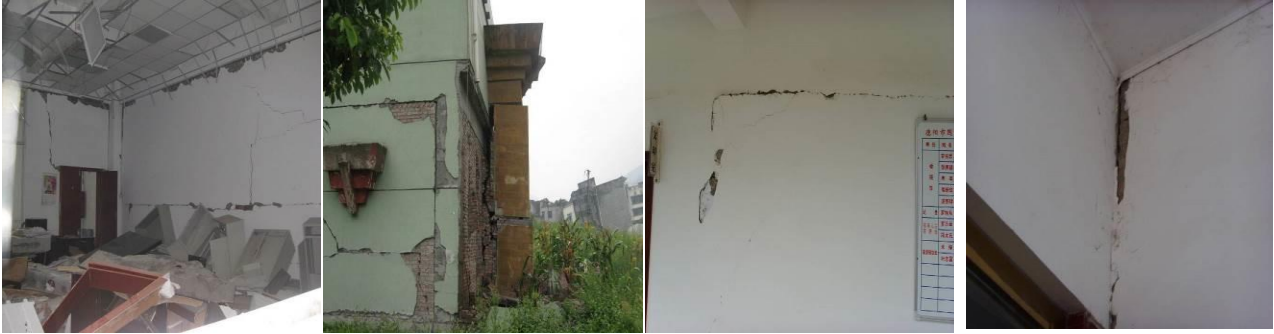
The failure of infilled wall is the most prominent in the investigation of seismic damage of RC frame structure. In the lower intensity zone, the horizontal earthquake action destroys the connection of frame column, beam and infilled wall, produces horizontal and vertical cracks around the extended infilled wall, as shown in Figure1.

Fig. 1 – Cracks around filling wall

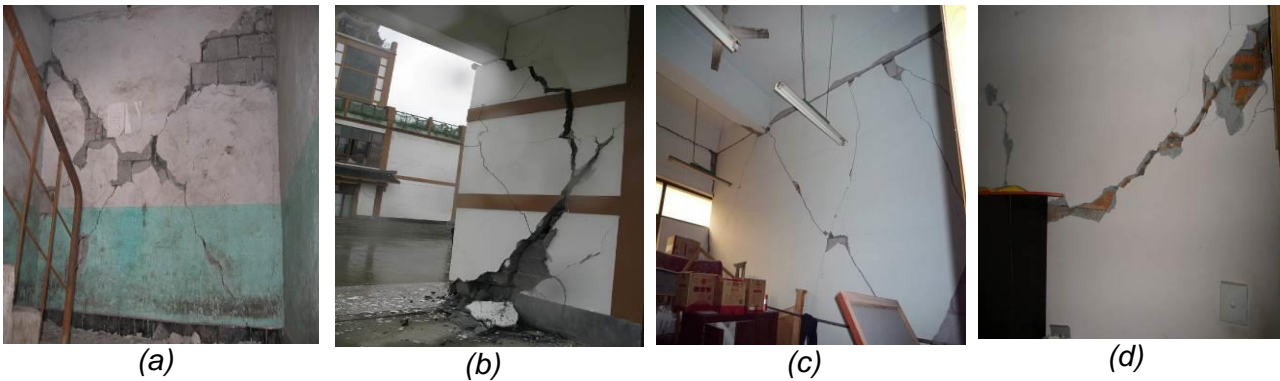
In higher intensity zone, X-shaped cross-inclined cracks or unidirectional inclined cracks appear in the filling wall due to the reciprocating effect of ground motions. This phenomenon is more obvious at the opening of the tunnel, as shown in Figure 2. When the seismic parameters reach the peak value, the infilled walls absorb a lot of energy, and even collapse locally or wholly.

Fig. 2 – Filling wall cracks: (a) (b) (c) filling wall cross-oblique cracks; (d) opening unidirectional cracks

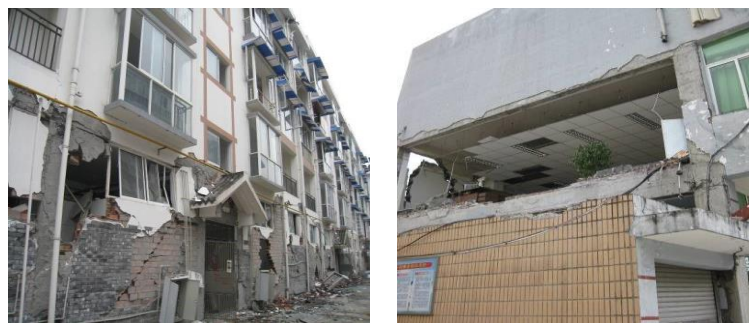
As shown in Figure 3, the main reason is the lack of effective tie with columns and beams. Plane instability occurs first under seismic action, which cannot well resist seismic action together with the main bearing members.

(a) Partial collapse of bottom filling wall

(b) Integral collapse of second-story filling wall

Fig. 3 – Filling wall collapse

However, from the analysis of the effect of the infilled wall, it has become the first seismic defence line of the whole RC frame structure to a certain extent, absorbed part of the vibration energy and played the role of energy dissipation and shock reduction. Therefore, the damage of the main structure has been delayed, especially in the higher intensity zone, which has played a role of protection for the principal structure in a certain sense. In seismic design, full consideration should be given to the anti-seismic effect of infilled walls to enable them to more accurately estimate the anti-seismic capacity of RC frame structures. The stiffness ratio between layers should be reasonably controlled to prevent damage caused by too weak bottom.

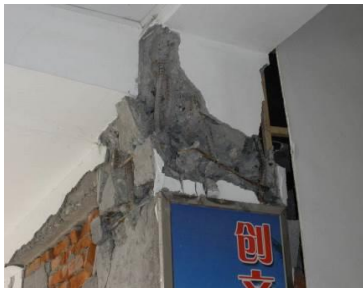
Depending on the results of seismic damage investigation of RC frame structure in Dujiangyan city, the damage characteristics of beams, columns and joints are basically the same as those of Muisne in 2016 and Emilia in 2012. Damage of frame columns is more serious than that of beams. Because of the complex force on the top of the column, under the coupling action of shear force, bending moment and axial force, brittle failure of concrete at the end, longitudinal buckling of reinforcing bars, failure of stirrups, inclined cracks and yielding of longitudinal bars often occur. Due to improper setting of stirrups on the top of the column, most of them are 90 degree bending hooks [10], incongruity effectively cooperate with the longitudinal bars to resist earthquake, and the stirrups of the column are insufficiently allocated or anchored, resulting in damage. As shown in Figure 4. The phenomenon of "strong beam and weak column" appears. Considering the effect of floor space and distributed reinforcement, and the excessive reinforcement of the beam, it contributes to the beam to a certain extent, resulting in lighter damage of the beam than that of the column. However, also a few cases of negative bending moment near the end of the beam, which leads to shear failure at the end of the beam, as shown in Figure 5. Under the influence of reciprocating seismic excitation, the beam-column joints are in the state of shear-compression composite stress, the concrete at the top of the column is peeled off, the steel bar is bent and exposed, and the crack damage occurs at the end of the beam, as shown in Figure 6. The low ratio of stirrups at joints leads to brittle failure. The poor quality of concrete pouring constitutes one of the factors leading to joint failure due to the dense arrangement of reinforcement at joints. The mechanism of beam hinges and "strong columns and weak beams" should be studied in depth to ensure that the structure has sufficient shear resistance and ductility, to control the axial compression ratio of frame columns, to consider appropriate enlargement of the design cross-section size of the bottom frame columns, to ensure their strength, and to ensure that the stirrup spacing at the top of the columns is small enough to ensure that the bottom has sufficient overall stiffness.

*Fig. 4 – Failure of frame beams and columns*

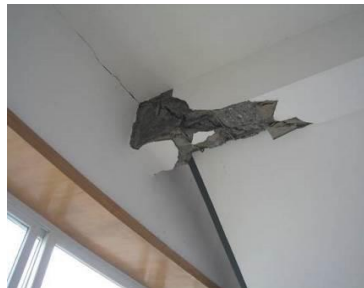
*Fig. 5 – Failure of frame beams end*

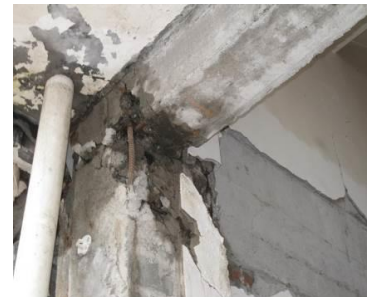
*Fig. 6 – Failure of joint*

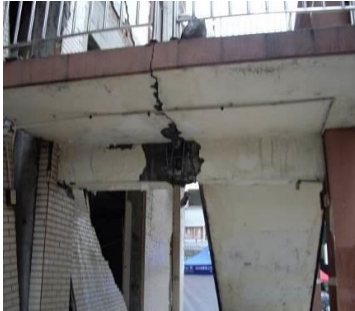
The investigation found that staircase damage occurred in multi-intensity zones. Some outdoor staircase steps were broken into several sections, Steel bars were exposed and distorted and yielded, staircase platform beams and stirrups were broken. As shown in Figure 7, concrete was crumbed and the protective layer was severely peeled off, staircase panels were broken, as shown in Figure 8, a large number of staircase walls were cracked and damaged, as shown in Figure 9. The function of stairs is not considered in the calculation and analysis of seismic system of RC frame structures, but the investigation of empirical seismic damage shows that stairs increase the lateral stiffness of structures to a certain extent and contribute to seismic resistance. Stairs and staircases are subjected to considerable shear force and bending moment under reciprocating earthquake action. Serious damage often occurs at the end of staircase beams, slabs, and the middle part of the span. Steel bars leak out, buckle, and concrete to crumble. The

*Fig. 7 – Fracture of stair platform beam*

seismic design of stairs in RC frame structures should be considered reasonable to effectively improve the overall connection with the main frame.

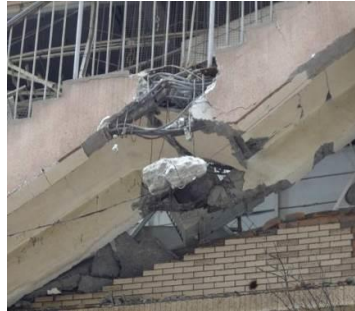
*Fig. 8 – Stairboard midspan breakage and failure*

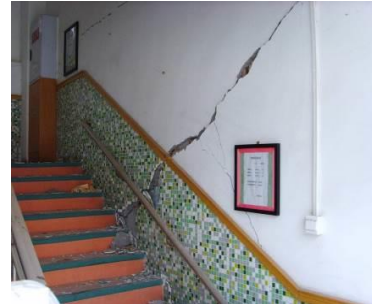
*Fig. 9 – Cracking of staircase wall*

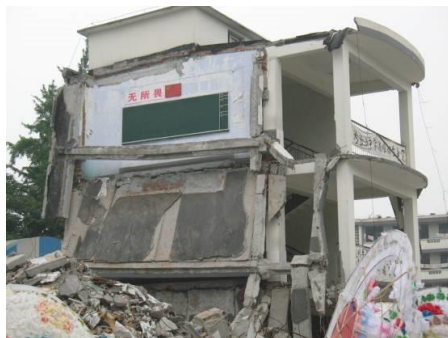
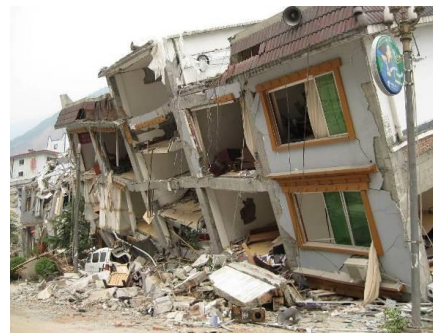
In the investigation of seismic damage in high intensity regions, it was found that some RC frame structures without seismic design and poor construction quality had partial or overall collapse, which was more prominent in the Kashmir earthquake in Pakistan in 2005 and Simav earthquake in Turkey in 2011. The main reasons for the damage are that the structure layout is relatively complex. Some of these structures are generally located in township areas, built by the residents themselves, lack of formal design and construction supervision, random material selection and structural form, poor construction quality and high intensity regions, which to some extent aggravate the damage degree of the structure, such as Figure 10 shows. It is necessary to pay full attention to the seismic design of this kind of structure in township areas, and strictly follows the design specifications for construction in order to improve the quality of engineering structures.

*(a) Partial collapse*

*(b) Ensemble collapse of bottom layer*

*Fig. 10 – Collapse failure*

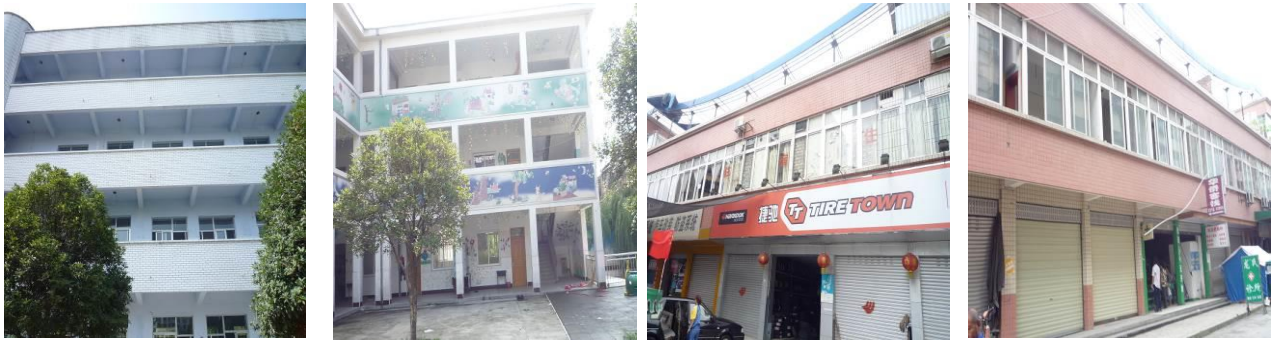
In the investigation of RC frame structures, most of the buildings suffer less seismic damage, even almost intact. Most of these structures are multi-storey RC frame structures in earthquake regions. Even in the high intensity region of XI degree, there is still quite a number of such structures which have been designed aseismic. The damage grade is slight damage or basically intact. According to seismic fortification of VII degree in Dujiangyan city, this kind of structure shows great aseismic potential, as shown in Figure 11.

Fig. 11 – RC frame structure after seismic design basically intact

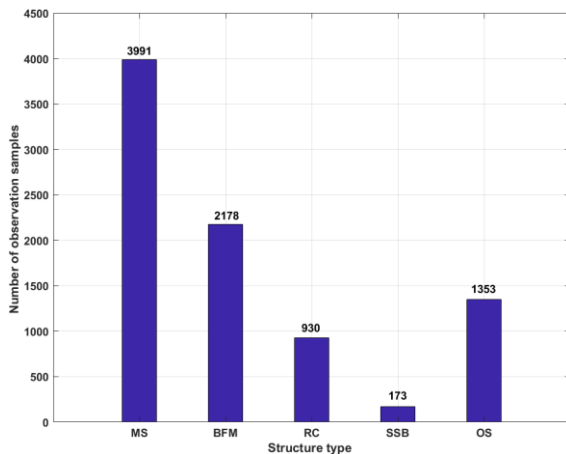
The seismic damage investigation team conducted a total sampling survey of 8625 buildings in Dujiangyan city, and assessed the seismic damage grade of each building. The main structural types of the city: masonry structure (MS), bottom frame-seismic wall masonry structure (BFM), reinforced concrete frame structure (RC), single-storey concrete and brick workshop (SSB), and other types of buildings (OS). Figure 12 displays the number distribution of structural types in the city. According to the Chinese Seismic Intensity Scale (GB/T 17742-1999) and Appendix A1.2 of GB/T 1828.3-2000, the seismic damage grades of structures are classified into five criteria: destroyed (D5), severely damage (D4), moderately damage (D3), slightly damage (D2), and basically intact (D1). As shown in Table 1, seismic damage grades of structures are evaluated. In order to ensure that the records of seismic damage investigation more standard, the seismic damage grades are expressed by 51, 41, 42, 43, 31, 32, 33, 21 and 11, respectively. Due to the great difference of damage degree between D3 and D4 buildings, for better evaluation of the detailed seismic damage situation under the same seismic damage grade, the two grades are refined within their grades (31, 32, 33), (41, 42, 43), respectively. RC frame structure is widespread used in the developed and developing countries in the world, and the data are comprehensive. The number of seismic damage survey samples accounts for a certain proportion. In this paper, the seismic damage investigation and survey data of RC frame structures in multi-intensity regions are summarised and analysed.

Fig. 12 – Quantity distribution of structural types in Dujiangyan city

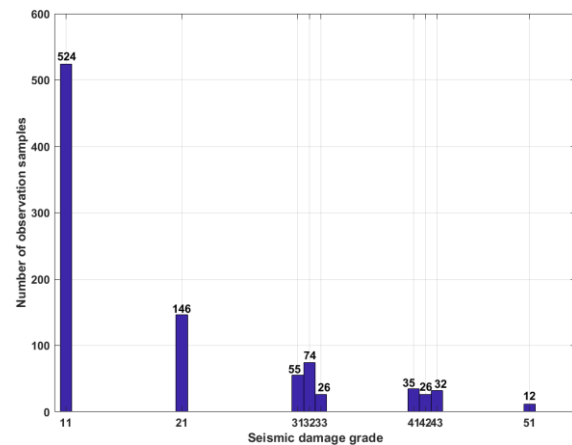
Statistical analysis of seismic damage of 930 RC frame structures in Dujiangyan City is carried out, as shown in Figure 13. Figure 14 shows the damage of proportional distribution of the structure under multiple seismic damage grades. 72% of the structures are in D1 and D2. Most of these buildings can be designed and constructed in accordance with the applicable chapters of the Code for Seismic Design of Buildings (GB50011-2001, GBJ11-89), showing good seismic performance. RC frame structures of D3, D4 and D5 are mostly self-built buildings without seismic design or are located in high intensity regions, and the seismic action is relatively large. Through program editing and analysis, the Polynomial cubic and Gaussian quadratic fitting curve of the non-linear model can continuously approximate the discrete points of RC frame structure samples, the  $R^2$  value is above 0.98, therefore, we develop them as nonlinear vulnerability regression function models, two non-linear functional model, such as Formula (1) and (2), can be established to obtain the relationship between the seismic damage grade ( $R_D$ ) and the number of seismic damage

Fig. 13 – Statistical analysis of seismic damage of RC frame structure

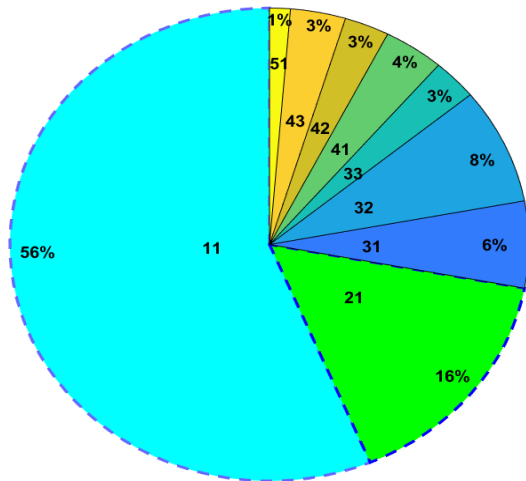
Fig. 14 – Proportion distribution of seismic damage grade of RC frame structure

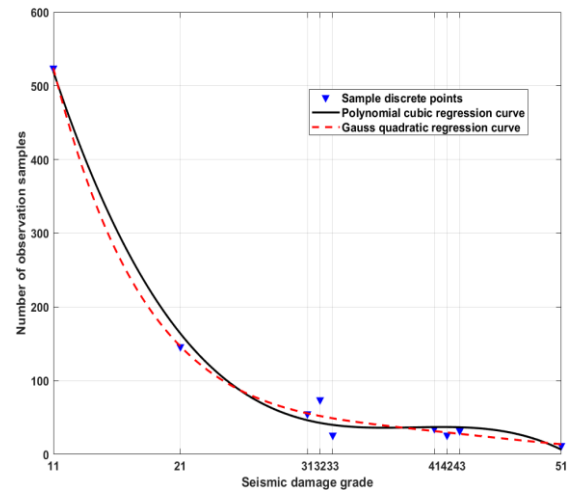
investigation samples ( $N_D$ ), among them,  $a, b, c, d, m_1, m_2$  are the regression parameters of the model. In which  $R_D$  refers only to the 9 seismic damage grades defined in this section. According to the empirical seismic damage survey sample data, using the above two non-linear models for regression, the empirical functional model and its fitting curve based on the grade of seismic damage and the number of seismic damage samples in the region are obtained, as shown in Formula (3), (4) and Figure 15. The investigation team found that the number of stories, construction age and seismic fortification factors of RC frame structure have a significant impact on the structural damage.

Fig. 15 – Nonlinear model curves of sample number and seismic damage grade

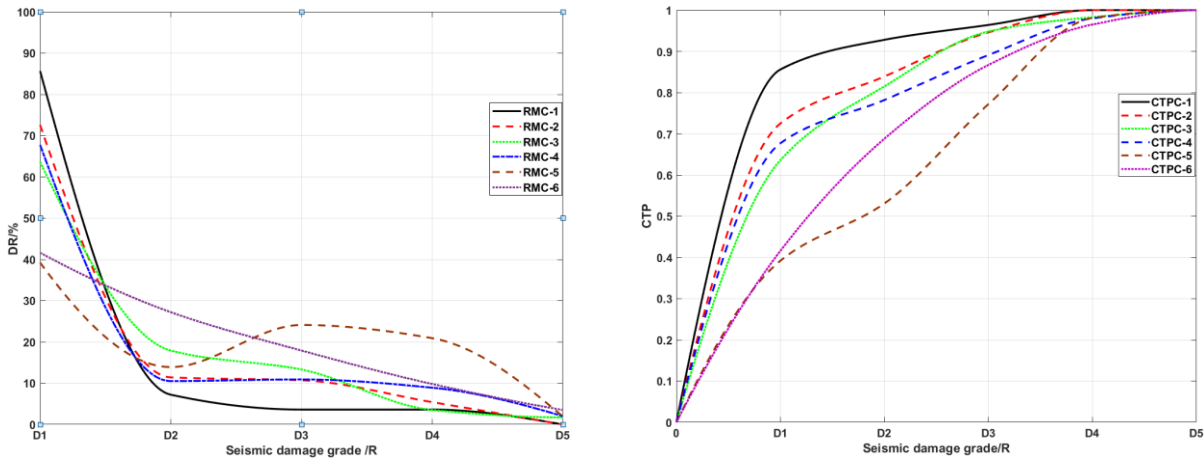
(a) Damage ratio regression model curve (b) Cumulative transcendental probability curve

Fig. 16 – Vulnerability curve considering floor factor

According to the visual inspection sample, the author carries on the statistical analysis separately. RC frame structure in this city, is mostly 6-storey and below buildings. Therefore, only 6-storey and below houses are analysed, which is representative to extent. A vulnerability matrix considering the floor number factor is established, as shown in Table 2. Figure 16 shows the damage ratio (DR) regression model curve (RMC) and cumulative transcendental probability curve (CTPC) of the structure considering story factor. The seismic damage of the first story RC frame structure is obviously lighter than that of other multi-story structures. On the overall trend, the damage grades of D3 and D4 increase with the increase of storeys. However, it is noteworthy that the seismic damage of a six-storey structure is weaker than that of five-storey, but more serious than that of other floor structures. Considering the sudden change of floor stiffness and the attenuation of ground motion, the mechanism of seismic damage is relatively complex, which should be paid attention to, and it is necessary to perform in-depth study.

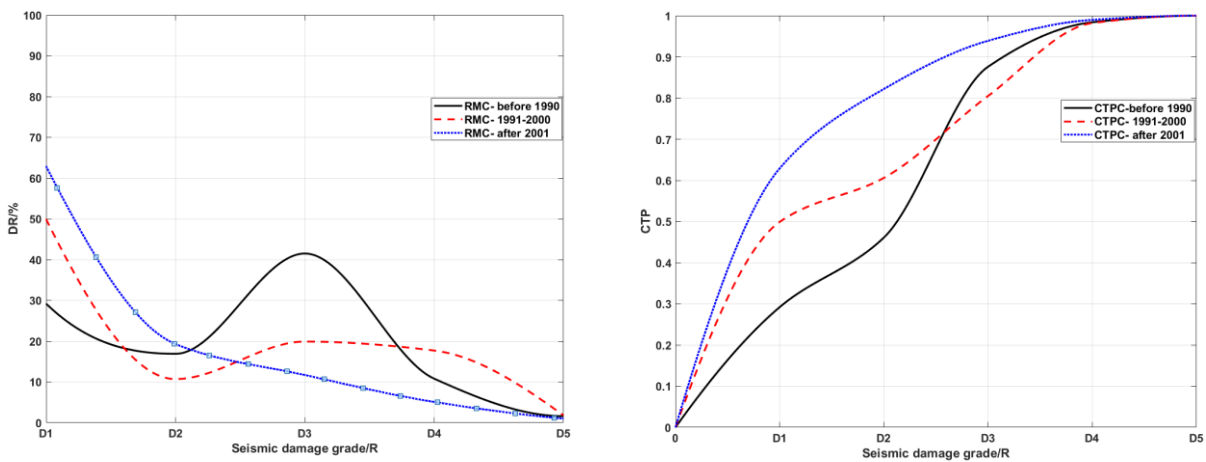
respectively, as shown in Table 3. Figure 17 shows the damage ratio and cumulative transcendental probability regression model curves considering the age-dependent factors, respectively. The RC frame structure constructed before 1990 has the greatest damage rate. With the increase of the years, the damage rate of the structure decreases obviously.

(a) Damage ratio regression model curve (b) Cumulative transcendental probability curve

Fig. 17 – Vulnerability curve considering age factor

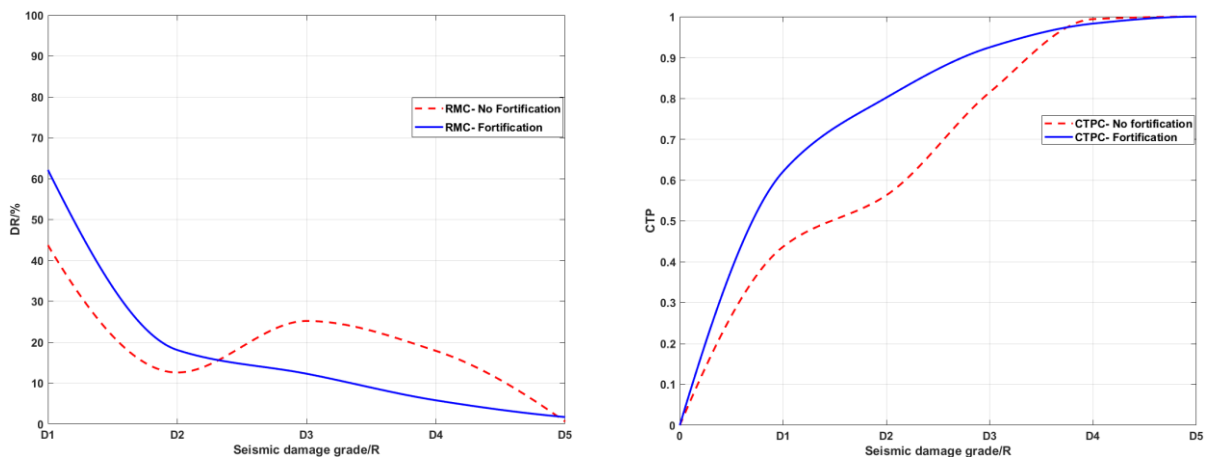
matrix based on this factor is established, as shown in Table 4. The numerical regression analysis is carried out and the curve of the non-linear regression model is given, as shown in Figure 18. The structure fortified according to the intensity of fortification in this zone is apparent superior to the structure constructed by township residents without considering seismic fortification. Most RC frame structures in the main urban area of Dujiangyan city can consider the impact of seismic factors on the structure. However, generous private buildings in towns and villages around the city, which do not consider the factors of seismic fortification, and bring about seriously damaged. The number of samples of RC frame structure D5 is scarce, so the regression curve is not remarkable for considering the difference of seismic fortification factors. To some extent, it also shows the seismic performance of RC frame structure in this huge earthquake.

(a) Damage ratio regression model curve (b) Cumulative transcendental probability curve

Fig. 18 – Vulnerability curve considering fortification factor

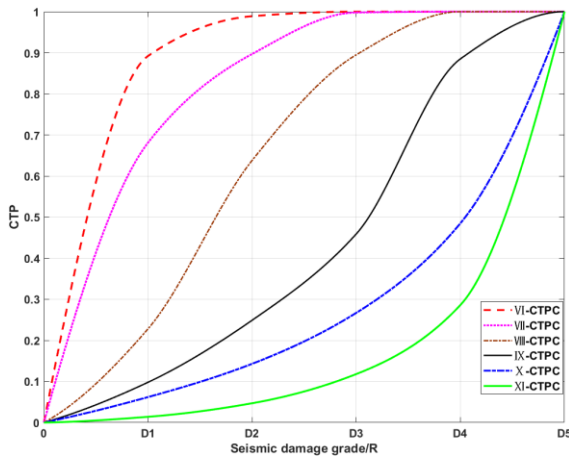
Fig. 19 – Vulnerability curve in multi-intensity regions

Table 5, SIR in the table represents the seismic intensity region. Considering that controversy in the initial delimitation of seismic intensity, the seismic damage in the region of VI degree is also considered in the investigation of seismic damage, and the probability curve of empirical seismic vulnerability is given, as shown in Figure 19. Figure 20 shows the structural damage under different seismic damage levels in multiple intensity regions.

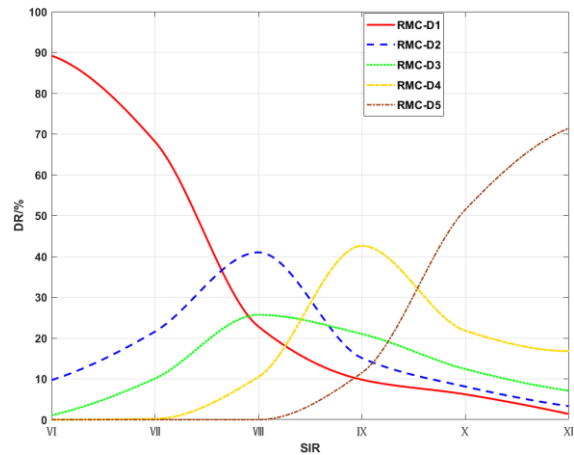
Fig. 20 – Seismic damage grades curve in multi-intensity regions

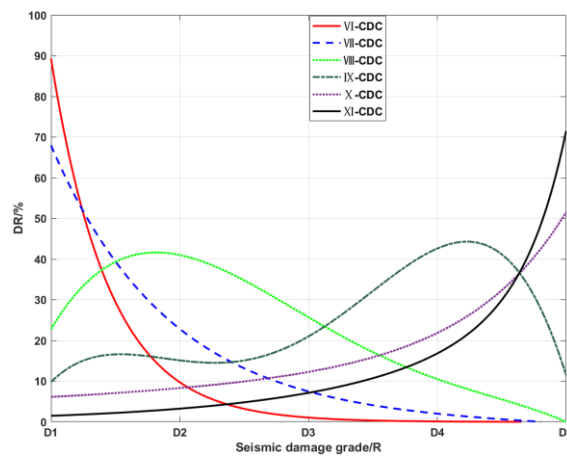
Fig. 21 – Continuous Model curve of Nonlinear Function n multi-intensity regions

Seismic intensity and damage grade are given as discrete integers in the application of structural damage assessment. It is difficult to achieve a more meticulous evaluation of seismic intensity and structural damage in a certain zone. Reference [12] establishes the attenuation model of seismic intensity and displacement, magnitude and regression curve to realize the continuous evaluation of seismic intensity. In reference [13], a vulnerability matrix based on the actual damage survey data of Athens earthquake in Greece in 1999 is established. The non-linear model curves between ground motion parameters (actual peak acceleration and reference acceleration ratio) and collapse ratio are given, and the continuous relationship between discrete ground motion parameters and collapse ratio is established. A continuous model of seismic damage grade and intensity should be considered, the seismic damage samples of 930 RC frame structures distributed discretely in multi-intensity areas in the city are analysed numerically. The Exponential quadratic fitting model is determined. However, the dispersion and variance of VIII and IX degree regions larger, and the fitting degree flat. Therefore, Polynomial quadratic fitting model is selected to model in these two intensity regions, as shown in formula (5-6). In the formula  $P_I$  represents the empirical damage rate of seismic damage under different damage grades in the I intensity region, and  $R_D$  represents the seismic damage grade.  $f, g, h, i, j, k, l, o, p$  represent regression parameter factors. Based on the regression analysis of the actual seismic damage survey data in the multi-intensity area, the parameter factors are determined, and the empirical vulnerability non-linear function model of the multi-intensity area in the city is established. As shown in Table 6 and Formula (7-12), the continuous distribution curve (CDC) is obtained, as shown in Figure 21. To a certain extent, the curve of the continuous model can realize the evaluation of the continuous seismic damage grade.

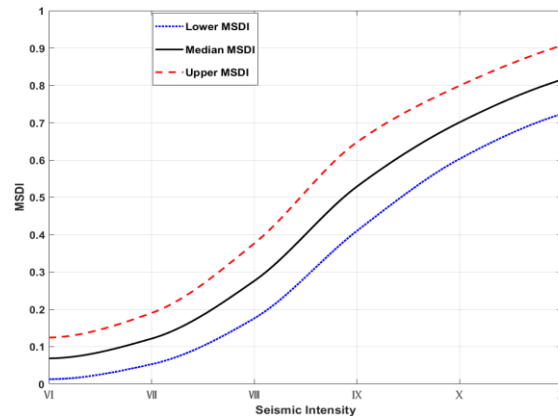
Figure 22 shows the regression curves of the MSDI in the multi-intensity region of the city. The empirical MSDI in the VI and IX regions is higher than the average values of D1 and D3 of  $d_i$  respectively, while the VII, VIII and IX regions are obviously lower than the slight damages and damages, and the MSDI in the X region is approximately equal to the average value of the  $d_i$ . The model analysis is basically consistent with the empirical observation damage investigation, which verifies the application value of the model to a certain extent.

Fig. 22 – Regression curve of MSDI in multiple intensity regions
