# FIELD TEST ON THE COOPERATION OF NSM STRENGTHENING AND EXTERNAL TENDON RETROFITTING TECHNIQUE

*Jianxi Yang, Jiaping Yu, Quansheng Sun, Hongshuai Gao and Jiawei Wang*

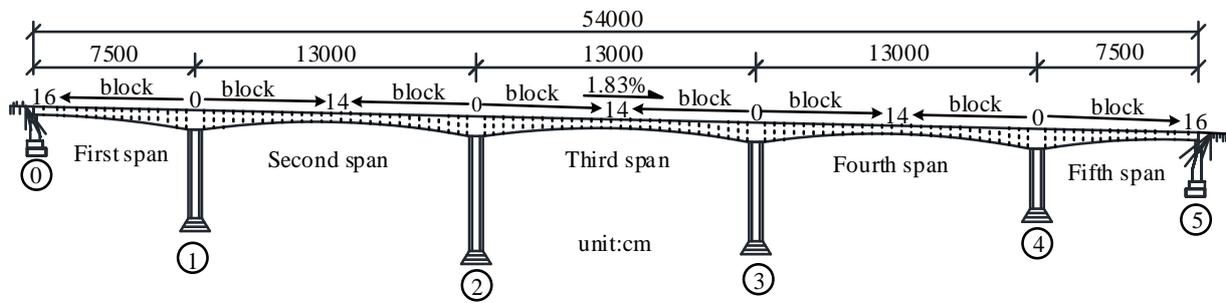
the piers are 35m, 45m and 24m, respectively. The design load of bridge reinforcement is highway grade I [21] (the original design load is vehicle super-20, trailer-120). The bridge was opened to traffic in 2006 and strengthened in 2016. Figure 1(a) shows the elevation drawing of the bridge structure, Figure 1(b) shows the overall perspective of the strengthening bridge.

Fig.1 – Details of the strengthening bridge: (a) elevation drawing; (b) overall perspective

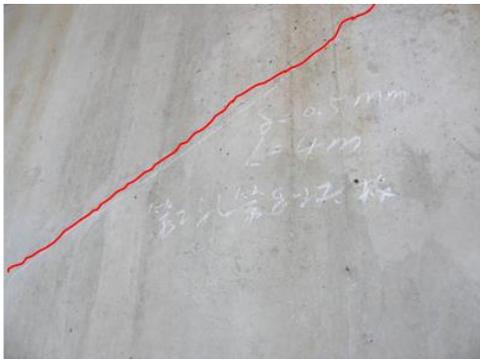
(a) No. 8 block exterior surface oblique crack (L=4m  $\delta$ =0.5mm  $\alpha$ =45°)

*Fig.2 – Crack distribution on the web of box girder of the second span*

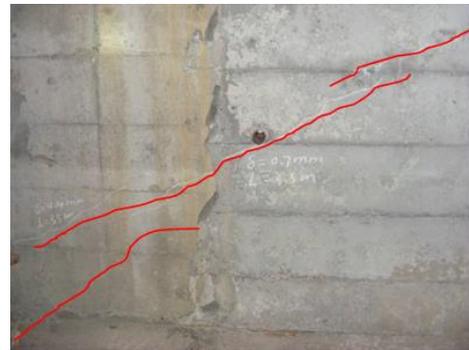
(b) No. 8 block interior surface oblique crack (L=8m  $\delta$ =0.7mm  $\alpha$ =35°)

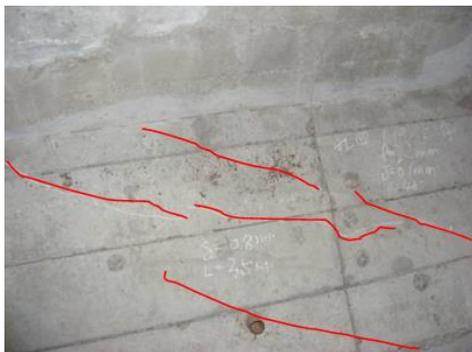
(c) No. 10 block right side interior surface oblique crack (L=9m  $\delta$ =0.5mm  $\alpha$ =35°)

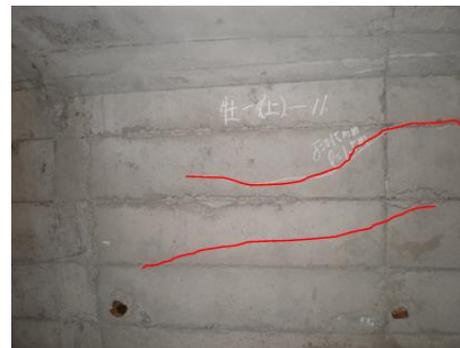
(d) No. 11 block left side interior surface crack (L=3.4m  $\delta$ =0.15mm  $\alpha$ =30°)

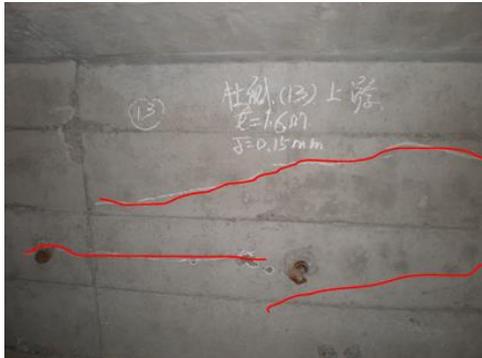
(e) No. 13 block right side interior surface crack (L=6.7m δ=0.15mm α=45°)

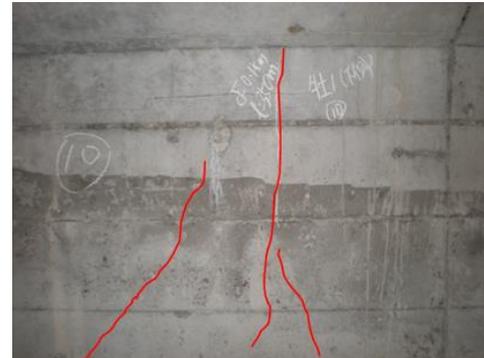
(f) No. 10 block left side interior surface crack (L=2.9m δ=0.10mm α=45°)

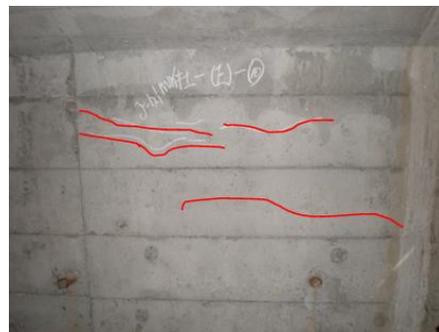
(g) No. 14 block right side interior surface crack (L=2.4m δ=0.10mm α=15°)

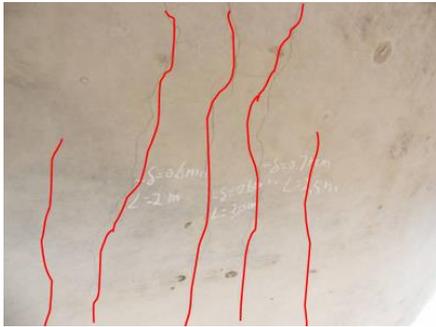
(a) bottom slab cracks of second span  
(L=20.5m δ=0.6mm)

*Fig. 3– Cracks on the bottom slab of the box girder of closure segment*

In 2013 inspection, 5 longitudinal cracks were observed at the exterior surface of box girder bottom slab of closure segment of the second span, the length of cracks were ranging from 2m to 7m and the width of cracks were ranging from 0.6mm to 4mm. In 2015 inspection, it was found that there were 9 longitudinal cracks on the bottom slab of the closure segment. There were 3 longitudinal cracks on the bottom slab of closure segment of the third span and 7 longitudinal cracks in closure segment of the fourth span, whereas bottom slab of second span was the most severe, the maximum width of the longitudinal crack is up to 4 mm and crack bulge deformation is about 3 mm. After chipping away loose concrete around the crack, hollow section was found and corrugate pipe was slightly damaged. Cracks on the bottom slab of the box girder of closure segment of second span and third span are shown in Figure 3.

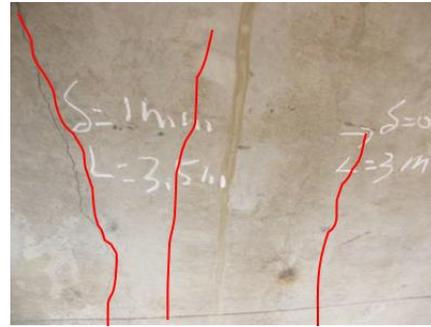
(b) bottom slab cracks of third span  
(L=8.5m δ=0.7mm)

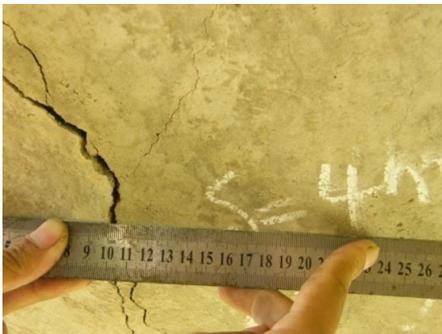
(c) longitudinal bottom crack of second span (L=0.7m δ=4mm)

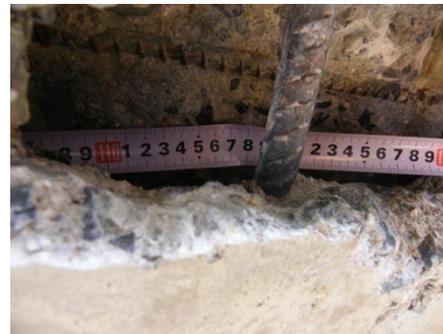
(d) Longitudinal crack hollow section of second span

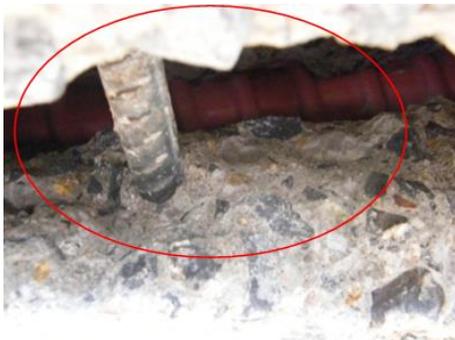
(e) Longitudinal crack hollow section of second span

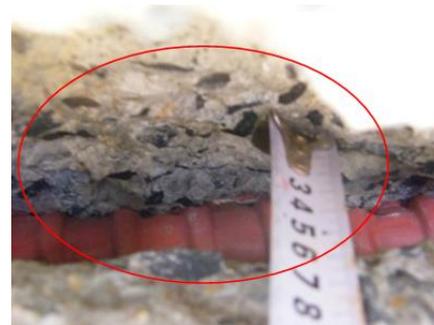
(f) longitudinal crack corrugate pipe deterioration of second span

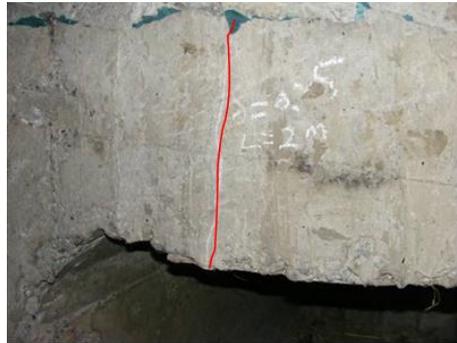
Moreover, there is a vertical crack on interior diaphragm of box girder end of the first span. The width and length of the crack are 0.25mm and 200cm, respectively, as shown in Figure 4.

Fig. 4 – Crack on interior diaphragm of box girder end of the first span  
( $L=2m$   $\delta=0.25mm$ )

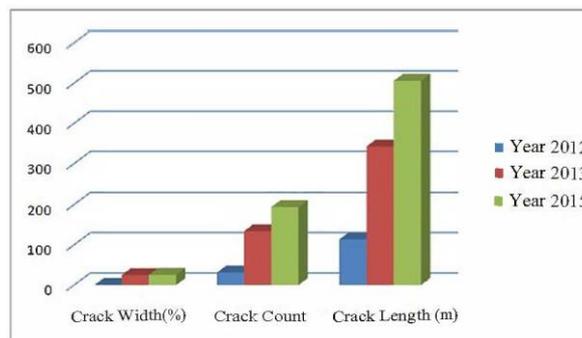
The number, length and width of cracks increase with the number of years of operation as shown in Figure 5. From 2012 to 2013, the width of cracks on the web of box girder increased by 24.77%, the number of cracks increased by 103, and the length increased by 229.37m. From 2013 to 2015, the width of cracks increased by 11.26%, the number of cracks increased by 60, and the length increased by 163.03m. The main causes of the development of the bridge crack in the period from 2012 to 2015 is that the increase of the heavy-load vehicle exceeds the design load capacity of the bridge, leading to the main tensile stress generated by the live load exceeding the design value, and the box girder generates the oblique crack disease.

Fig. 5 – Comparative Diagram of cracks in Box girder in different Detection years

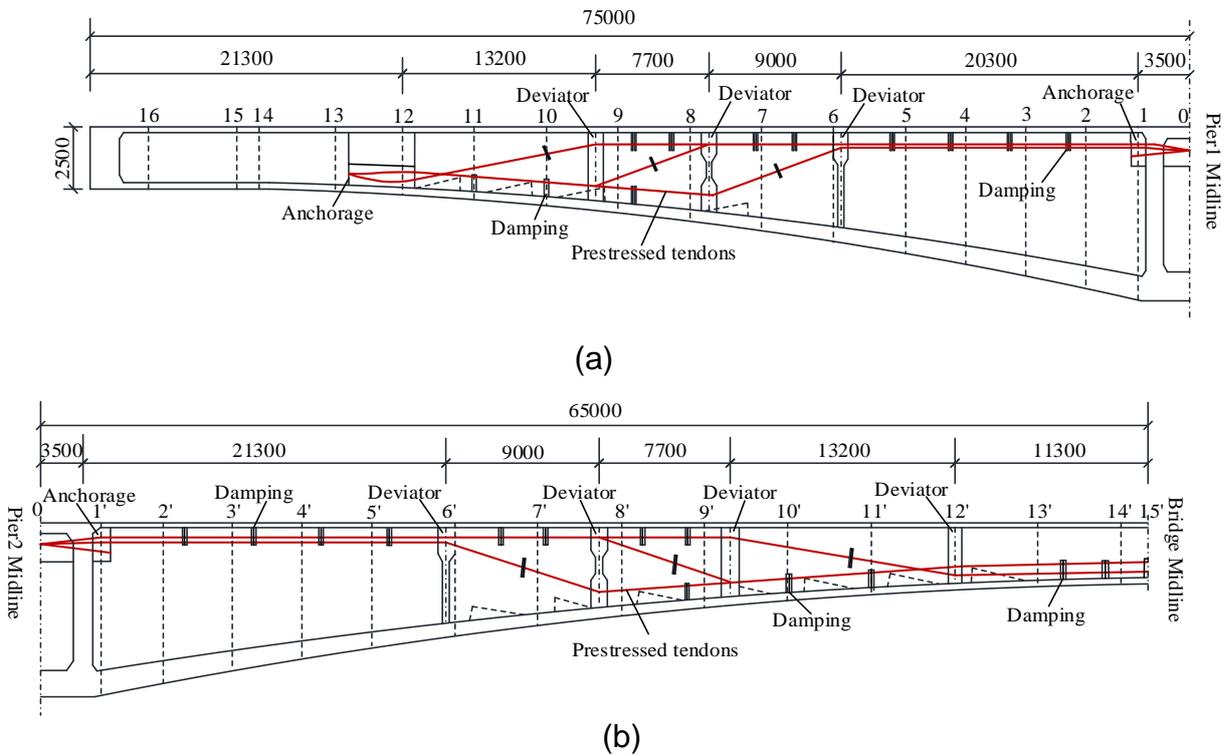
The external tendons were stretched at both ends. External prestressing tendons were cross-anchored at the top of the main pier, and the cast-in-place anchor block was used for anchoring at the box girder end. The number of external prestress tendons is determined by reducing the web shear force and making the main tensile stress of the web of the box girder meet the code, and increasing the bending capacity of the normal section of the span and the compressive stress reserve at the bottom of the beam. Eight bundles of 17  $\phi^s$  15.24 prestressed steel strands are used in each span, and the tensile control stress is 930MPa, which is 50% of the standard strength. The detailed arrangement of external prestressed tendons is shown in Figure 6.

Fig. 6 – External prestressing strands arrangements for: (a) side span; (b) middle span (unit: mm)

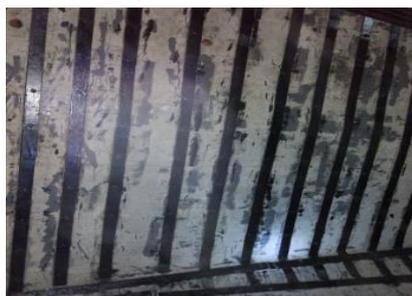
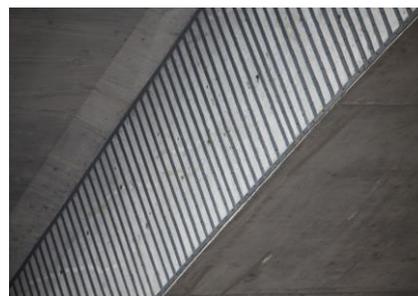
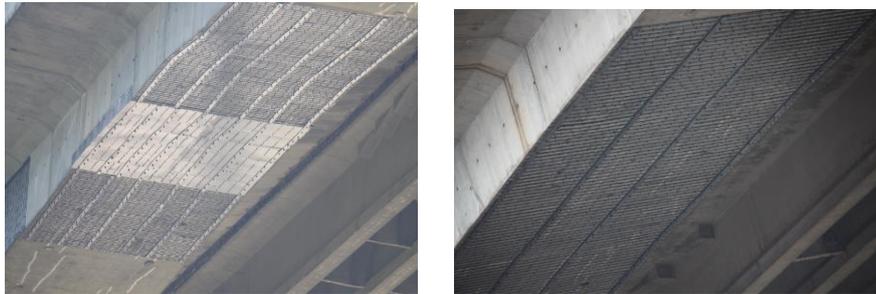
The vertical steel strip is pasted on both sides of the web to strengthen the oblique section of the box girder. The reinforcement range of the inside of the web of the box girder is from 6 to 14 girder segments, and that of the outer side of the web is from NO.6 to NO.10 block of the middle span. The steel reinforcement of the top plate of box girder is the non-thickened area of the web. The bending capacity of the bottom plate is increased in the range of 15 m of the mid-span closure section by the use of an adhesive steel strip. The penetration anchoring is carried out by anchoring bolt in the range where is no bottom plate prestress in the center of web and bottom plate. The thickness and width of the steel plate are 6mm and 60mm, respectively. The length of the steel plate depends on the disease distribution area. The steel plate is made of Q235 steel. The thickness of zinc-rich primer is 70 μ m, and the epoxy asphalt paint consists of intermediate layer and topcoat, with a total thickness of 200 μ m. Steel plate reinforcement of box girder is shown in Figure 7.

*Fig.7 – Steel plate reinforcement of box girder: (a) inner wall of web (b) outer wall of web (c) and (d) bottom plate*

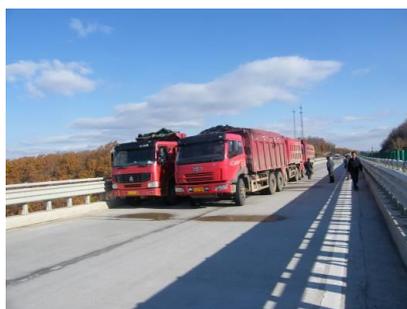
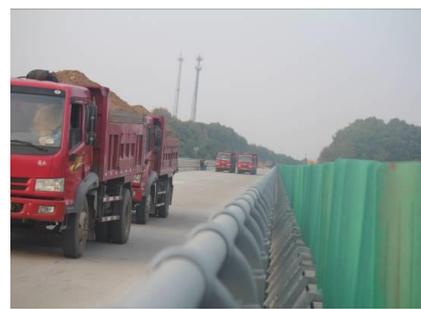
The design load grade of deteriorated rigid frame continuous box girder bridge was vehicle-20, trailer-100 according to Chinese design code JTG 021-1985[22]. The lane load is composed of the uniform load of 10.5kN/m and the concentrated load of 360kN, which is similar to AASHTO HS15 loading in the American bridge design code[23]. Static loading tests were performed to obtain structural behaviour of the bridge before and after strengthening (Figure 8). The main objectives of the static loading test were to test the following:

*Fig.8 – Illustration of field static load test (a) eccentric loading test before or after strengthening; (b) centric loading test before or after strengthening*

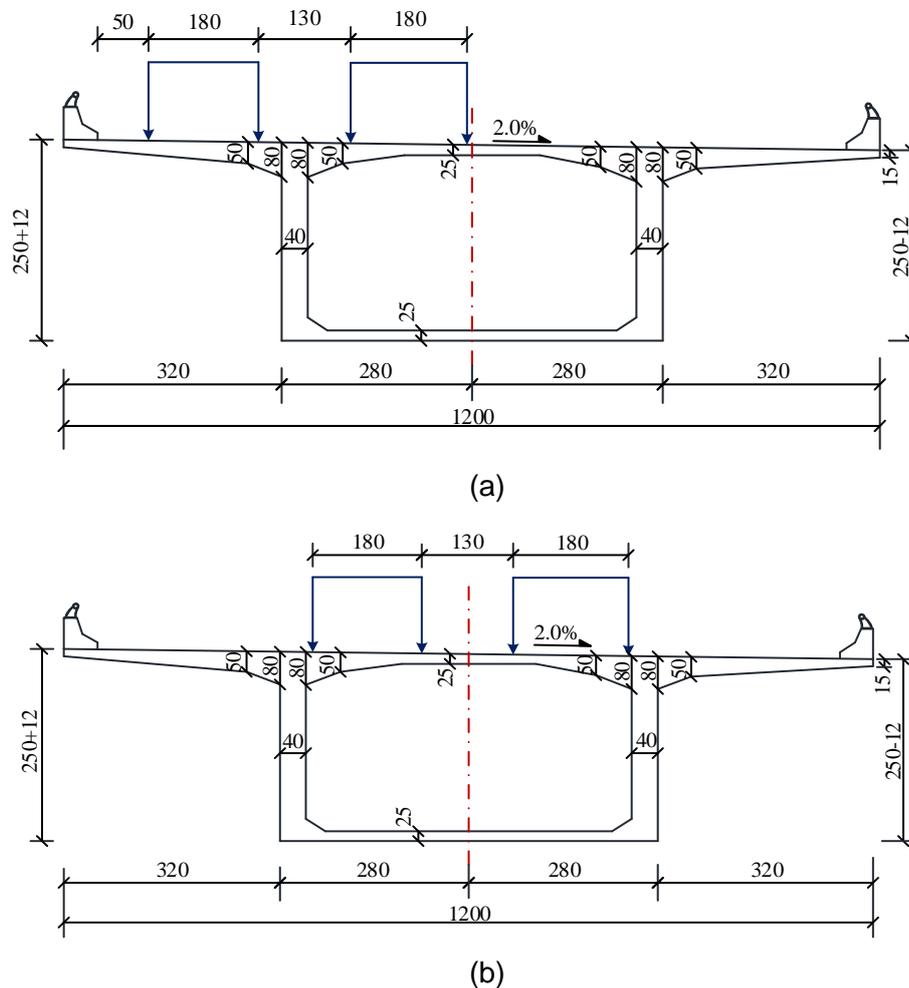
Centric and eccentric loading were performed on mid-span cross-sections and eccentric loading was performed on pier cross-section, maximum bending moments were measured for each load cases before and after strengthening. Static Loading Schemes are shown in Table 2. Eccentric and centric loading location drawing plans are shown in Figure 9.

Fig. 9 –Lateral arrangement of static load test load (a) eccentric loading; (b) centric loading (unit: cm)

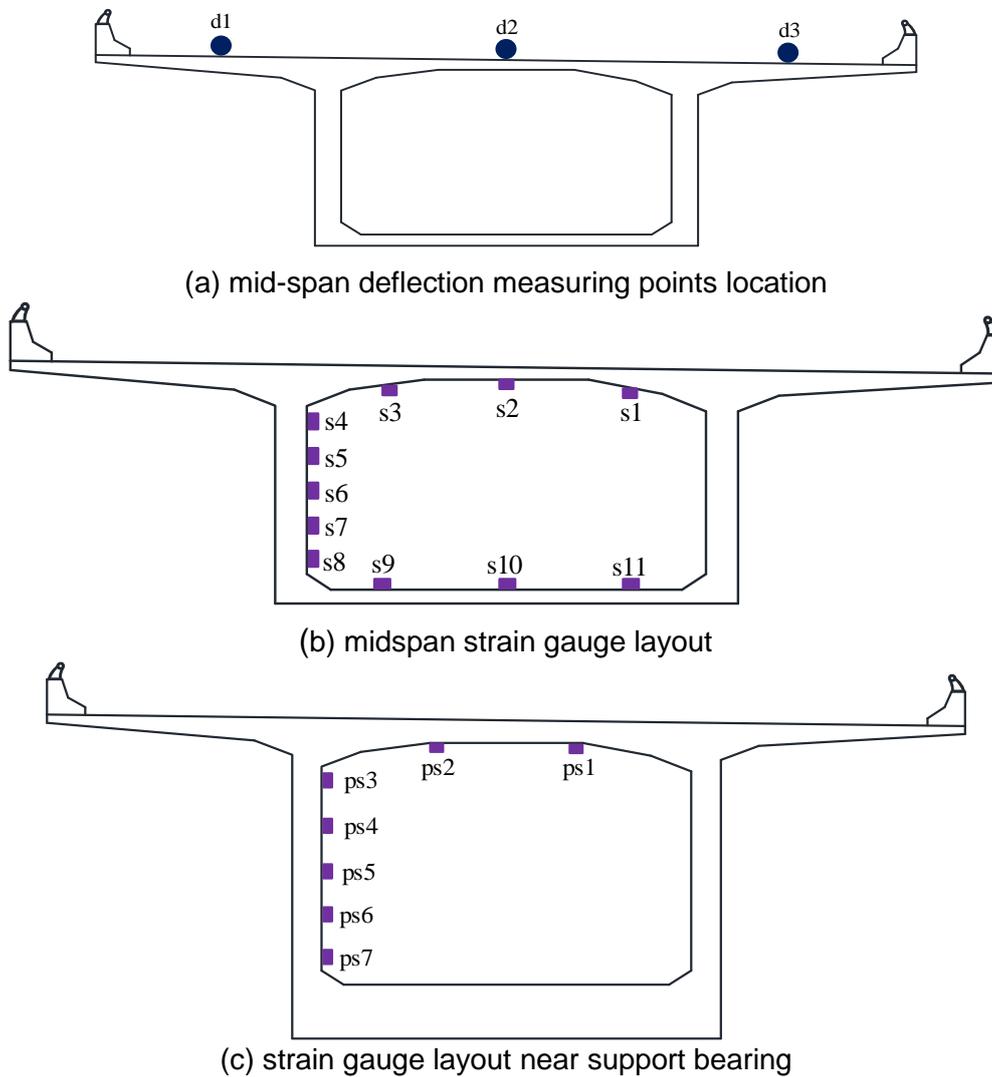
The bridge detection system consists of deflection measuring point and strain sensors. Deflection measuring point and strain sensors were strictly controlled at the same locations before and after strengthening. Deflection measuring points were placed at the middle of the span, the measuring point number is d1, d2 and d3. The deflection is measured by precision level. Strain measuring points of midspan were placed on the interior surface of the top slab, web and bottom slab of the box girder, the measuring point number is s1~s11. Strain measuring points of pier cross-section were placed only on the inner wall of top slab and web of box girder, the measuring point number is ps1~ps7. The strain sensors are all vibrating wire strain meters. Deflection measuring point and strain sensor layout of box girder before and after the strengthening are shown in Figure10.

Fig. 10 – Deflection measuring point and strain sensor layout of box girder

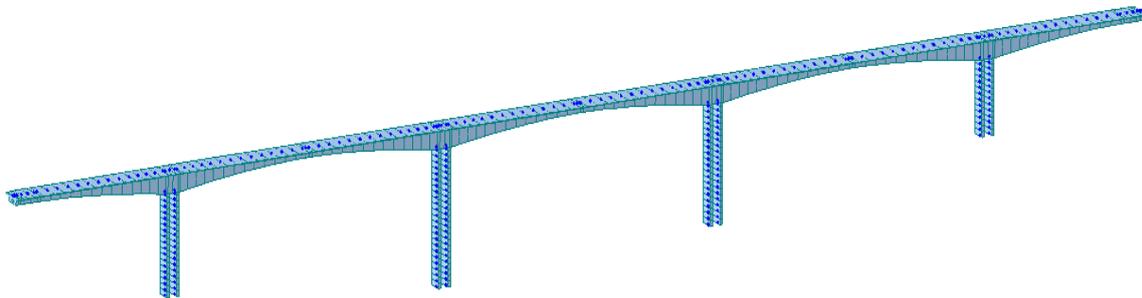
The Midas Civil software is used to establish the spatial finite element model of bridge before and after reinforcement, as shown in Figure 11. The box girder and pier are simulated by beam element. The prestressed steel wire strand bundle number of top plate, bottom plate and the web of box girder of the bridge is 229,100 and 64, respectively. Eight bundles of 17  $\varphi^{s15.24}$  prestressed steel strands are used in each span of the bridge after reinforcement. The prestressed steel wire strand bundles are simulated by tension frame unit. There are 290 units in the bridge finite element model. The connection between the top of the pier and the box girder is rigid connection, and the bottom of the pier is consolidation connection. The end of the bridge constrains vertical displacement and lateral displacement. The load of the vehicle of static load test is simplified into a concentrated force calculation, the actual bearing capacity of the reinforced bridge is obtained by comparing the calculated value with the measured value.

Fig. 11- Spatial finite element model of bridge

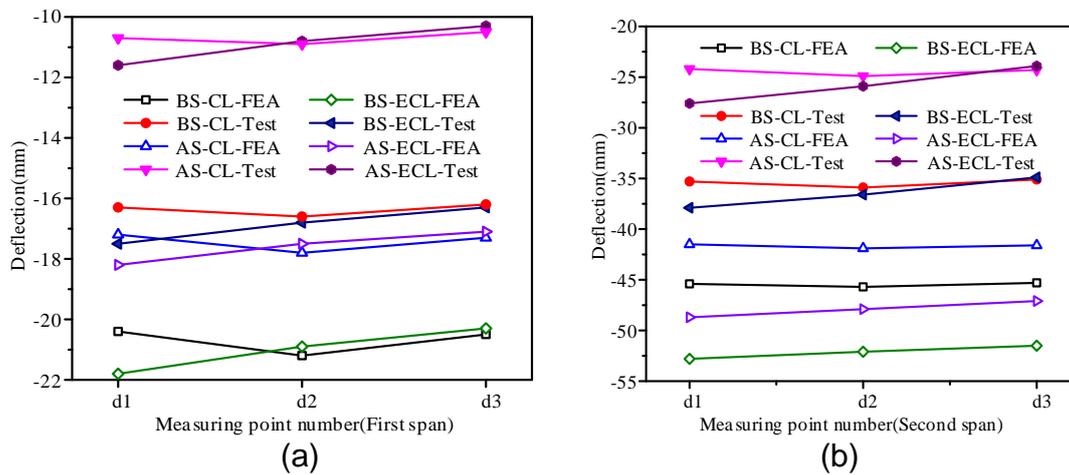
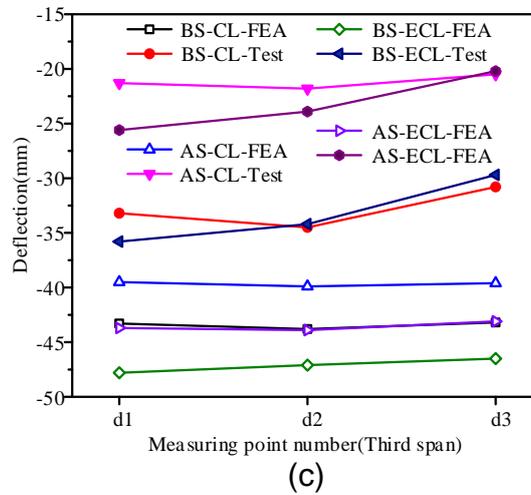
The deflection value, as the key control parameter of the static load test of the bridge, reflects the overall stiffness of the bridge structure. The finite element model calculation value and test value for load test of deflection before and after strengthening are shown in Figure 12. In the following figures, BS and AS indicate before and after strengthening, CL and ECL indicate centric and eccentric load, FEA and Test indicates finite element analysis and static load test result, respectively.

Fig.12– Calculated and Measured vertical displacement curve for (a) First span; (b) Second span; and (c) Third span

After bridge reinforcement, as shown in Figure 12, under the action of load test under each working condition, the measured deflection values of each measuring point are less than the theoretical values. For the first span, the deflection coefficient of correction is between 0.60 and 0.64, the coefficient of correction of the bridge is increased by 22.7% after reinforcement, the bearing capacity has increased by 18.2%. For the second span, the deflection coefficient of correction is between 0.51 and 0.59, the coefficient of correction of the bridge is increased by 23.8% after reinforcement, the bearing capacity has increased by 17.5%. For the third span, the deflection coefficient of correction is between 0.47 and 0.59, the coefficient of correction of the bridge is increased by 27.0% after reinforcement, the bearing capacity increased by 19.7%. The results show that external prestressing strengthening can significantly improve the performance of the structure. However, due to the loss of prestress caused by reinforcement construction, the actual deflection improvement value is less than the theoretical deflection improvement value.

Measured deflection values of the bridge after reinforcement are all smaller than the values of the bridge before reinforcement. The maximum displacement after the strengthening decreased to 27.6mm, compared to 37.9mm before strengthening. After strengthening, the displacement of all spans decreased. The strengthening effect of the maximum displacement of the static loading test was improved by 27%.

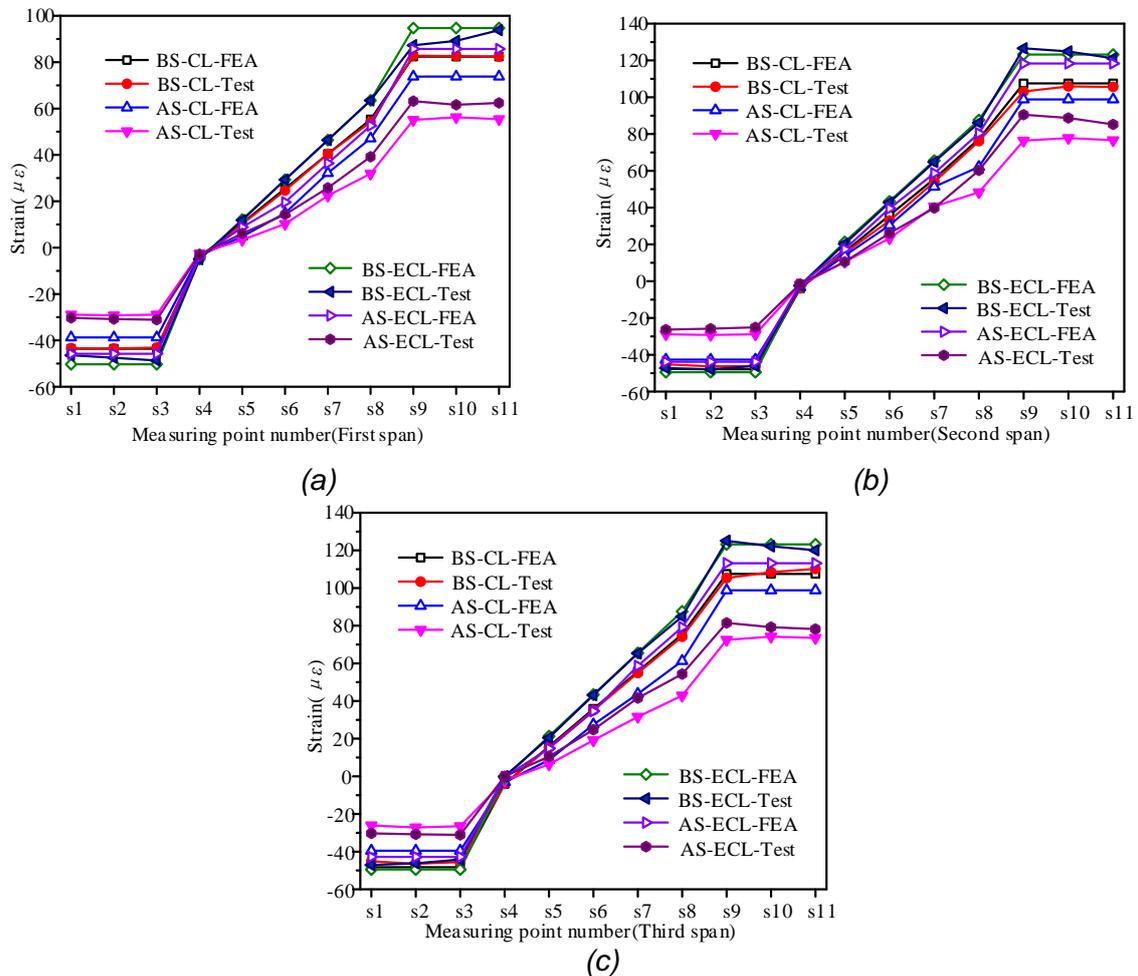
Strain is another key data that reflects the stress of bridge. Measured strain data under static loading before and after strengthening is shown in Figure13 and Figure14.

Fig. 13 – Measured strain data under static loading tests

After bridge reinforcement, as shown in Figure 13, the measured strain values of each measuring point are less than the theoretical values of finite element model. The measured strain values of each load cases of the first span all show improvement after external prestressing strengthening. For the first span, the strain coefficient of correction is between 0.66 and 0.75, which indicated stiffness improvement of the bridge structure. The average increment of load carrying capacity and coefficient of correction are 28% and 27%, respectively. For the second span, the strain coefficient of correction is between 0.57 and 0.79. The average increment of load carrying capacity and coefficient of correction are 26% and 27%, respectively. For the third span, the strain coefficient of correction is between 0.57 and 0.76. The average increment on strain and coefficient of correction of midspan centric loading are all 27%, and the average increment on strain and coefficient of correction of midspan eccentric loading are 23% and 24%, respectively.

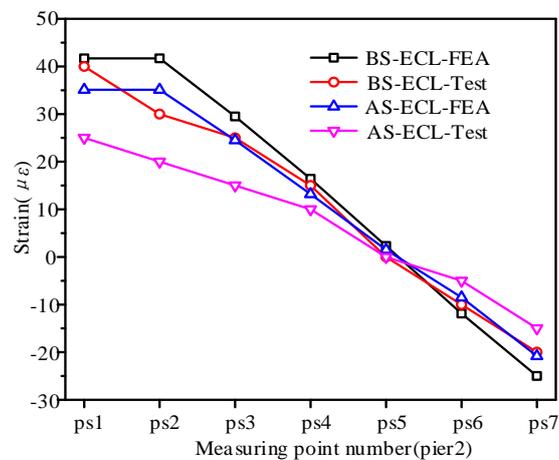
Fig. 14 – Measured strain data under static loading tests of pier 2

At pier 2, as shown in Figure 14, the measured strain values of each measuring point are less than the theoretical values of finite element model. The bearing capacity increased by 15%, and coefficient of correction increased by 18%. After the strengthening of the deteriorated bridge, the measured strain values under static loading tests at each span are all less than the values of the bridge before strengthening. The bridge structure showed significant improvement entirely on stiffness as well as bearing capacity. Therefore, the external prestressing reinforcement method not only can effectively improve the structural performance of the bridge, but also can improve the strength and the safety reserve of the bridge.
