A WIRELESS RAILWAY MONITORING SYSTEM OF PROBLEMATIC SUBSTRUCTURE IN TUNNEL

Yanxin Yang¹, Jianlin Ma¹ and Yong Huang²

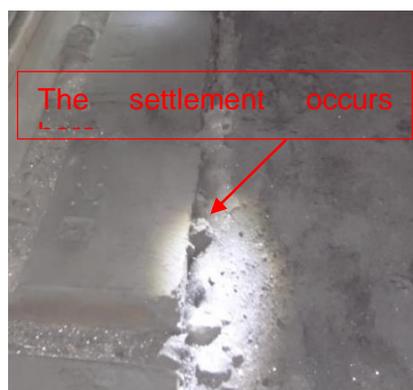
(a) Settlement of substructure

Type 1 is settlement of the substructure: the settlement of the railway substructure was observed at the center and side of the track close to the drainage ditch, which was the heavy-haul track out of the two tracks in the tunnel. The vibration of the sleeper and roadbed of the heavy-haul track were observed when the vehicle ran on the rails. The observation of settlement was shown in Figure 1 (a). The settlement of the substructure was identified along the heavy-haul track at the section K279+917-K279+947. The value of settlement was not measured during the in-situ survey due to the limited condition.

Severe damages were identified at the section K279+902-K279+962 (where K stands for kilometre). The damages to the railway substructure and tunnel lining were investigated and shown in Figure 1, and the damages were categorized into 4 different types.

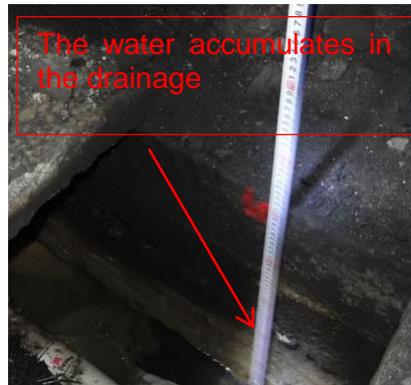
(b) Water pooling

Type 2 is water pooling: water pooling was observed at the side drainage ditch close to the heavy-haul track. Figure 1 (b) showed the water pooling at the drainage ditch close to the heavy-haul track. The depth of water pooling was measured as 0.3m at the Section K279+927. The cracks of the concrete beneath the drainage ditch were observed at the side and center drainage ditch. At section K279+935-K279+937, the width of the cracks was as much as 200 mm. Flowing water was identified at the center drainage ditch in the tunnel. The road bed was stroked by the flowing water at the center drainage ditch, due to the vibration of the vehicle. Water wave was observed at the side drainage ditch and the amplitude of the water vibration was as much as 10 cm.

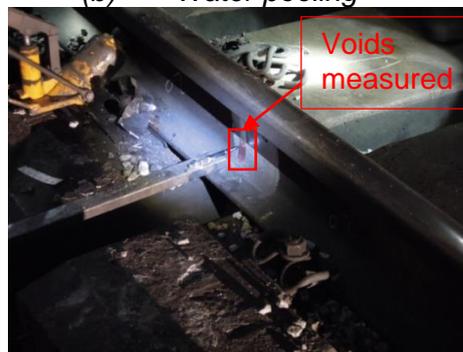
(c) Measurement of the underground voids

Type 3 is underground void: beneath the base of the substructure, the underground voids were observed. The height of the voids was ranging from 0.03 m to 0.15 m at the section K 279+907-K279+947. The vibration of the sleeper was observed when the vehicle was running on the trail. Figure 1 (c) showed the measurement of underground voids by steel scale.

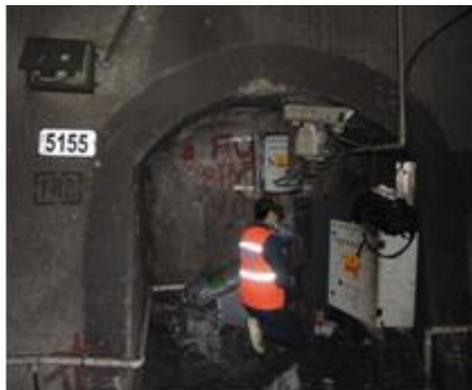
Fig. 5 - Data collector and processor

the period that train passed on the rails. Cameras and Led lights were installed along the wall of the tunnel to capture the real-time image of the railway substructure. There were two types of cameras used in the system: the type-A camera was a dome camera and type-B camera was the outdoor camera. The video system could be switched on or off based on the demand of the user in the control module. Figure 4 (a) showed the sectional view of the laser rangefinder, and Figure 4 (b) showed the accelerometers installed at the sleeper of the rails. In Figure 4 (c), the water level gauges installation was shown, and in Figure 4 (d), the camera installation was shown. Before the data was transferred to the data management system, the measured data were collected and processed in the data collector and data processor, as shown in Figure 5.

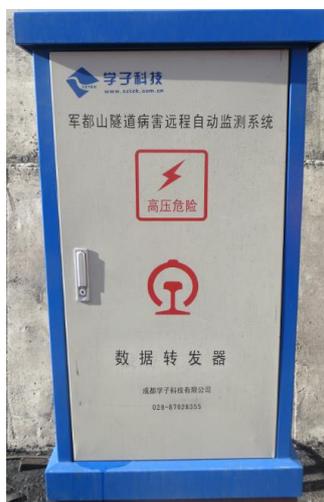
(a) Data forwarder at the tunnel exit

In the wireless transferring module, as the distance between the monitoring system and control center was long, a two-stage data transferring was proposed: the data needed to be transferred through the tunnel to the entrance of the tunnel, and the data needed to be transferred from the tunnel entrance to the control module. In the module, the data were collected from the sensors and transmitted to the station at the entrance of the tunnel via optical fiber and then to the control center via GPRS or GSM. The fiber optics networks along the tunnel were used for data transmission inside the tunnel as well as for video transmission, and the mobile telephony was used for transmitting the signals outside the tunnel. In Figure 6, the data forwarder and antenna for data forwarding at the tunnel exit were shown in Figure 6 (a) and Figure 6 (b), respectively.

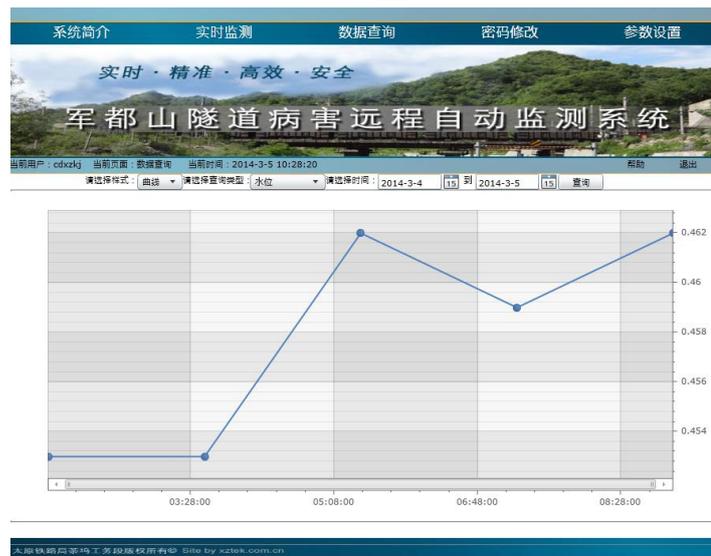
In the control module, the data was transferred and stored, and the data was accessible to the user. A data managing system was developed, which consisted of several functions: an introduction to the system, real-time monitoring and analysis, data inquiry, parameters setting and data managing. The introduction to the system provided the basic information of the data managing system. The real-time monitoring and analysis showed the measured data in the format of numbers and the curves. When the measured data was greater than the criteria value, the system sent alerts to the user. Data inquiry allowed the user to extract the history data in the format of numbers or curves. The parameter setting set the basic information of the project, the type of monitored data, the criteria value of the measured data, the receiver of the alert and the accessibility of the data. Data managing was aiming to collect and store the data. In Figure 7, the screenshot of the data managing system was shown.

Fig. 7 - Screenshot of data managing system

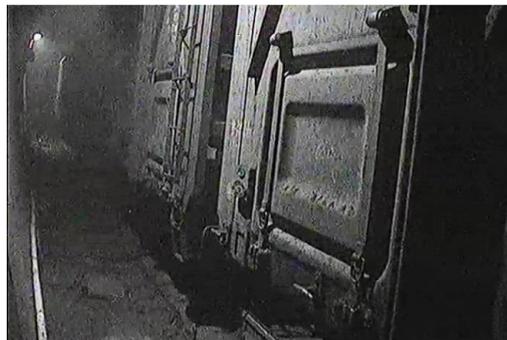
The cameras were used to capture the real-time image in the tunnel. The measured data was shown and analysed in the control module, once the irregular data was shown in the data managing system, the health state of the substructure needed to be examined by the real-time surveillance, and the video surveillance captured the image and video of the substructure for determining if an in-situ investigation was needed. Figure 8 showed a real-time image in the tunnel.

Fig. 8 - A real-time image in the tunnel
