IMPACT OF IMAGE RESOLUTION ON PAVEMENT DISTRESS DETECTION USING PICUCHA METHODOLOGY

Reus Salini¹, Bugao Xu² and Mena Souliman³

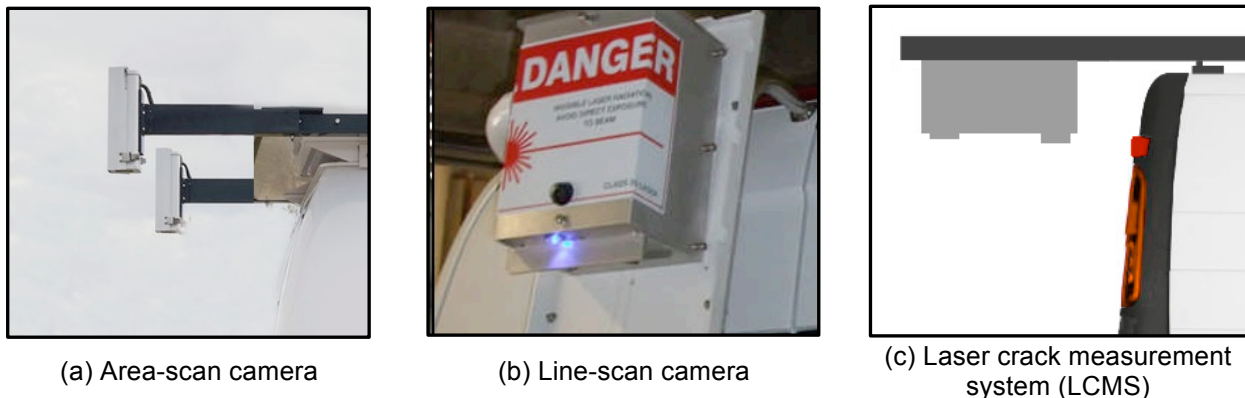
Figure 2 - Camera technologies for pavement surveys

Area-scan cameras were the first generation of equipment for pavement survey. They are adaptations of general purpose cameras (*Figure 2.a*) and are notorious for its low cost. Some integrators assemble two cameras together for a higher resolution. This type of camera takes a rectangular image on every shot (e.g. 2048x512 pixels) that results in a number of problems, especially image distortions since some pavement areas are closer to the camera lens than others, and non-homogeneous illumination, because some areas of the pavement are closer to the illumination source than others. Those problems are especially visible when two or more images are assembled together and generate an extra challenge for the distresses detection by software. Area-scan cameras are not compatible with laser illumination, requiring many lamps that usually are strobe flashlights.

Line-scan cameras represent an advance in technology and image quality (*Figure 2.b*). As its name suggests, it takes one single line of pixels on every shot (e.g. 2048 x 1 pixels). Image distortions and illumination heterogeneity are minimal. The line-scanned pixels can be assembled together to generate a consistent and flat rectangular image. It is compatible with laser (beam) illumination in addition to incandescent, LED and others.

The laser crack measurement systems (LCMS) collect two different information at the same time: an image and a transverse profile (*Figure 2.c*). The image is usually a by-product for this equipment and its quality tends to be low. The analysis is performed by using the profile data to locate the cracks over the image. It is especially accurate to identify cracks and rutting. Some

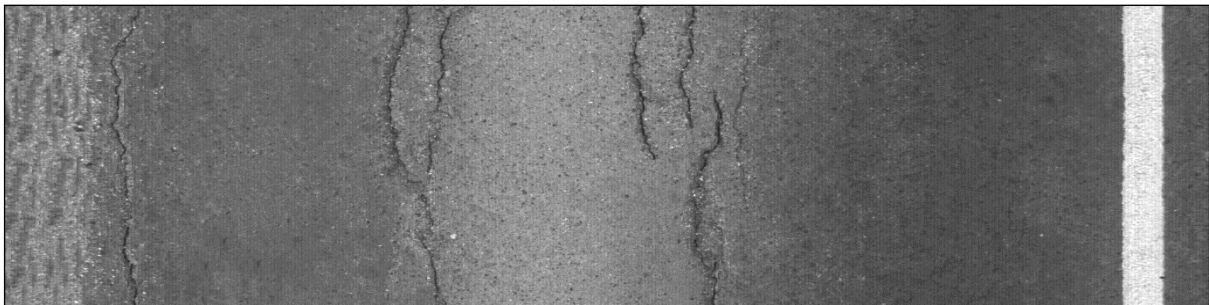
Figure 3 - Image with original resolution of 2048 x 512 pixels

An image taken with a line-scan camera with an original resolution of 2048 x 512 pixels, and covering an area of approximately 3.6 x 0.9 m (Figure 3), was downsized to the tested resolutions. Such image was chosen because it is representative of how PICUCHA performs. In addition it shows different kinds of patterns, including good pavement, raveling, cracks with different severities and a white strip. The 3D points mesh as well as the pixels decks with artificial colors for such image are shown on Figure 4 and Figure 5, respectively. They are part of

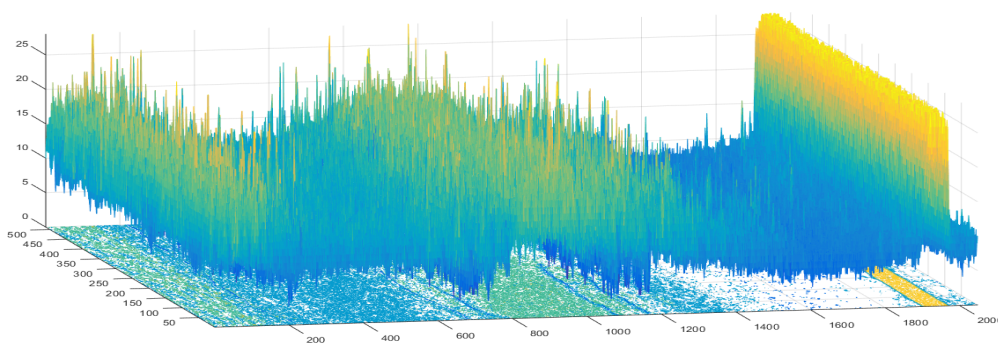
Figure 4 - The 3D mesh of points representation for the 2048x512 pixels image

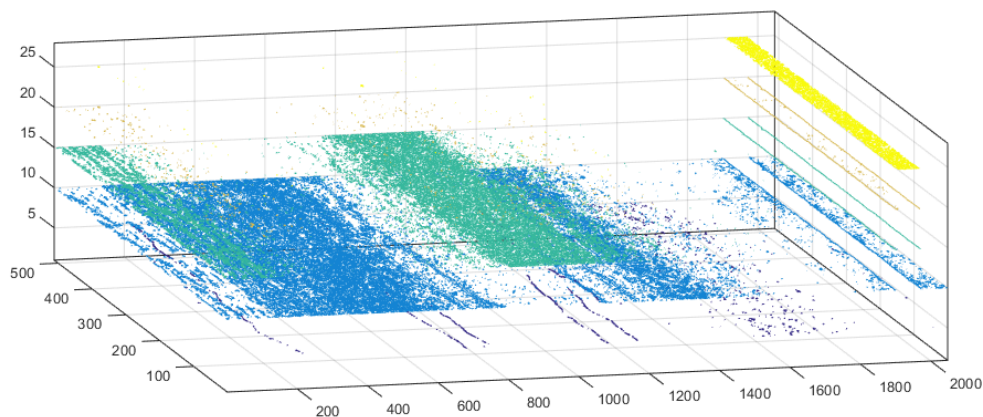
Figure 5 - The 3D pixel decks for the 2048x512 pixels image

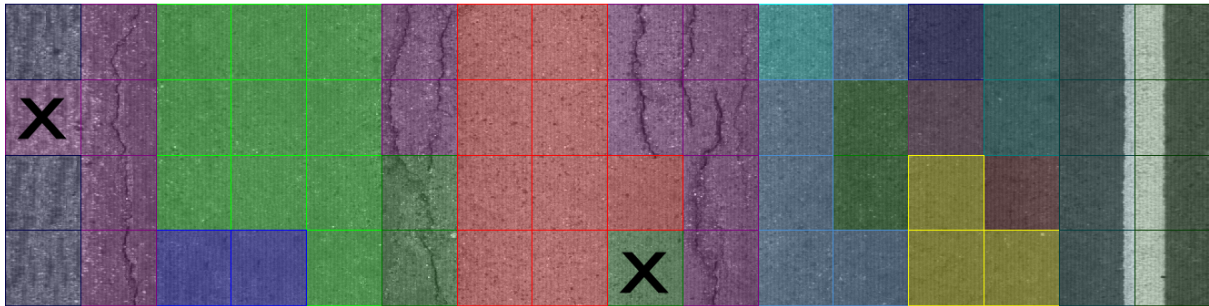
Figure 6 - Cells classification for the 2048x512 pixels image

The image, at its five different resolutions, was submitted for classification using PICUCHA algorithms. To keep the test consistency and the image slicing to the same number of cells for every case, the cell size was reduced in the same proportion of the image resizing, as shown in Table 2. The classification results are shown in Figure 6-10 where the generated groups can be seen. Because of the unsupervised nature of this artificial intelligence approach the cells marked with the same color belong to the same group and should have the same pattern. The cells that do not attend that criteria, i.e., were included in a group with a different predominant pattern, represent the algorithm error and are marked with a “x”. The identification of misclassified cells was performed by an experienced pavement engineer. In this study the colors are used only for the groups’ identification and, because every image (Figure 6-10) represents a different processing started from the ground, same colors in different images may represent different patterns. Another situation that frequently happens is that the algorithms, while performing the self-learning, may decide to create different groups for cells with patterns that, from a human perspective, look similar. When this situation happens the (human) pavement expert analyst will, in the step 3 of this methodology (Figure 1), set that groups with the same description for the distresses accounting.

As expected, the number of misclassified cells rose as the resolution dropped, but not in a linear way. At the highest resolution, 2048x512 pixels, the error was the smallest, with just two cells being misclassified among 64. At the lowest resolution, 1024x256 pixels, six cells were misclassified with an error rate of 9.4%. The largest error was found at resolution of 1280x320 pixels with seven cells misclassified, corresponding to an error of 10.9% as shown in Table 2.

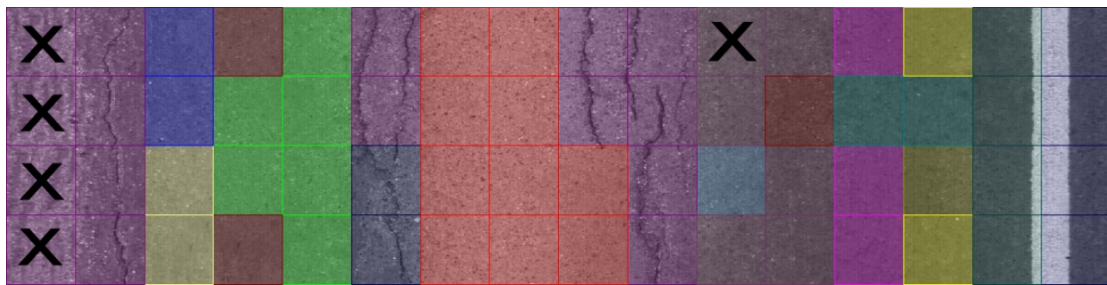
Figure 7 - Cells classification for the 1792x448 pixels image

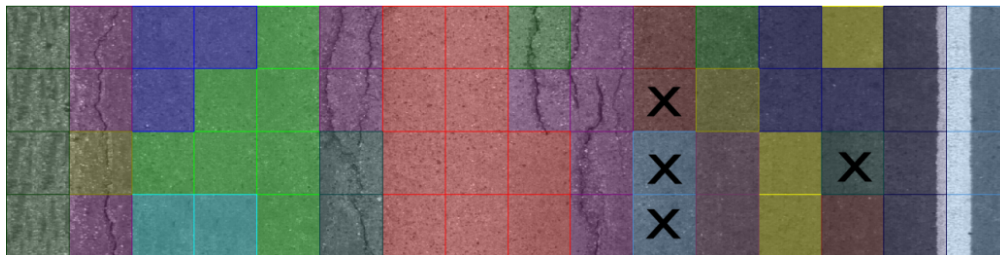
Figure 8 - Cells classification for the 1536x384 pixels image

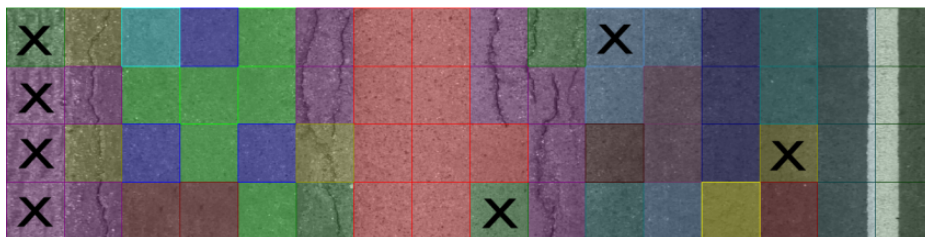
Figure 9 - Cells classification for the 1280x320 pixels image

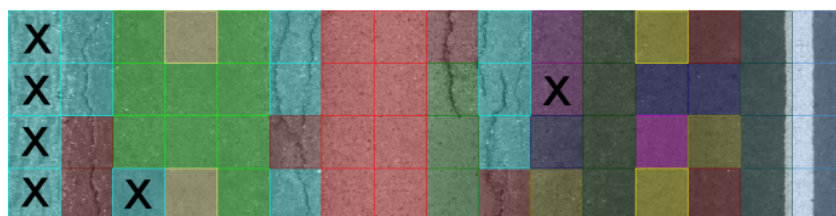
Figure 10 - Cells classification for the 1024x256 pixels image

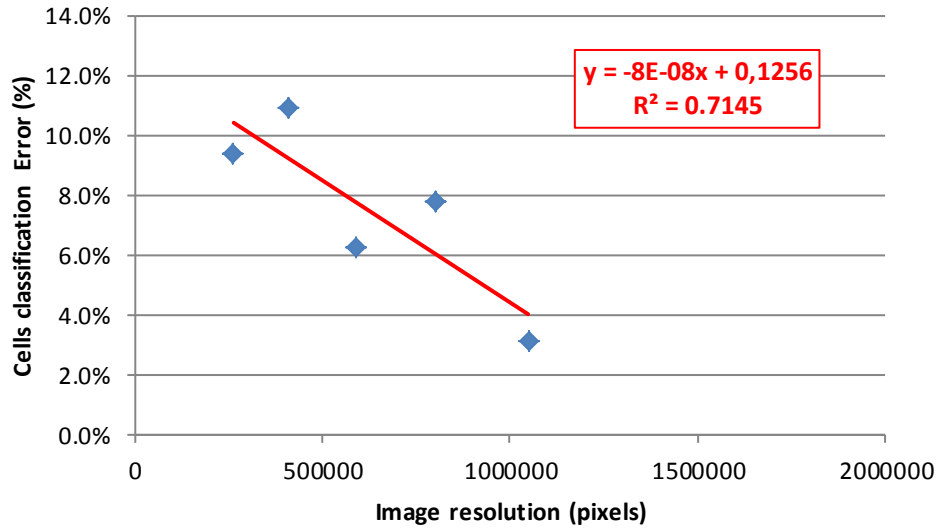
Figure 11 - Classification error according to the image resolution

Figure 11 shows the found errors graphically with a respective trend line and a prediction equation. On the basis of the trend line, the upper and lower limits can be plotted with a plus and minus standard deviation (3.0%), as shown in Figure 12. By extrapolating the upper limit, the ideal image dimension can be identified at a location near 2 megapixels where the theoretical error is zero. This dimension is equivalent to an image size of 2900x725 pixels, or a resolution of 1.24 mm/pixel.

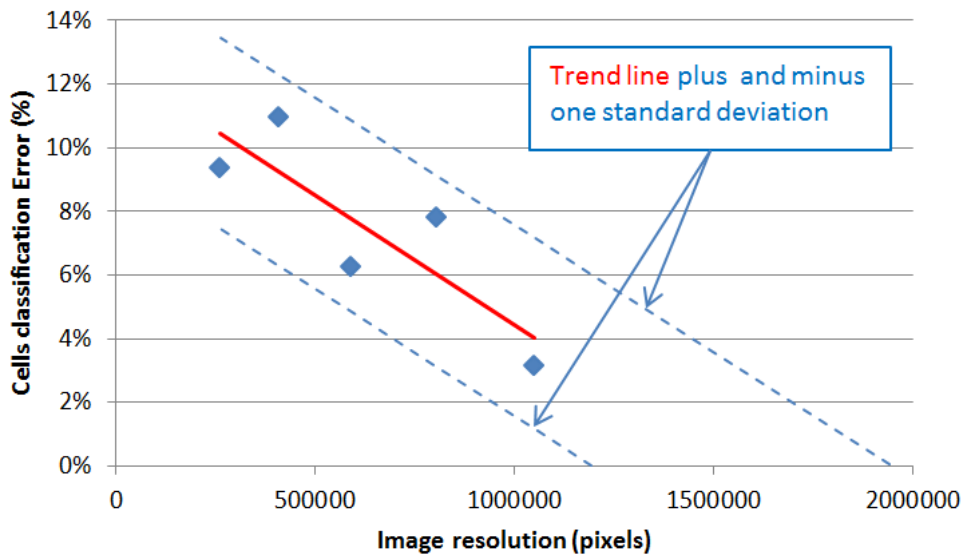
Figure 12 - Projection of ideal image resolution for PICUCHA method

The error trend line analysis suggests the optimum transverse image resolution should be more than 2900 pixels, i.e., around 1.24 mm/pixel. Although this should not be assumed as a definitive parameter, it is a good resolution reference for selecting a camera system for pavement surveys when PICUCHA will be used for the analysis.
