EXPERIMENTAL RESEARCH INTO DYNAMIC PROPERTIES OF MASONRY BARREL VAULTS NON-REINFORCED AND REINFORCED WITH CARBON COMPOSITE STRIPS

Zigler Radek¹, Witzany Jiří¹, Makovička Daniel², Urushadze Shota³,
Pospíšil Stanislav³, Kubát Jan¹, and Kroftová Klára⁴

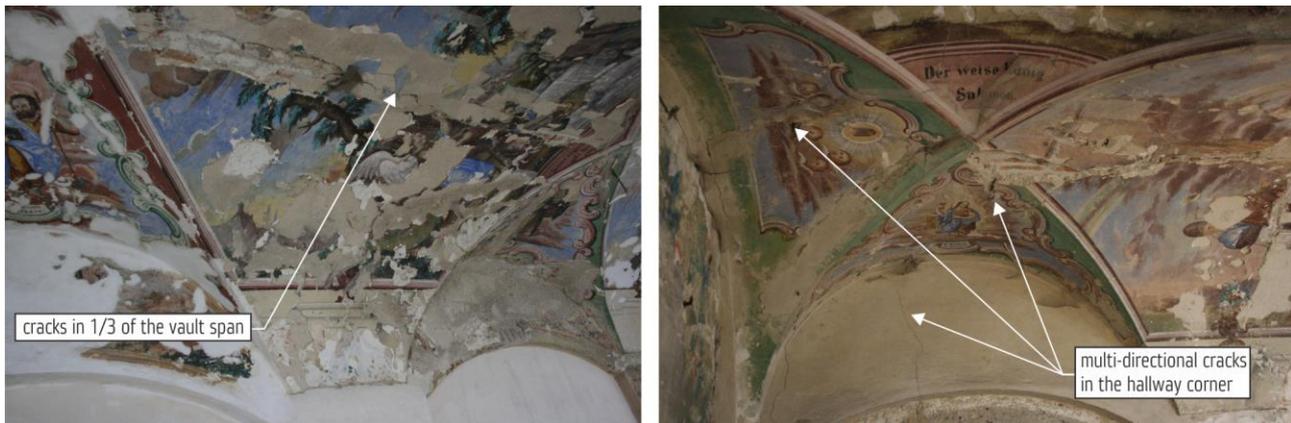
Fig. 1. - Vault in Loretto near Bor u Tachova

The restoration of historic buildings is frequently connected with reconstructions and rehabilitations of barrel vaults damaged mostly by the effects of induced deformations. In regions with the occurrence of natural seismicity, the failures of vaults are caused by their inelastic response to dynamic effects (Figure 1).

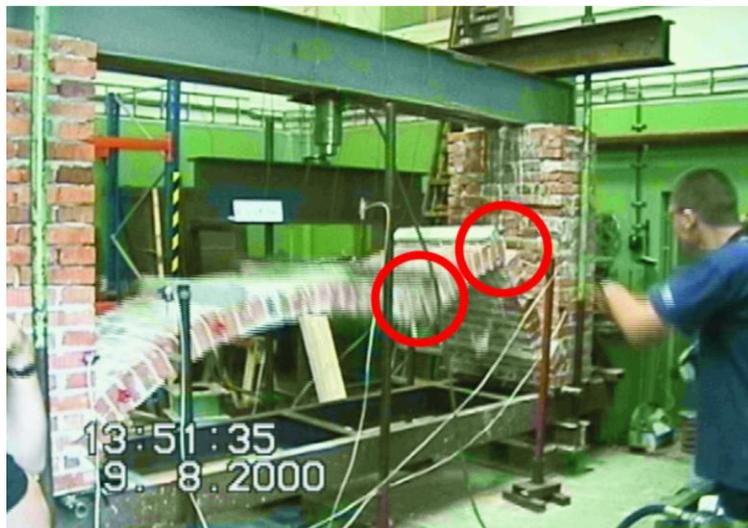
Fig. 2. - Vault collapse due to the supporting system's failure (horizontal displacement of supports)

imperfections and, last but not least, the stiffness and stability of the supports (Figure 2).

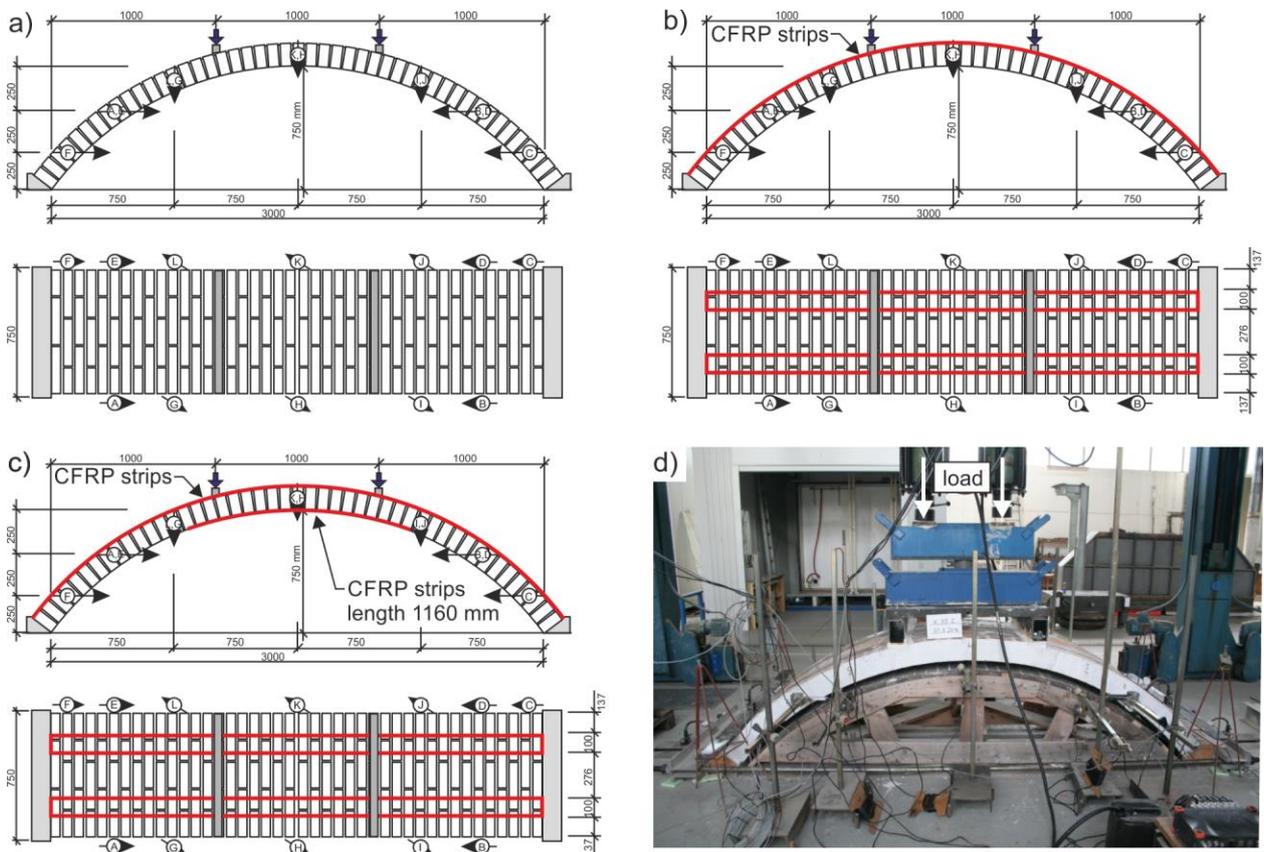
Fig. 3. - a) Scheme of vault K34 – non-reinforced, b) Scheme of vault K35 – reinforced at the extrados, c) Scheme of vault K36 – reinforced at the extrados and on the soffit, d) Test setup example

Experimental research into segmented barrel vaults was performed on test pieces fabricated in a 1:1 scale – segmented masonry barrel vault sections 0.75 m in width, with a span of 3 m, with a rise of 0.75 m and a vault masonry thickness of 0.15 m, made of bricks of P15 quality and MVC 2 mortar (Table 1, Figure 3).

- K34 – non-reinforced vault,
- K35 – reinforced vault, reinforcement at the extrados (upper surface) with 2 strips of the Tyfo SCH 41 carbon fabric glued with the Tyfo S epoxy resin. The strips

are 100 mm in width, the composite thickness for the calculation is 1 mm, the strips cover the whole length of the extrados. The strips (strip edges) are placed 137 mm from the vault edges.

- K36 – reinforced vault, reinforcement at the extrados (upper surface) and on the soffit (lower surface) always with 2 carbon fabric strips (see K35). The strips are 100 mm in width, the composite thickness for the calculation is 1 mm. The strips on the upper surface (extrados) again cover the whole length of the extrados, while the strips on the lower surface (soffit) are placed at the vault crown, the length of strips being 1180 mm. The strips (strip edges) are placed 137 mm from vault edges.

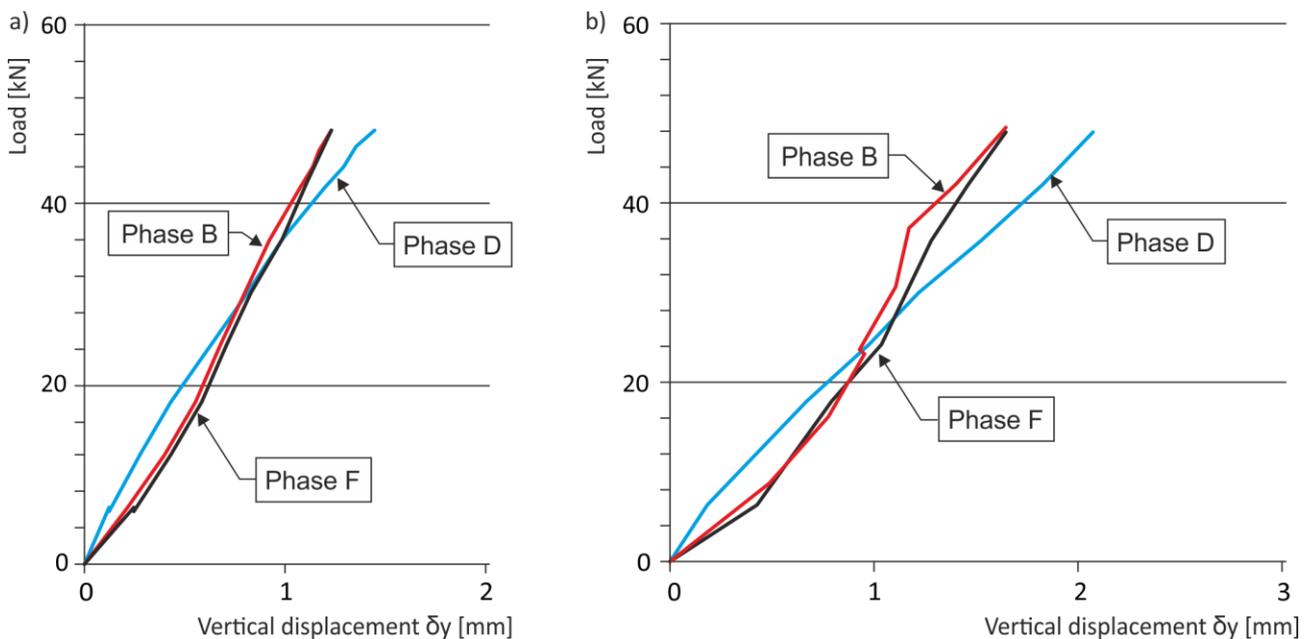
Fig. 4. - a) Pattern of vertical deformations $\delta_y \times L$ of a non-reinforced vault (K34) under static loading (2x24 kN) in individual loading phases, b) Pattern of vertical deformations $\delta_y \times L$ of a vault reinforced on the extrados (K35) under static loading (2x24 kN) in individual loading phases

The static loading of segmented barrel vaults was carried out with the help of two synchronised hydraulic actuators applying individual, monotonously rising steps of 2x 3kN. Partial results of the behaviour of barrel vaults symmetrically loaded in one third of their span with a pair of vertical forces (see Figure 3) are summarised in Table 3 and graphically displaced in Figures 4 and 5.

The results of experimental values obtained from the investigation of the response of vaulted structures to static loading imply (comparison of vault deformation values from the second and third static phase – see Table 2) that the effect of dynamic loading results in the “stabilisation” (consolidation, “strengthening”) of the vaulted structure. We may presume that some portion of non-elastic deformations occurred during the first dynamic test (additional pushing of bed joints, stabilisation of the supporting system, etc.). These values can be experimentally measured (during dynamic loading) with difficulty. This issue will be the subject of further experimental verification.

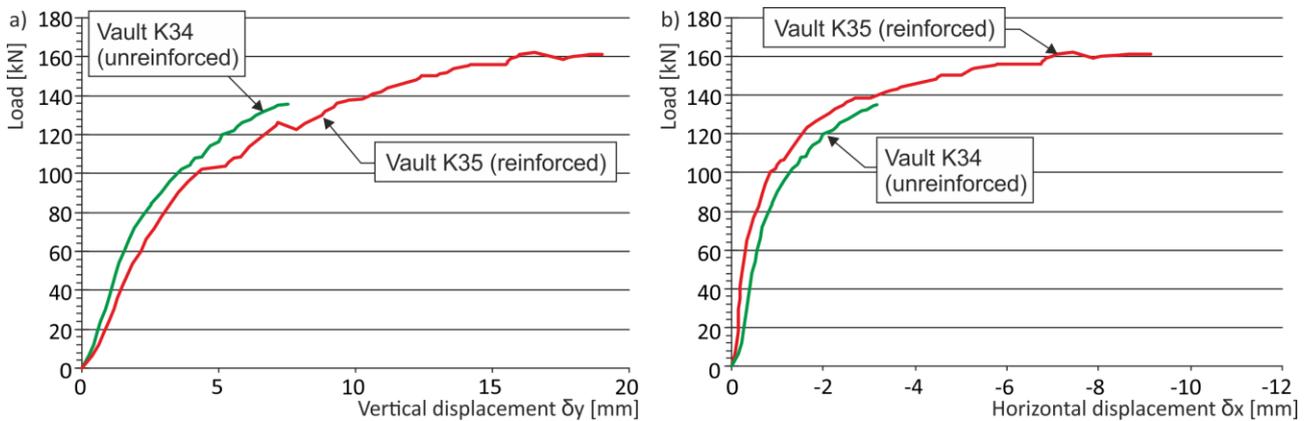
Fig. 5. - a) Overall working diagrams of vertical deformations $\delta y \times L$ of segmented barrel vaults under loading until failure, b) Overall working diagrams of horizontal deformations $\delta x \times L$ of segmented barrel vaults under loading until failure

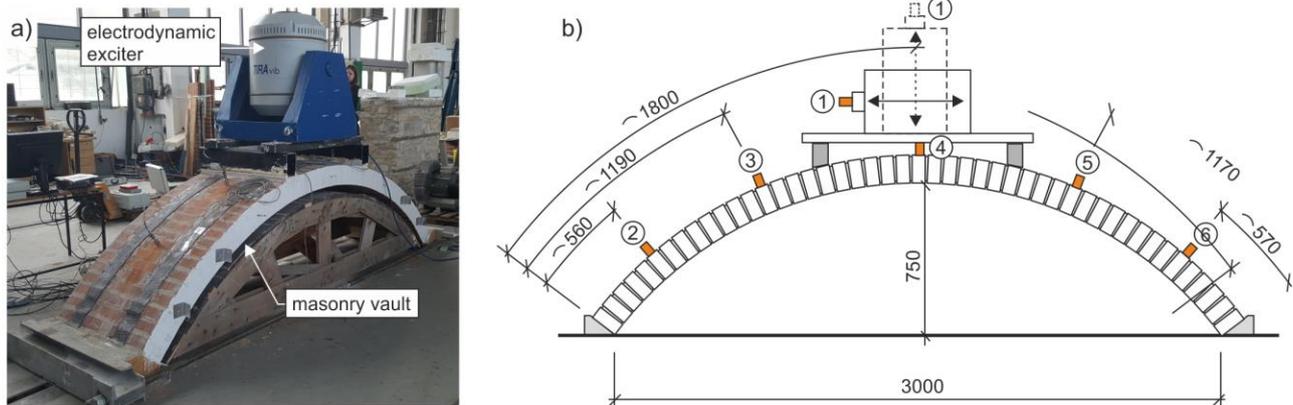
Fig. 6. - a) Mounting of the TIRAvib electrodynamic exciter on the vault, b) Distribution of sensors on the vault

Dynamic loading in both the vertical and horizontal direction was applied with the TIRAvib electrodynamic exciter, type TV5550/LS with a weight of 550 kg. Its operating frequency range is from 0 up to 3 kHz and the maximum rated travel of mobile mass is 100 mm. The exciter was fixed to the vault and adapted to vertical and horizontal oscillations (Figure 6a). The vertical response was measured with five Wilcoxon accelerometers, model CMMS 793L, with an output sensitivity of 51 mV/ms^{-2} . One of them was positioned on the mobile part of the exciter to read the mass motion. Other sensors were positioned on the vault (Figure 6b).

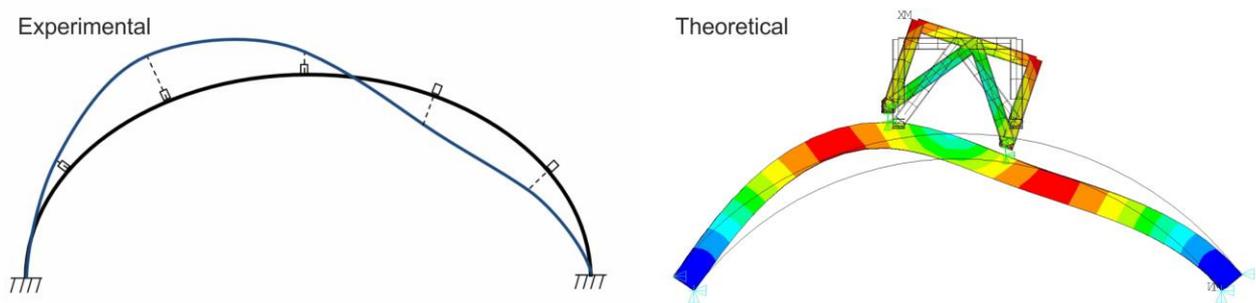
Fig. 7. - Oscillation shapes, theoretical and obtained from experiments, corresponding to the first natural frequency (see Tables 1 - 3)

Following each loading step, especially after static loading, there was a drop in the effective vault stiffness, which was manifested by a drop in the natural frequencies and, in some cases, by increased internal damping, most likely due to the appearance of microcracks over the whole vault cross section. Changes in stiffness and geometry after each loading step were manifested by the changes in the dynamic characteristics during the monitoring of changes in the vault's state. Frequencies were also detected on a numerical model (Figures 7 – 10) comparing theoretical and experimental oscillation shapes corresponding to the 1st to 6th natural frequencies. The obtained patterns show satisfactory agreement of theoretically and experimentally identified oscillation shapes. Successive harmonic loading occurred in the vicinity of such identified resonant frequencies with the objective of identifying also resonant oscillation shapes.

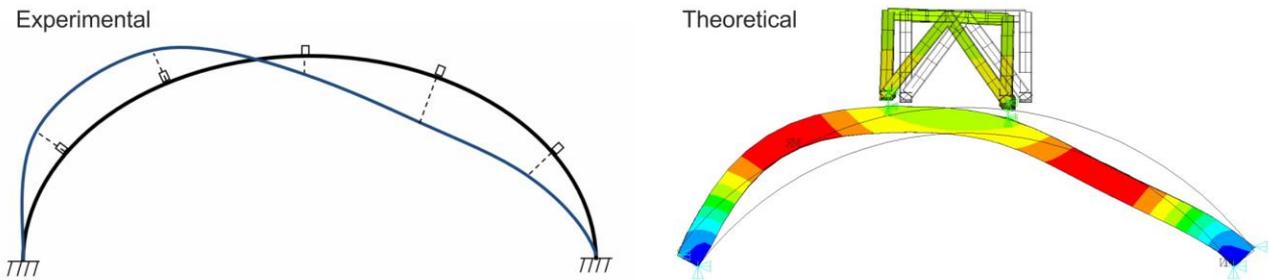
Fig. 8. - Oscillation shapes, theoretical and obtained from experiments, corresponding to the second natural frequency (see Tables 1- 3)

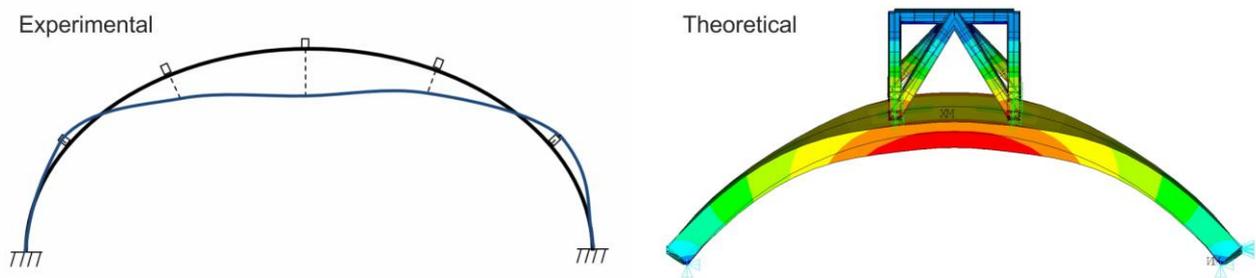
Fig. 9. - Oscillation shapes, theoretical and obtained from experiments, corresponding to the fifth natural frequency (see Tables 1 - 3)

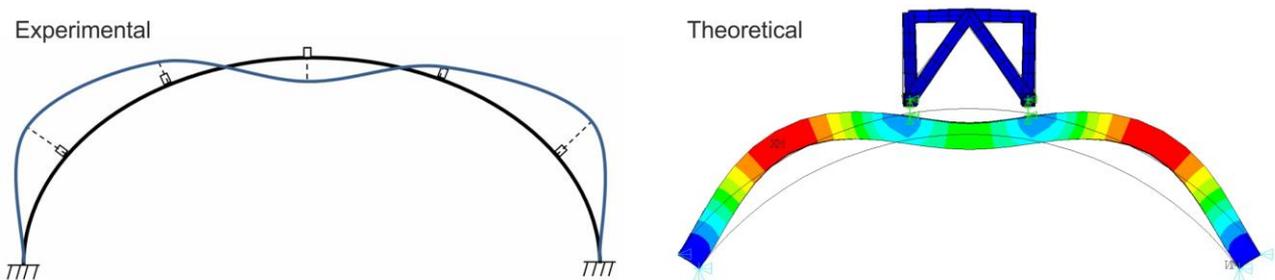
Fig. 10. - Oscillation shapes, theoretical and obtained from experiments, corresponding to the sixth natural frequency (see Tables 1 - 3)
