DAMAGE DETECTION ON COOLING TOWER SHELL BASED ON MODEL TEXTURES

David Zahradník and Filip Roučka

Czech Technical University in Prague, Faculty of Civil Engineering, Department of Geomatics, Thákurova 7, Praha 6, Czech Republic; david.zahradnik@fsv.cvut.cz

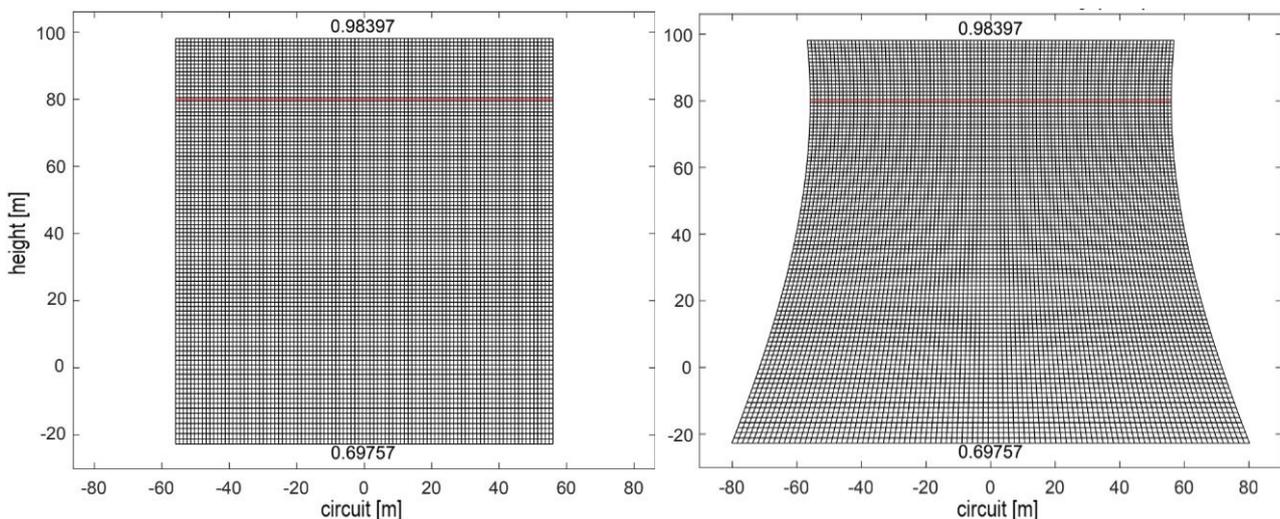
Fig. 1 – Textures (diffuse, normal, displacement, occlusion)

The textures of the mesh model were united into a map projection. A similar approach was used for laser scanning data to estimate the difference between mathematical model and measured model of cooling tower [29-30]. Cooling towers can be divided according to meridians and parallels, parallel are horizontal lines of circuit and meridians are vertical lines of height.

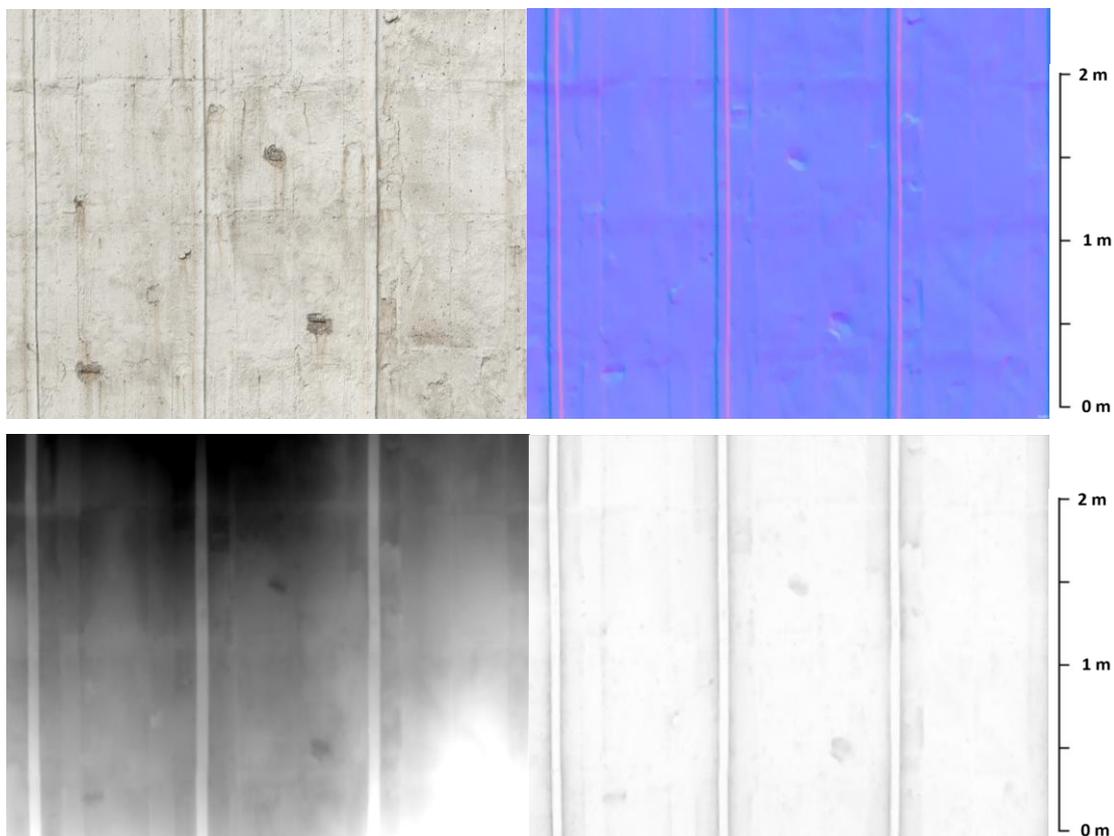
Fig. 2 – Textures (diffuse, normal, displacement, occlusion)

The sub-goal of this article is to utilise textures commonly used in rendering techniques to enhance detection in the field of civil engineering. Diffuse texture is used to define the base colour of an object. It is also known as the albedo map. The diffuse map is responsible for the colour of the object when it is not affected by any lighting conditions. Lighting conditions during the capture of input images impact the diffuse texture in photogrammetry if de-lighter software is not used. Normal texture is used to provide the perception of depth on a flat surface. It is used to add small details to the surface of an object without changing the geometry of the object. The normal map is created by using a high-resolution model and then transferring the surface details to a low-resolution model. The purpose of displacement texture is to enhance the three-dimensional appearance of an object's surface. It is used to create the illusion of geometry that is not present in the model. The displacement map is created by using a high-resolution model and then transferring the surface details to a low-resolution model. In the field of photogrammetry, a displacement texture is analogous to a Digital Elevation Model (DEM), except it is derived from a distinct foundational model rather than a flat plane. An occlusion texture is employed to replicate the phenomenon of shadowing that arises when two objects are close to one another. It is employed to enhance the three-dimensional appearance of the shadows and indentations on an item. [33] These textures are visible on Figure 2.

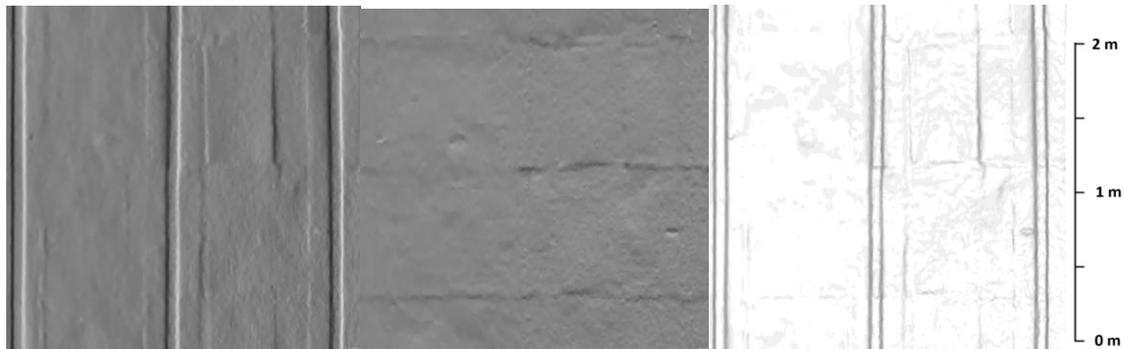
Fig. 3 – Normal texture - x (left), y (middle) and z (right)

The intriguing texture is the normal texture. The texture consists of three bands that carry X, Y, and Z values of the normal vector visible on Figure 3. The normal vector values from the high-resolution model are recorded as pixel values in a normal texture. In the figure below, it is visible that the Y band eliminates the ribbing on concrete. This effect is achieved by aligned ribbing with a coordinate system of normals, which is helpful for the detection of ribbing.

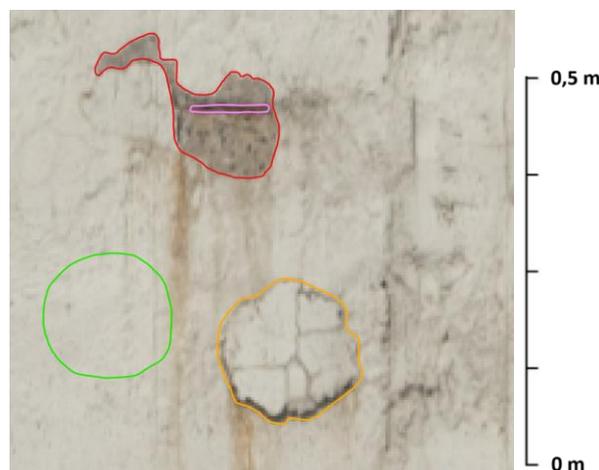
Fig. 4 – Red - high damage, pink - steel reinforcement, yellow - low damage, green - concrete

The goal of the research was the automatic detection of damaged concrete on the tower shell. Damage is categorised into 4 categories visible in Figure 4: fine concrete, low damage, high damage without reinforcement and high damage with reinforcement. The key characteristics defining damage in the sustainability lifecycle of a cooling tower include the area, depth, volume, and length of visible reinforcement.

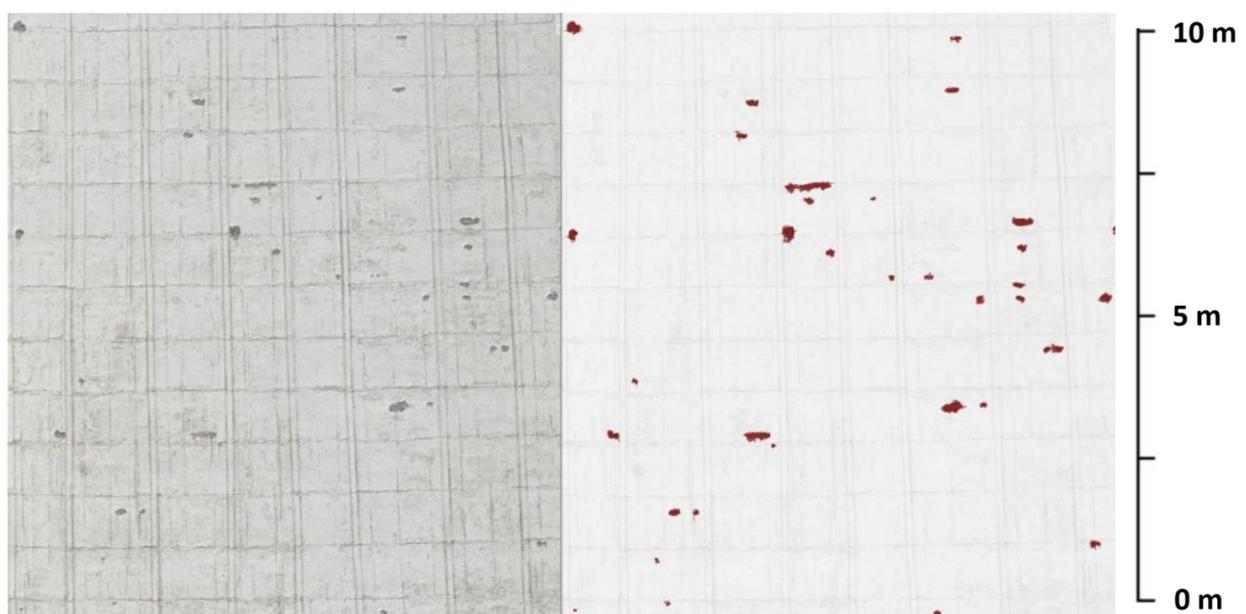
Fig. 5 – Detected High damage

The Convolutional Neural Network contained 2 hidden layers. The kernel of the first layer was set at 7 and the number of distinct feature maps was 12. The kernel of the second layer was set to 5. CNN was trained by a 0.0006 learning rate, with 5000 training steps and 50 samples were used in each training step. Applying CNN heat maps with probabilities of occurrence of wanted objects were created. The raster layer was multi-resolution segmentation by Object-based image analysis (OBIA) with each layer (RGB texture and heatmaps). Generated objects were classified by heatmap values. Objects with the same classification were merged visible on Figure 5.

Identifying extensive damage poses the least challenging aspect of the detection process. High damage is characterised by disturbed concrete with a different colour than fine concrete. For detection, diffuse texture (RGB) was used as the input layer for CNN in eCognition software version 10.3. Samples were created in QGIS as polygon objects with type attributes: concrete, low and high. Table1.

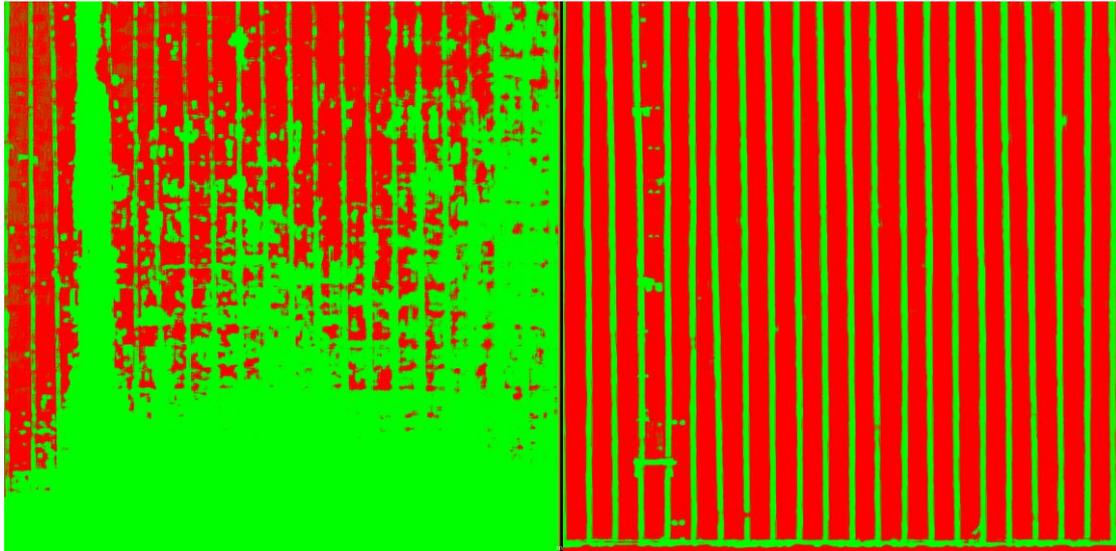
Fig. 6 – Classified concrete ribbing from diffuse (left), from normal (right)

Ribbing on tower shells is a disruptive element for low damage detection. Vertical edges of ribbing are similar to cracks of low damage. Meanwhile, testing detection of low damage with CNN was found to require the elimination of ribbing, for detection of ribbing CNN was used with the same design as in High damage detection. It was compared to the input layer to CNN: diffuse and normal texture visible on Figure 6. Polygons for sample creation were identical. For sample augmentation: horizontal flip and zoom. Rotation and vertical flip are unwanted due to ribbing orientation.

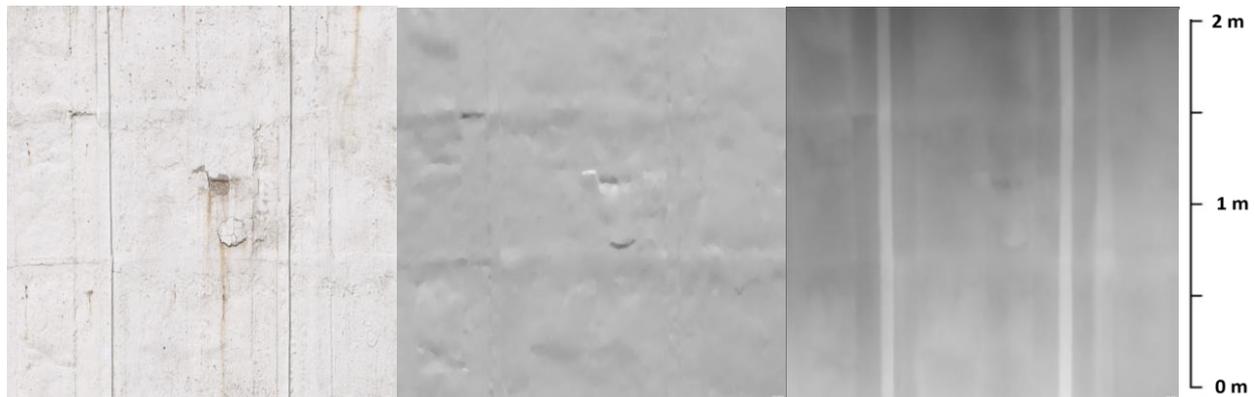
Fig. 8 – (input - diffuse, normal y, displacement)

The composed raster layer is based on diffuse texture, normal texture, and displacement texture. The diffuse texture was converted from RGB to HSI colour space. An intensity band from HSI was used for further processing. From normal texture were used only bands with y values - normal Y. Displacement texture containing values from -20cm to 20cm, which is not suitable for slope estimation, so displacement texture was multiplied 1000x times to increase values to prevent numerical errors. Each raster is visible on Figure 8.

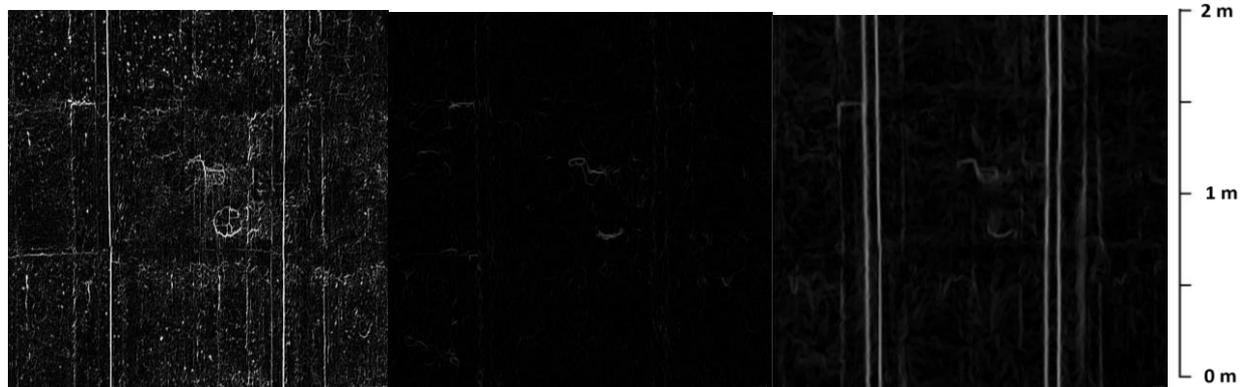
Fig. 9 – (Intensity ridge filter, normal Y ridge filter, slope)

The intensity layer and normal Y were processed by the Ridge filter to highlight raster edges. The kernel of the Ridge filter was set to size 3. The slope raster is calculated from multiplied displacement texture visible on Figure 9.

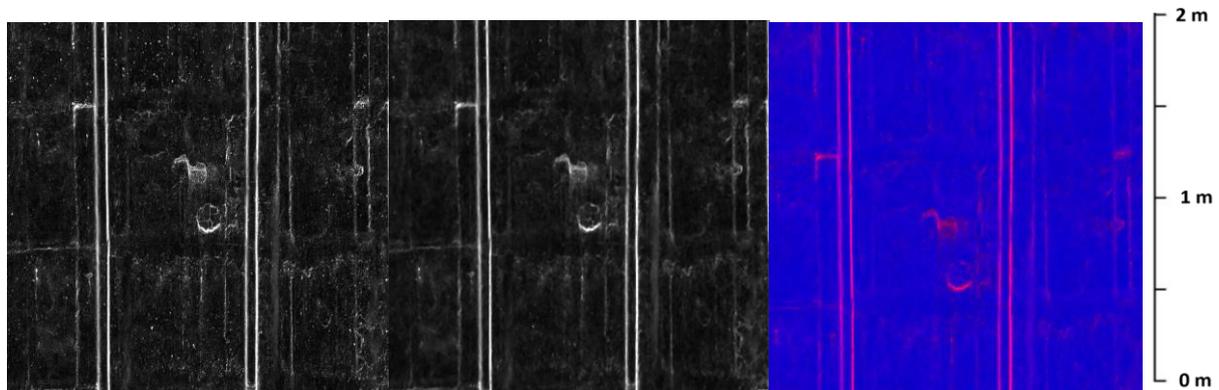
Fig. 10 – (summarization of highlight edges raster, median blur filter, composed raster layer)

Layers with highlighted edges were joined together with the same weight and blurred by a median filter to remove air pores. The final raster layer is composed of the Intensity band and the blurred band visible on Figure 10.

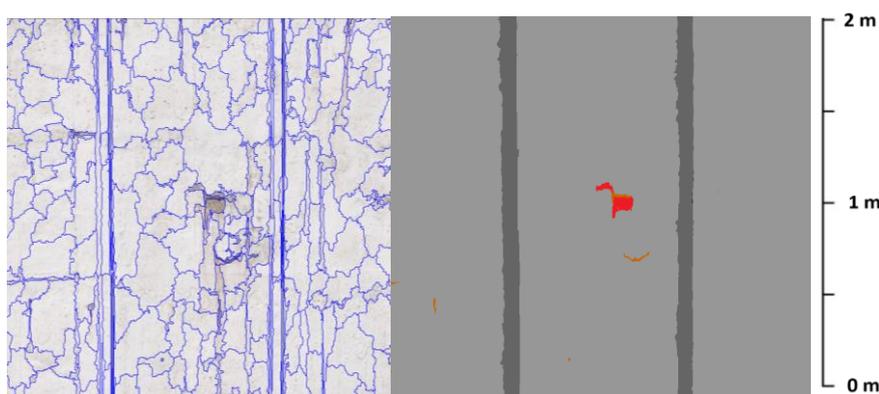
Fig. 11 – (segmented objects - left, classified object - right)

The composed raster layer is used for multi-resolution segmentation by OBIA in eCognition software. The scale parameter was set to default on value 42. The shape parameter was set to 0.2 and compactness 0.7. Created objects were classified by rules in Table 3 below into 4 categories: fine concrete, ribbing, low and high damage visible on Figure 11.

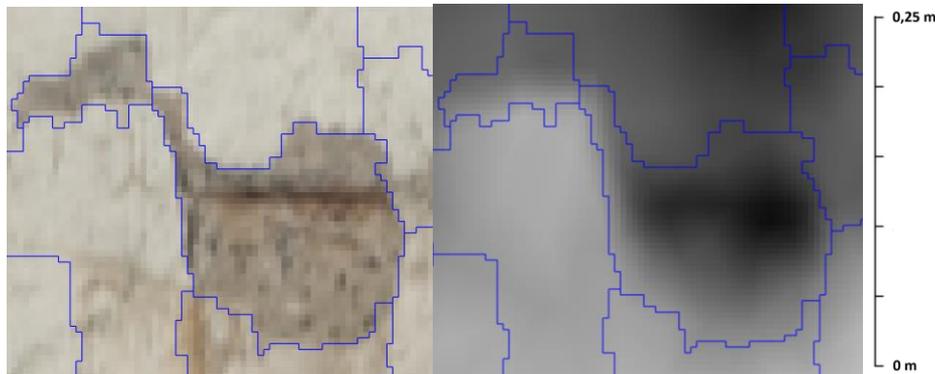
Fig. 12 – high damage on diffuse (left) and displacement texture (right)

Estimation of missing concrete volume is processed by pixel summarization like on DEM. On the contrary, DEM utilises displacement texture, assigning values based on the disparity between the actual geometry and the design geometry. Volume is estimated by summarization of pixel values on high-damage objects reduced by mass given by a boundary-like fitting plane on the boundary. Example of estimation of missing concrete is visible on Figure 12, 13.
