EXPERIMENTAL STUDY ON QUALITY LOSS AND MICROSTRUCTURAL CHARACTERISTICS OF REINFORCED CONCRETE IN BRIDGE DECK PANELS AFTER SALT FREEZING

Xilong Zheng¹, Di Guan², Honglei Zhang³

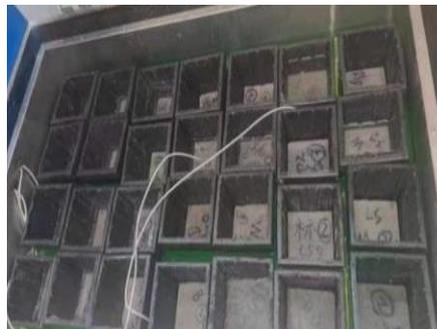
Fig. 1 – Freeze-thaw cycle diagram of concrete

The experiment uses plain concrete specimens with dimensions of 100 mm×100 mm×400 mm, formed horizontally. A total of 12 specimens are prepared and divided into 4 groups. After being left to stand at room temperature for 24 hours, the specimens are demolded and numbered as follows: Group 1, numbered A13D~B33D; Group 2, numbered A41D~A43D; Group 3, numbered A11D~A31D; Group 4, numbered A12D~A32D. Different liquids are poured into each group during the freeze-thaw test, including water, NaCl solution, Solution A, and Solution B. To meet the requirements of the control study, 3 specimens without any damage treatment are prepared, making a total of 15 specimens. Freeze-thaw test was carried out in freeze-thaw chamber. Each cycle includes 2 hours of freezing and 2 hours of thawing. Freeze-thaw cycle diagram of concrete is shown in Figure 1.

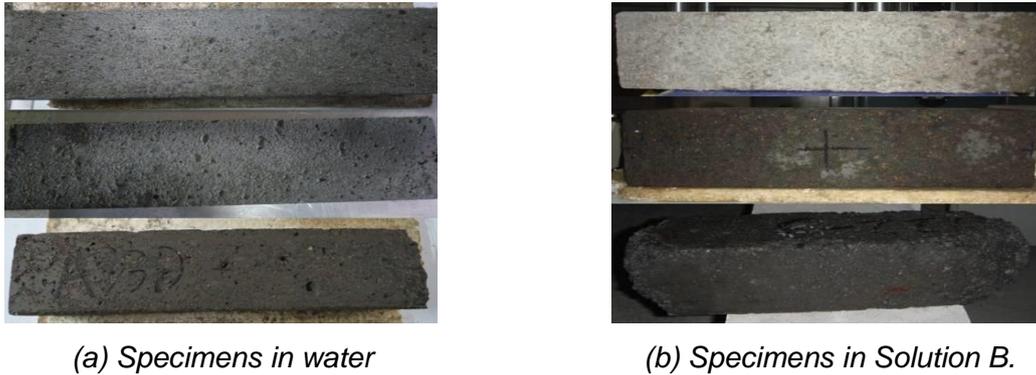
The erosion conditions of the specimens in water and Solution B are shown in Figure 2, from top to bottom, representing specimens subjected to 50, 150, and 250 freeze-thaw cycles respectively.

Fig. 2 – Visual changes of the specimen’s external damage

From Figure 3, it can be observed that the freeze-thaw damage test of the specimens in the salt solution follows the same four-stage failure mode. In Figure (b), the upper specimen is after 50 freeze-thaw cycles, with a smooth and flat surface. The middle specimen is after 150 cycles, and localized surface cracks and detachment of the surface mortar can be observed, but the damage is slight, with no exposed aggregates, and the local area remains smooth. The lower specimen is after 250 cycles, where the surface erosion is already severe, with pits and grooves throughout the specimen, significant loss of concrete mortar and fine aggregates, and even some detachment of coarse aggregates, exposing them. The cross-sectional area has reduced significantly, with the ends of the specimen resembling elliptical cones. When struck with a hard object, the surface feels loose, and materials may detach.

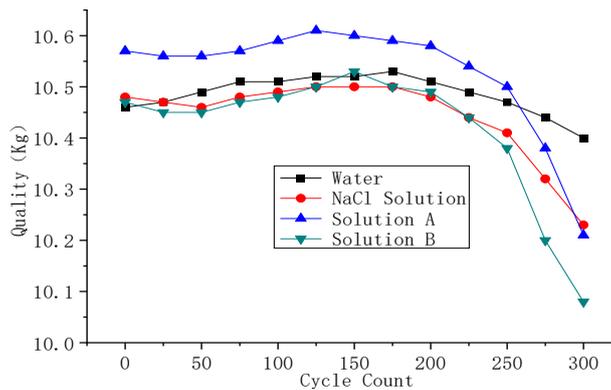
The mass changes of the specimens during 300 freeze-thaw cycles in water and different solutions are shown in Figure 3.

Fig. 3 – Graph of the mass changes of the specimens

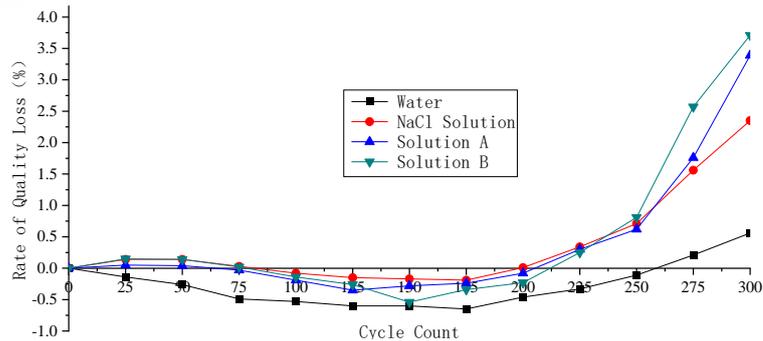
Fig. 4 – Graph of the specimen mass loss rate

From Figure 4 and Figure 5, it can be seen that throughout the entire freeze-thaw cycle, the mass changes of the specimens do not continuously decrease. In the early stage (0-150 cycles) of the freeze-thaw test, there is a slight increase in mass for the specimens in water and different solutions, but the trend is relatively stable. In the middle and later stages, the mass loss of the specimens (especially in the different solutions) intensifies, and the mass loss curve becomes steeper. After 300 freeze-thaw cycles, the mass loss rates of the specimens in water, NaCl solution, Solution A, and Solution B are 0.56%, 2.36%, 3.39%, and 3.71% respectively.

This change in mass loss is caused by multiple factors, including temperature stress, osmotic pressure, and crystallization pressure. In the early stage, the intact concrete surface has a dense structure with low porosity and no significant cracks or defects. When the surface mortar undergoes freeze-thaw spalling, micro-pores and cracks are exposed, facilitating the penetration of ions. As the ions from the solution penetrate deep into the concrete, complex physicochemical reactions occur with the concrete materials, resulting in the formation of crystals and harmful substances. At this stage, the amount of reaction products slightly exceeds the amount of concrete spalling, leading to

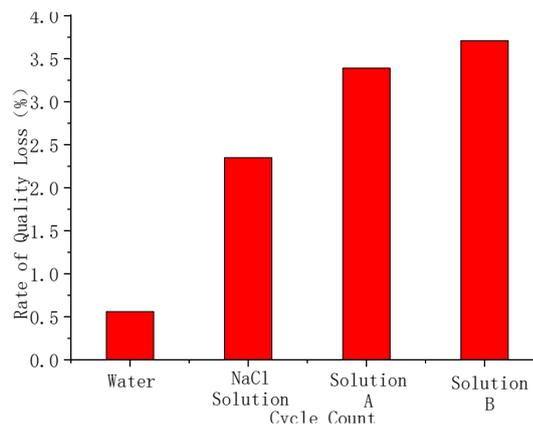
Fig. 5 – Mass loss rate of the specimens after 300 cycles

The experiment shows that chloride salt solution can significantly accelerate the freeze-thaw damage process of concrete structures. Taking 300 freeze-thaw cycles as an example, the mass loss rates of the specimens in NaCl solution, Solution A, and Solution B are 4.2, 6.0, and 6.5 times higher than that in water, respectively. Using Matlab analysis software fitting, it is found that the mass loss of specimens in Solution B will reach 5.02% (the limit specified in the standard is 5%) after 410 freeze-thaw cycles, reaching the failure limit first.

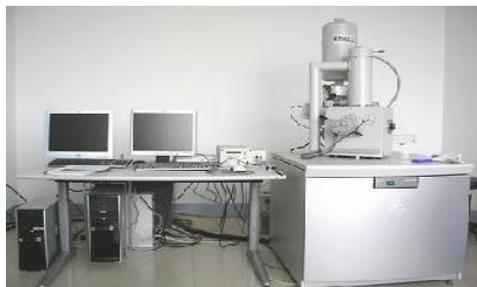
Fig. 6 – Scanning electron microscope (SEM)

In this experiment, the QUANTA200 scanning electron microscope (SEM) manufactured by Japan Electron Optics Co., Ltd. is used. The SEM operates at an accelerating voltage of 20 kV and has an instrument resolution of 3.5 nm. Elemental analysis is performed using the Oxford INCA energy-dispersive spectroscopy (EDS) analyzer. The scanning electron microscope (SEM) is shown in Figure 6.

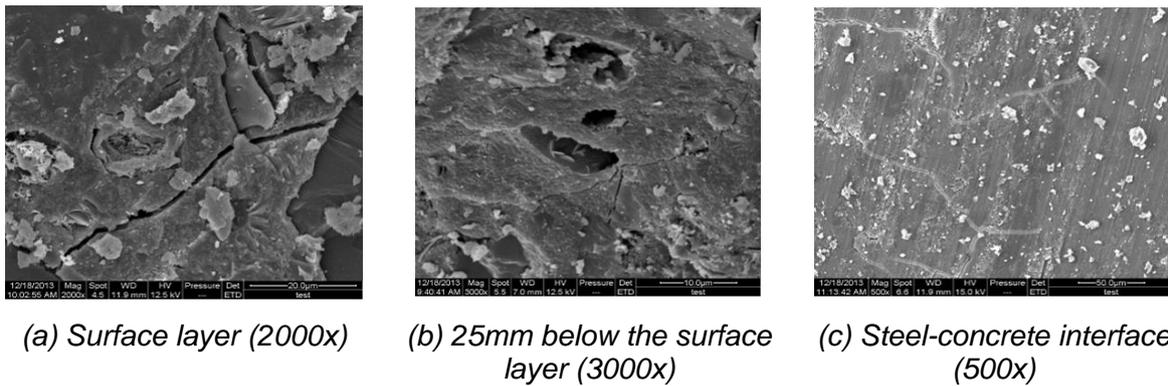
(1) Electron microscopy observation and elemental energy spectrum analysis of specimen L20 SEM images of the microstructure of concrete samples from specimen L20 are shown in Figure 7, and elemental energy spectrum analysis is presented in Figure 8 - Figure 10.

Fig. 7 – SEM images of microstructure of L20 specimen

From the SEM images, it can be observed that cracks have occurred in the concrete at three different depths. Among them, the concrete cracks at the steel-concrete interface are narrow and short, mainly formed due to concrete shrinkage, and their development is limited as the internal temperature stress has little effect on them during freeze-thaw cycles. On the surface, there is a long crack in the concrete with a wider width. This crack is caused by significant strains due to temperature stress, resulting in severe damage. The concrete at a distance of 25 mm from the surface exhibits a level of damage between the two cases, with the cracks developing at the interplay of concrete shrinkage and temperature stress and showing some degree of progression.

After freeze-thaw cycles, the surface concrete becomes more porous and its permeability significantly decreases. There is also a certain development in the pore structure, and noticeable chloride salt products can be found on the surface. At a distance of 25 mm from the surface, no significant chloride salt products are detected, and the structure is relatively compact. The concrete at the steel-concrete interface appears relatively smooth and dense, exhibiting good overall integrity and resistance to permeability.

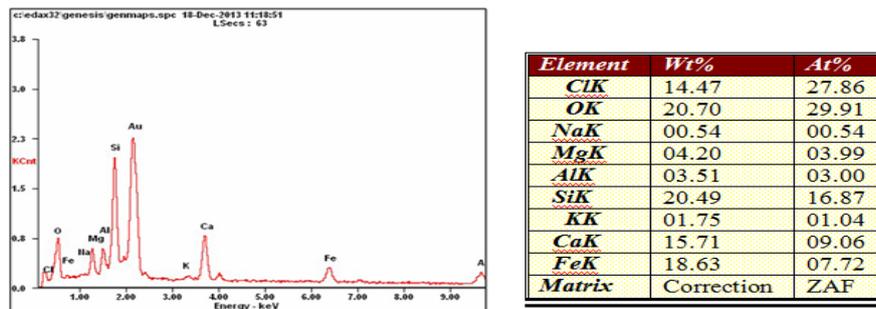
Fig. 8 – Energy-dispersive X-ray spectroscopy (EDS) analysis of surface elements of L20 specimen

From the energy-dispersive X-ray spectroscopy (EDS) analysis, it can be observed that the distribution of Cl⁻ varies significantly among different depths. The surface concrete has the highest content, with a mass percentage of up to 14.47% and a molar percentage of 27.86%. The concrete at a distance of 25 mm from the surface comes next, with a mass percentage of 9.92% and a molar percentage of 18.64%. No presence of Cl⁻ is detected at the steel-concrete interface, indicating that after 50 freeze-thaw cycles, Cl⁻ failed to effectively penetrate to the steel-concrete interface. The concrete at the steel-concrete interface is only subjected to temperature stress and has not been corroded by chloride salt media.

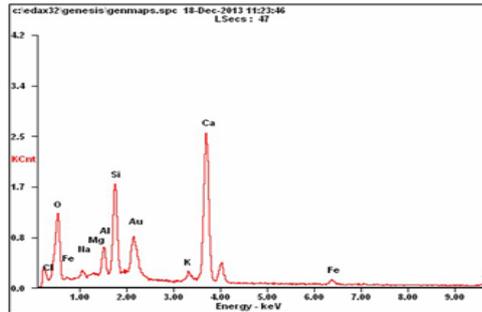
Element	Wt%	At%
ClK	09.92	18.64
OK	31.71	44.75
NaK	01.22	01.19
MgK	00.47	00.43
AlK	03.29	02.75
SiK	11.45	09.21
KK	02.01	01.16
CaK	35.98	20.27
FeK	03.96	01.60
Matrix	Correction	ZAF

Fig. 9– Energy-dispersive X-ray spectroscopy (EDS) analysis of elements at a distance of 25mm from the surface of L20 specimen

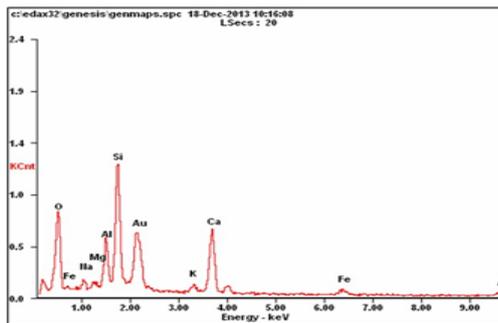
Element	Wt%	At%
OK	37.40	55.41
NaK	02.02	02.08
MgK	00.92	00.89
AlK	07.02	06.17
SiK	21.76	18.36
KK	02.44	01.48
CaK	21.14	12.50
FeK	07.31	03.10
Matrix	Correction	ZAF

Fig. 10 – Energy-dispersive X-ray spectroscopy (EDS) analysis of elements at the steel-concrete interface of L20 specimen

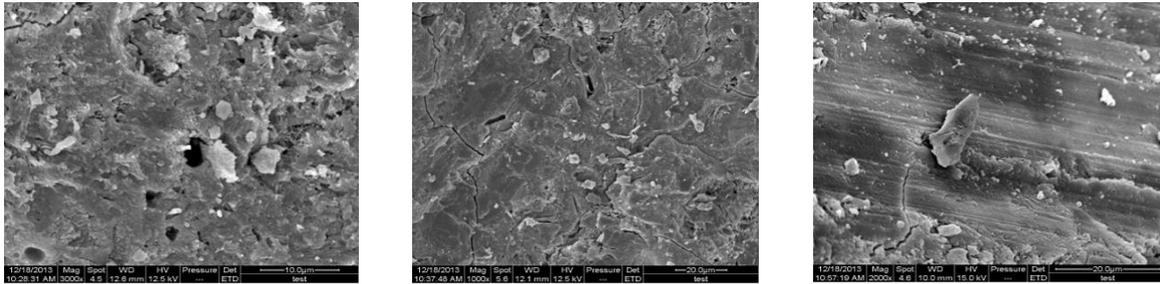
The microstructure SEM images of the concrete specimens of L22 are shown in Figure 11, and the elemental energy-dispersive X-ray spectroscopy (EDS) analyses are shown in Figure 12 - Figure 14.

(a) Surface layer (3000x) (b) 25mm below the surface layer (1000x) (c) Steel-concrete interface (2000x)

Fig. 11 – SEM images of the microstructure of the L22 specimen

Based on the SEM images, it can be observed that cracks have developed in the concrete at different depths. The cracks at the steel-concrete interface are narrower, shorter, and more sporadic. They are mainly caused by concrete shrinkage, and the influence of internal temperature stress during freeze-thaw cycles is relatively minor. Therefore, the crack propagation is slow. The concrete at the surface layer exhibits a prominent crack with a wider width. This crack is a result of significant strain caused by temperature stress, leading to severe damage. The concrete at a distance of 25 mm from the surface layer shows intermediate levels of damage. Cracks have formed due to the combined effects of concrete shrinkage and temperature stress, with some degree of propagation.

After freeze-thaw cycles, the surface layer of the concrete becomes more porous, resulting in a significant decrease in permeability. The pore structure also develops to a certain extent, with numerous and larger-sized pores. There are visible chloride salt deposits on the surface. At a distance of 25 mm from the surface layer, a small amount of chloride salt deposits can be found, and the structure is relatively denser. The concrete at the steel-concrete interface is relatively smooth and compact, exhibiting overall integrity and good resistance to permeability.

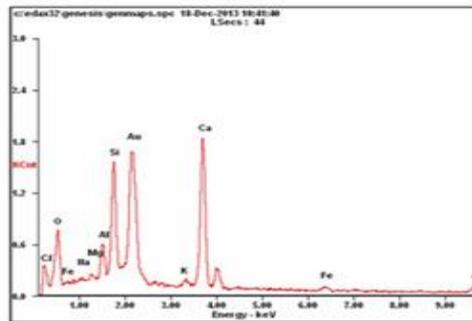
Element	Wt%	At%
ClK	15.23	29.46
OK	25.54	34.22
NaK	00.55	00.62
MgK	00.62	00.66
AlK	04.22	04.04
SiK	16.70	10.36
KK	01.70	01.12
CaK	31.15	17.52
FeK	04.28	01.98
Matrix	Correction	ZAF

Fig. 12 – Elemental energy-dispersive X-ray spectroscopy (EDS) analysis of the surface layer of the L22 specimen

The distribution of Cl⁻ in different depths can be observed from the energy-dispersive X-ray spectroscopy analysis. The surface layer of the concrete has the highest concentration, with a mass percentage of 15.23% and a molar percentage of 29.46%. The Cl⁻ content is lower at a depth of 25 mm from the surface layer, with a mass percentage of 10.52% and a molar percentage of 20.01%. The Cl⁻ content is the lowest at the steel-concrete interface, with a mass percentage of 3.47% and a molar percentage of 12.16%, exceeding the critical value for inducing reinforcement corrosion. This indicates that Cl⁻ has only penetrated to the steel-concrete interface after 100 freeze-thaw cycles, where the concrete is mainly affected by temperature stress and less influenced by chloride salt corrosion.

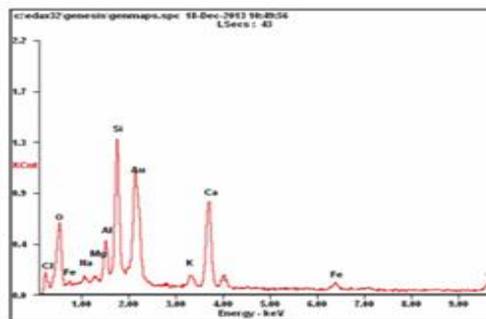
Element	Wt%	At%
ClK	10.52	20.01
OK	24.24	37.59
NaK	01.41	01.53
MgK	00.60	00.62
AlK	05.05	04.70
SiK	19.55	15.27
KK	03.74	02.40
CaK	27.46	14.53
FeK	07.44	03.34
Matrix	Correction	ZAF

Fig. 13 – Elemental energy-dispersive X-ray spectroscopy (EDS) analysis of the L22 specimen at a distance of 25mm from the surface layer

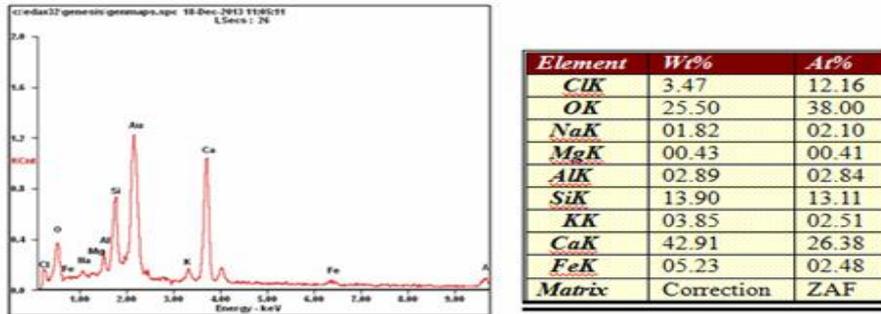
Fig. 14 – Elemental energy-dispersive X-ray spectroscopy (EDS) analysis of the steel-concrete interface of the L22 specimen

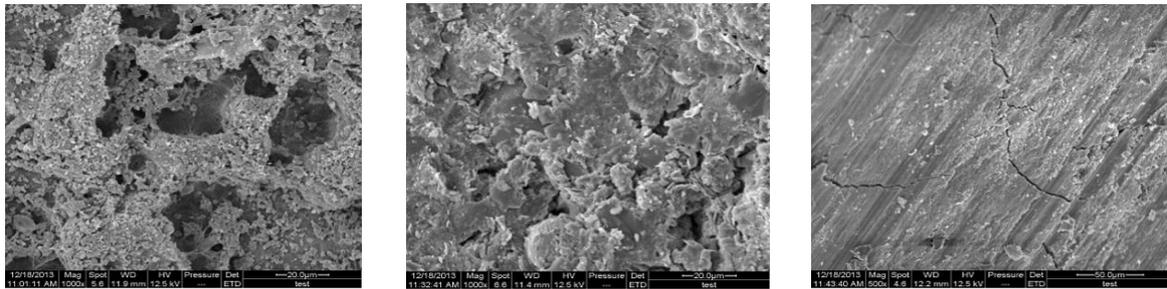
SEM images of the microstructures of concrete specimens for L24 specimen are shown in Figure 15, while the elemental energy-dispersive X-ray spectroscopy analyses are shown in Figure 16 - Figure 18.

(a) Surface layer (1000x) (b) 25mm below the surface layer (1000x) (c) Steel-concrete interface (500x)

Fig. 15 – SEM images of the microstructure of the L24 specimen

shrinkage, temperature stress, and chloride ion erosion, the surface morphology of the concrete exhibits a honeycomb-like appearance, with severe loose, porous, and fragmented characteristics. The impermeability can be considered negligible as the surface is heavily covered with chloride salt deposits, indicating the loss of its protective structural function. The concrete cracks at the steel-concrete interface have significantly developed in width compared to 50 and 100 cycles of freeze-thaw cycles, transitioning from fine mesh-like cracks to coarse, deep-through cracks. No cracks were observed at a distance of 25 mm from the surface, but the concrete still exhibited severe loose, porous, and fragmented characteristics, leading to a significant reduction in impermeability.

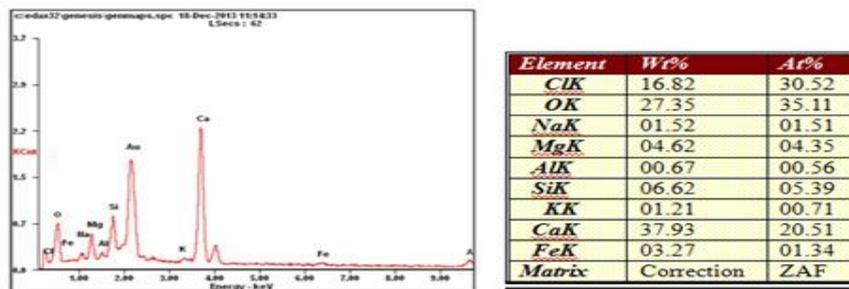
Fig. 16 – Elemental energy-dispersive X-ray spectroscopy analysis of the surface layer of the L24 specimen

From the energy-dispersive X-ray spectroscopy analysis, it can be observed that the content of Cl⁻ increases significantly in different depth layers. The surface layer of the concrete has the highest content, with a mass fraction of up to 16.82% and a molar percentage of 30.52%. The content of Cl⁻ at a distance of 25 mm from the surface is the second highest, with a mass fraction of 12.34% and a molar percentage of 22.18%. The Cl⁻ content at the steel-concrete interface is the lowest, with a mass fraction of 4.72% and a molar percentage of 13.56%, exceeding the critical value for inducing steel corrosion. This indicates that after 100 cycles of freeze-thaw, Cl⁻ has just penetrated the steel-concrete interface, where the concrete is primarily affected by temperature stress and has a lesser influence from chloride salt erosion.

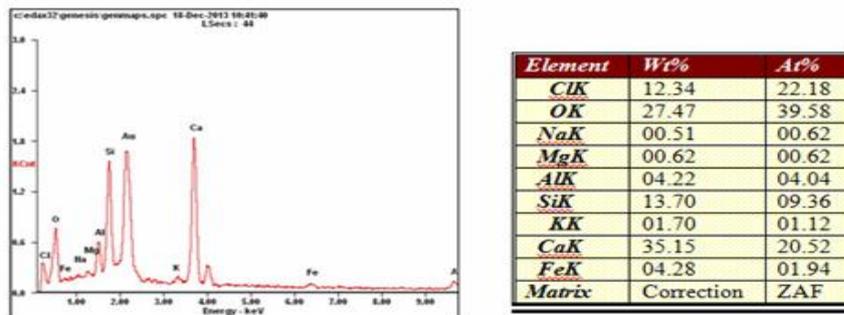
Fig. 17 – Elemental energy-dispersive X-ray spectroscopy analysis of the L24 specimen at a distance of 25mm from the surface layer

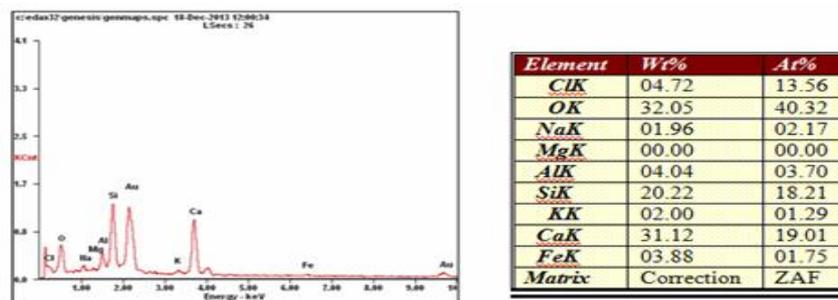
Fig. 18 – Elemental energy-dispersive X-ray spectroscopy analysis at the steel-concrete interface of the L24 specimen
