# EXPERIMENTAL RESEARCH INTO THE RESPONSE OF HISTORICAL STRUCTURE TO THE EFFECTS OF NATURAL SEISMICITY

## LUBY RECTORY

## **ANALYSIS OF FAILURES IDENTIFIED DURING A PRELIMINARY VISUAL BUILDING TECHNICAL SURVEY**

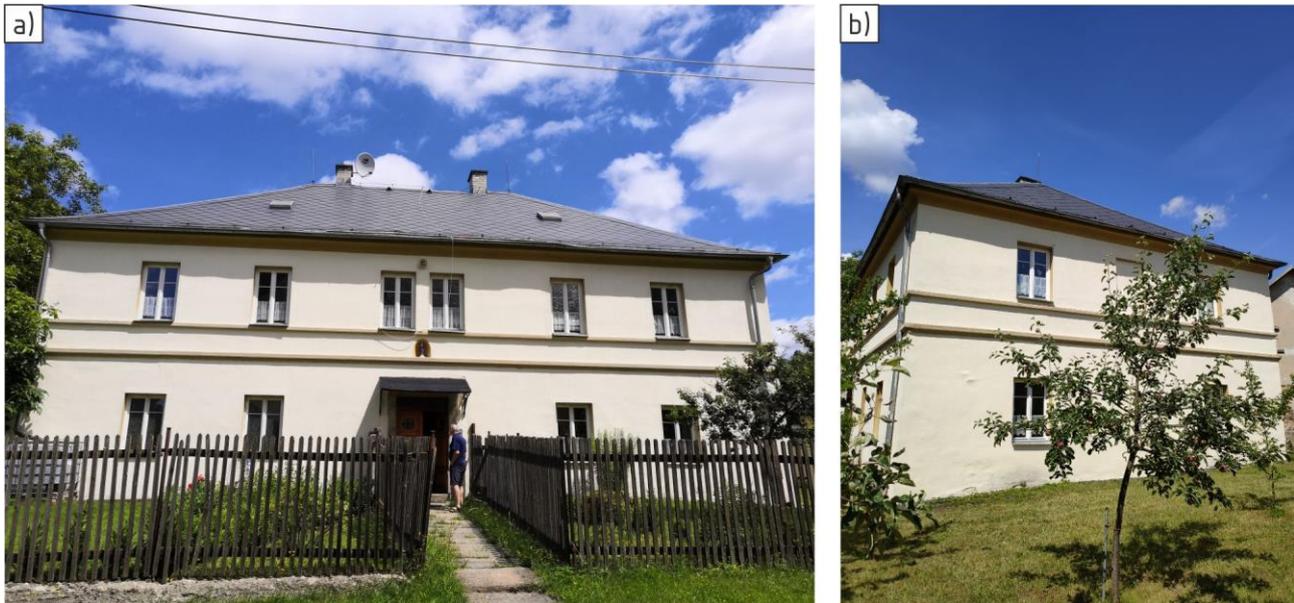
of load-bearing walls on the 1<sup>st</sup> overground storey remained. After the fire, the rectory was restored, but in 1865 it burned down again and was newly restored (Figure 2). Up to now, no major construction work has been done in the rectory building. As part of routine maintenance, the roofing and windows were replaced, bathrooms and toilets were gradually installed inside the building, and ceilings were replaced in some rooms. Throughout the whole time of the building's existence, cracks caused by the assumed effects of earthquakes have been repeatedly repaired. The rectory has served its purpose with varying intensity until the present day.

*Fig. 2 - Luby Rectory – a) southern elevation, b) eastern elevation*

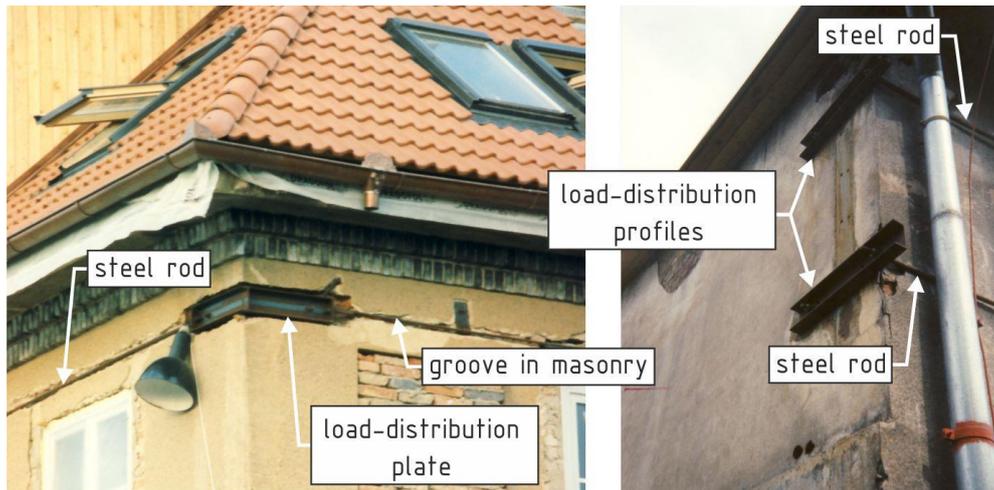
Fig. 6 - a) Bracing walls with circular steel sections, b) temporary bracing of masonry [10]

Additional reinforcement of historic masonry buildings currently mostly applies the bracing of masonry with steel tie rods of circular cross-sections, strip steel, or prestressing patent wires inserted in grooves up to 150 mm deep arranged in both directions of the building (Figure 6). Another solution is an effective and controlled activation of the existing wall or beam ties, tie rods and load distribution anchor plates (e.g. by additional activation of the beam tie attached to the rehabilitated joists).

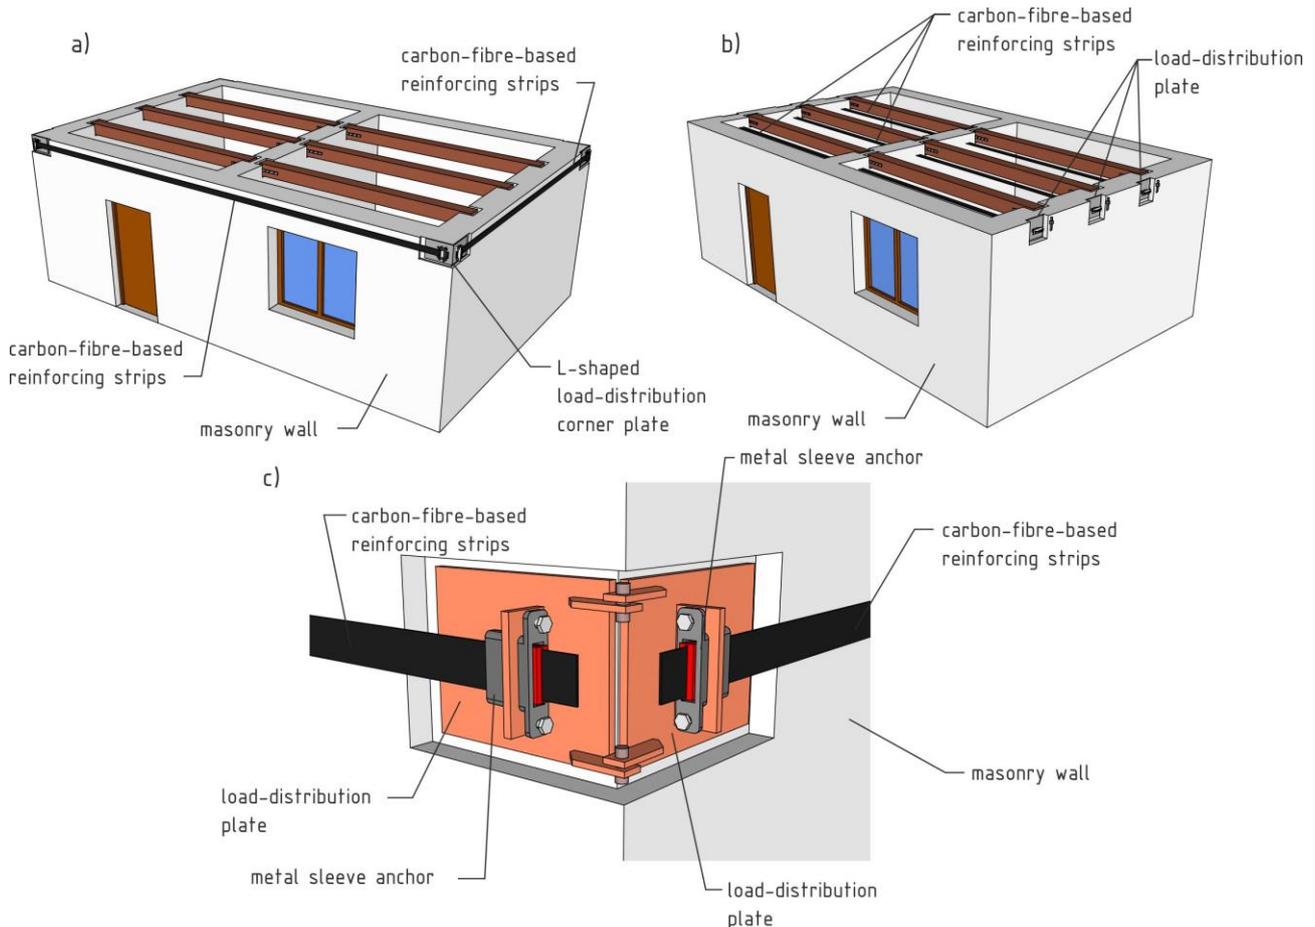
Fig. 7 - Reinforcement of damaged masonry buildings with insufficiently functioning tie rods and beam ties or with their absence by means of lamellas based on carbon or aramid fibres

Damaged masonry buildings with insufficiently functioning tie rods and beam ties, or with the absence of wall and beam ties in some historic buildings can be reinforced with lamellas based on carbon or aramid fibres fitted in their end parts with special metal anchoring elements enabling the activation or pre-tensioning of the lamellas to the required force. Steel load distribution plates or special prestressing devices must be mounted in the anchoring parts of the lamellas and the masonry must be reinforced (Figure 7) [11, 12].

In cases of active prestressing of lamellas to higher tensile force values, the building must be prestressed around the perimeter by means of lamellas anchored in "L"-shaped corner metal load distribution plates located in the corners of the building at one height level. The prestressing must be performed gradually by alternately applying the prestressing force in both directions (see Figure 7).

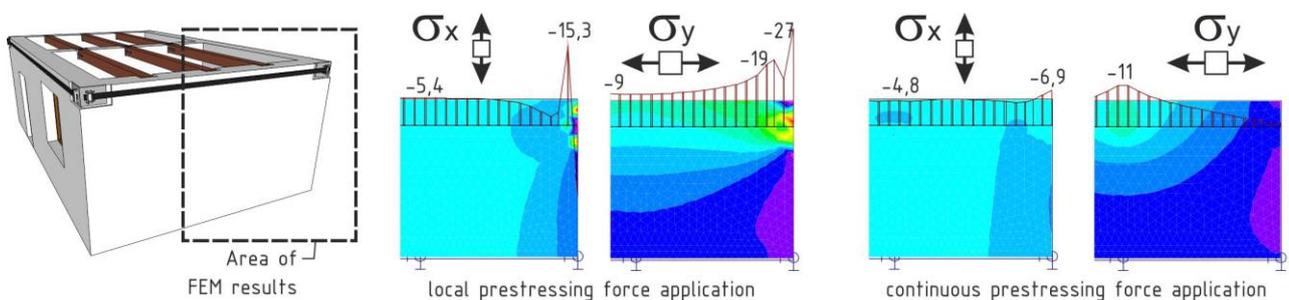
Fig. 8 - Stresses in masonry in the end area of prestressing members

prestressing should be applied to the existing masonry structure along the entire length of the prestressing tie rod, lamella, etc. (Figure 8). In cases where a prestressed lamella, fixed by the prestressing tie device and laid in a shallow groove is coated with structurally effective plaster, adhesive sealant, an adhesive layer, etc. and the prestressing device is only released after the required strength of this “covering and fixing” layer has been reached, the prestressing force can be applied along the entire length of the lamella (Figure 8). This solution usually removes extreme stresses in the place of prestressing devices and anchor plates [10].
