# REHABILITATION OF HISTORIC HALF-TIMBERED WALLS WITH COMPOSITE MATERIALS BASED ON HIGH-STRENGTH

rehabilitation, strengthening, historic half-timbered walls, FRP fabrics

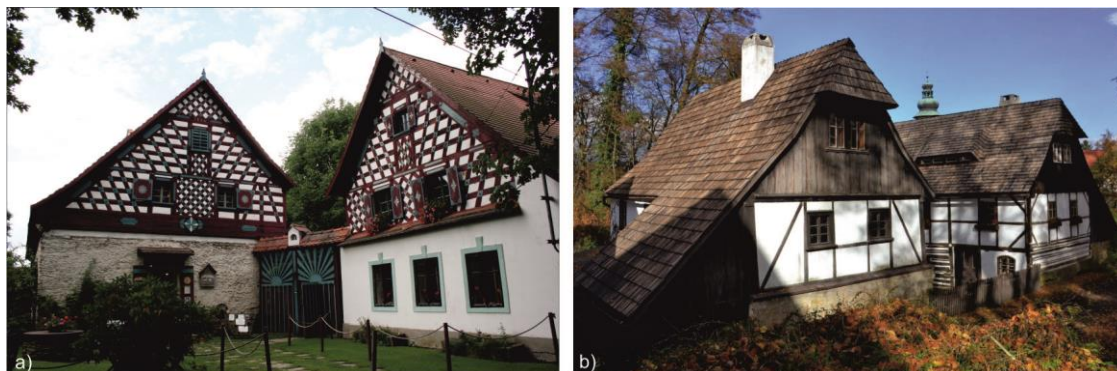
Fig. 1: Examples of half-timbered houses a) Doubrava; b) Kytlice

The origins of half-timbered buildings (Fig. 1a) most likely go back to the ancient world as evidenced e.g. by Vitruvius in his Ten Books on Architecture [1]. The origins of half-timbered and timber-framed buildings which were built in the Czech lands from the 14th to the late 19th century can be traced to Germany and Scandinavian countries, but also France, Switzerland and Austria. Numerous modifications and shape patterns of wooden elements of half-timbered walls are typical and expressive architectural and decorative elements of these buildings. The buildings preserved on the territory of the Czech Republic, mainly in the northwest border regions, largely represent houses with half-timbered constructions on the upper floor and in the gable and a timbered or masonry ground floor (Fig. 1b) [1].

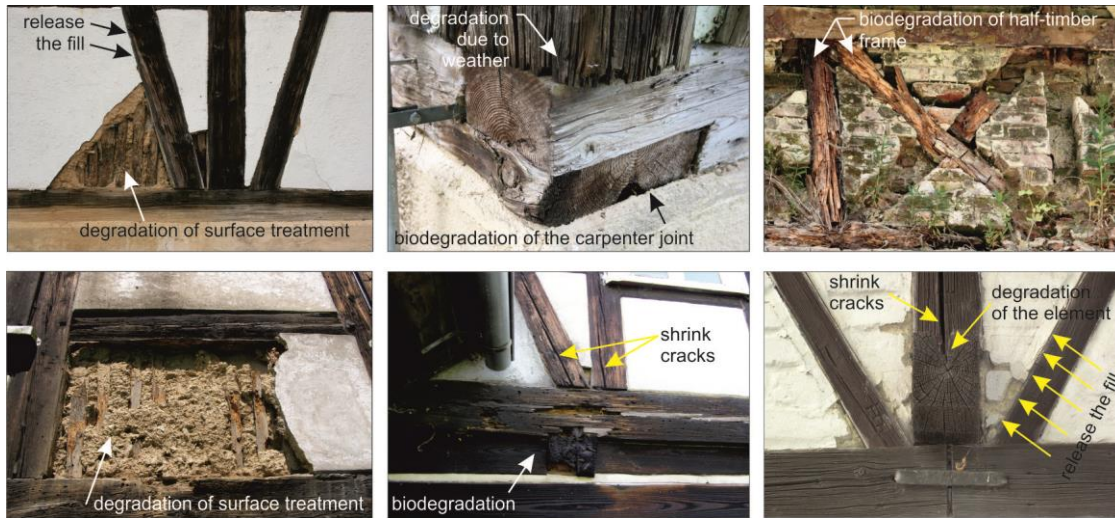
Fig. 2: Degradation of half-timbered houses

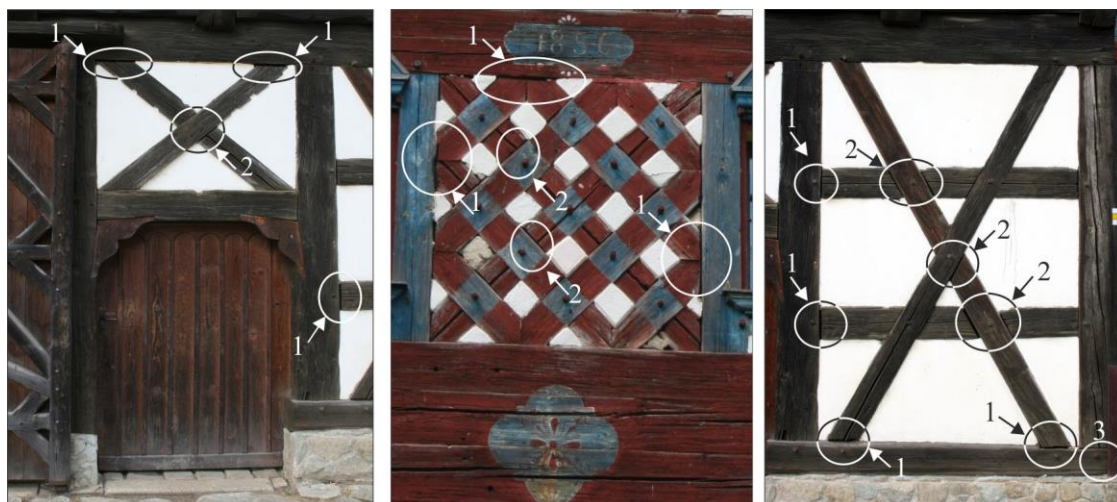
Fig. 3 Examples of failures (loosened connections) of different carpentry joints (legend 1 – tenon jointing (struts, noggins, posts), 2 – dapping (struts, noggin), 3 – halving (foundation plate))

The survey revealed that the main causes of failures of half-timbered buildings were inadequate foundations (settlement and deformation of foundations), deformations and strain of the timber construction due to the shrinkage (or swelling) of wooden elements, insufficient rigidity and stability, roof truss deformations, loosening of joints of wooden elements and their degradation by wood-decay agents and rotting due to elevated moisture levels, high temperatures or aggressive environments, improper use and unqualified interventions. Fig. 3 shows examples of degraded carpentry joints and wooden elements of half-timbered constructions.
