A GEOTECHNICAL INVESTIGATION FOR AN OFFICE BUILDING IN THE FOOTHILLS OF THE BOHEMIAN FOREST

ABSTRACT. An office building with a partial basement on an undeveloped plot within Polná na Šumavě was proposed. The municipality is located on the border of Boletice Military Training Area which had some specific security measures that had to be respected during the investigation. The detailed geotechnical investigation describes the geological conditions of the area, points out several complications that can be expected and finally proposes solutions to mitigate them.

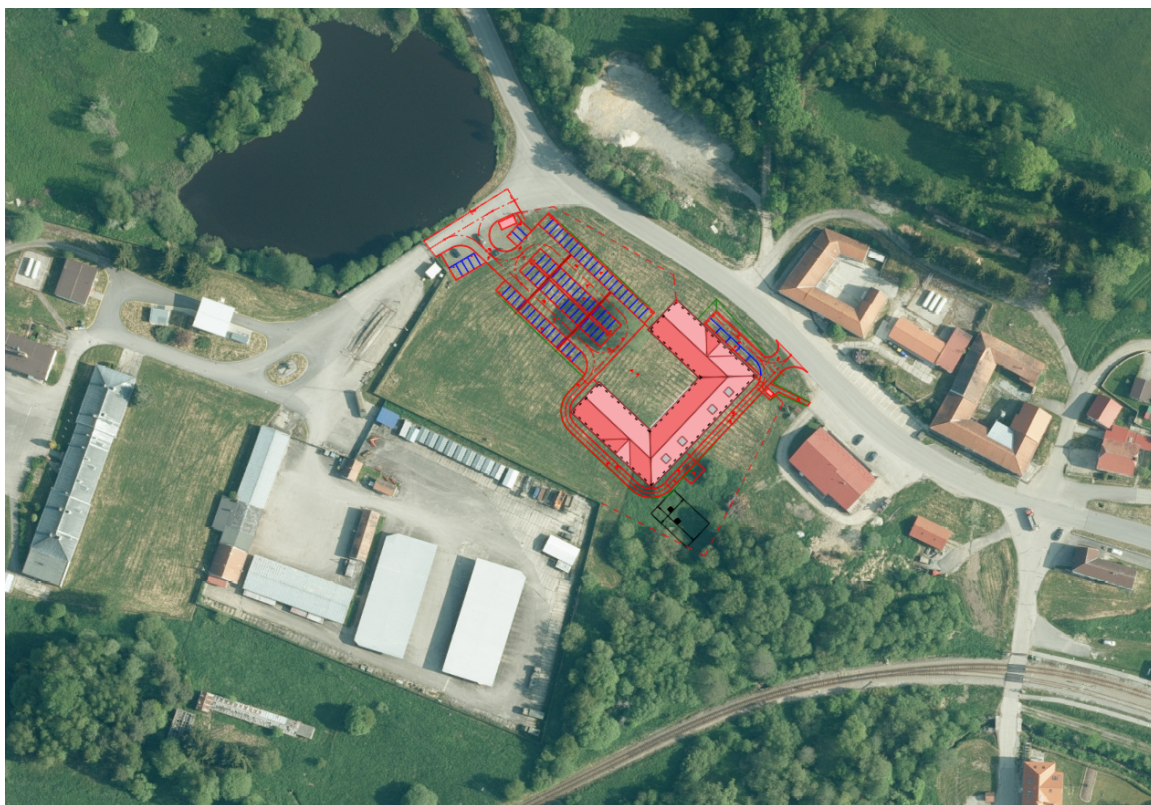
FIGURE 1. Site plan of the area of interest including a car park.

In the first half of 2024 the INSET s.r.o. company carried out a detailed geotechnical investigation for a new office building in Polná na Šumavě [1]. The project assumes the construction of an office building with a partial basement on an undeveloped plot within the municipality, located close to military grounds (see Figure 1).

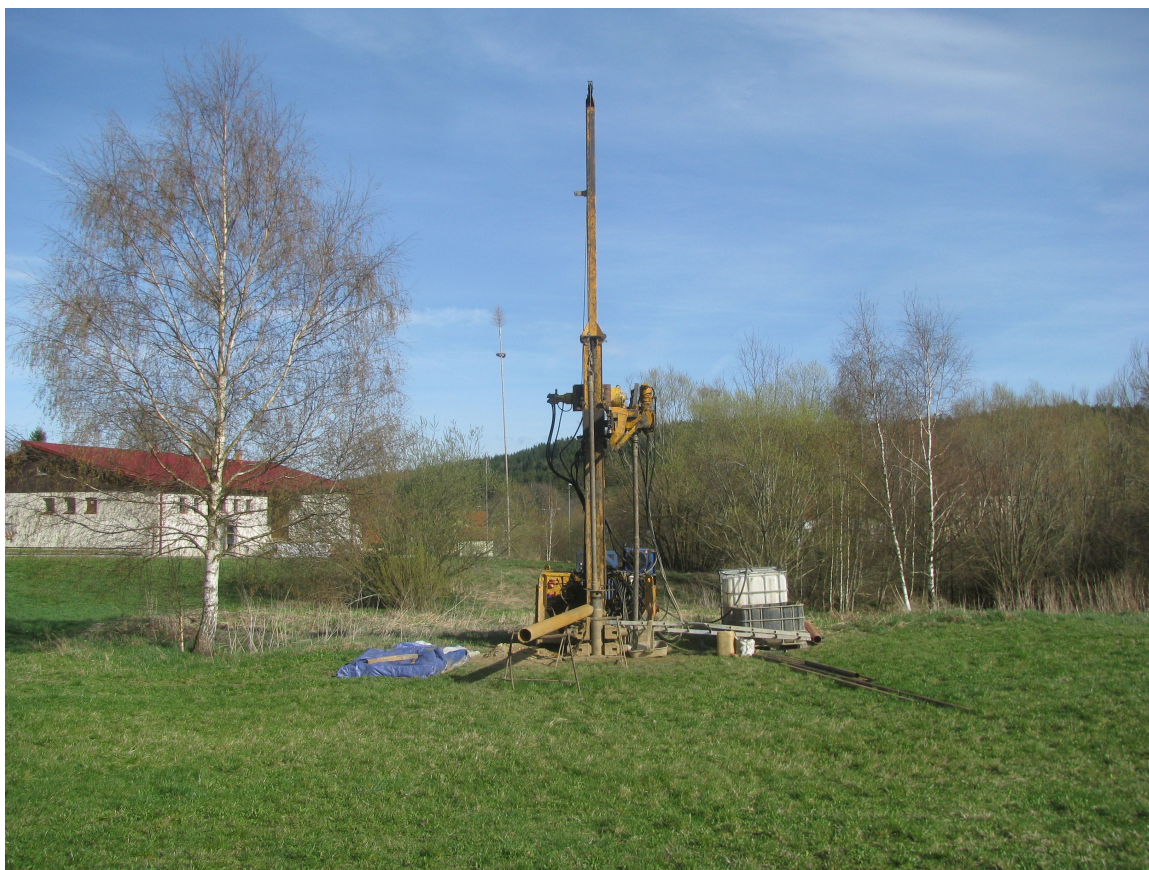
bit and a double tube core barrel, utilizing water as drilling fluid (Figure 2).

FIGURE 2. Drilling rig on site.

Two of the boreholes reached the bedrock. After overcoming sedimentary layers boring continued up to the final depth using a diamond encrusted drill
