# 3D Modelling of a Tunnel Re-excavation in Soft Ground

M. Hilar

## Abstract

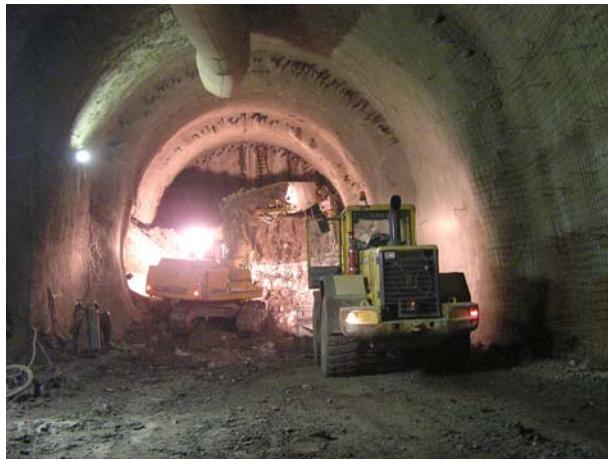
The tunnel profile was regularly protected by micropile umbrellas (Figure 11); the micropiles were embedded into the pile walls on both ends. Some attempts were made to embed the micropiles into

Fig. 11: Tunnel construction under micropile umbrellas the horizontal jet grouting columns (to increase their stiffness), but like the jet grouting columns drilled into the face, this approach was finished after the third section.
