# DAMAGE CONTROL OF INTUMESCENT PAINTING

## Influence of imperfections in intumescent painting

Tom Molken<sup>a</sup>

<sup>a</sup> StuBeCo bvba, Engineering office, Overpelt, Belgium

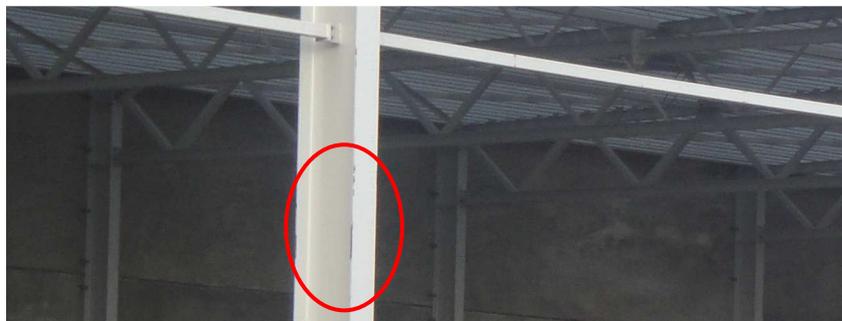
Fig. 1. Local damage

Most of the damage occurs at the location of temporary support timber for storage and transport or where lifting straps are attached to beams, columns or other members. To obtain uniformly distributed stresses in the elements typically those areas are situated at 1/5<sup>th</sup> of the total length, we have estimated them over the whole width of the IPE 330 and with a length of 200 mm.

On each beam/column we introduced a damaged part at 1/5<sup>th</sup> of the end, in this way the initial hyper-static systems will be reduced to a kinetic one with weaker rotational springs at the referred locations
