POTENTIAL APPLICATIONS OF TRANSPARENT FABRIC BASED ON NANOFIBRES FOR THE STRENGTHENING OF PLASTERS DECORATED WITH PAINTINGS AND FRESCOES

Klára Kroftová¹ and Markéta Šmidtová²

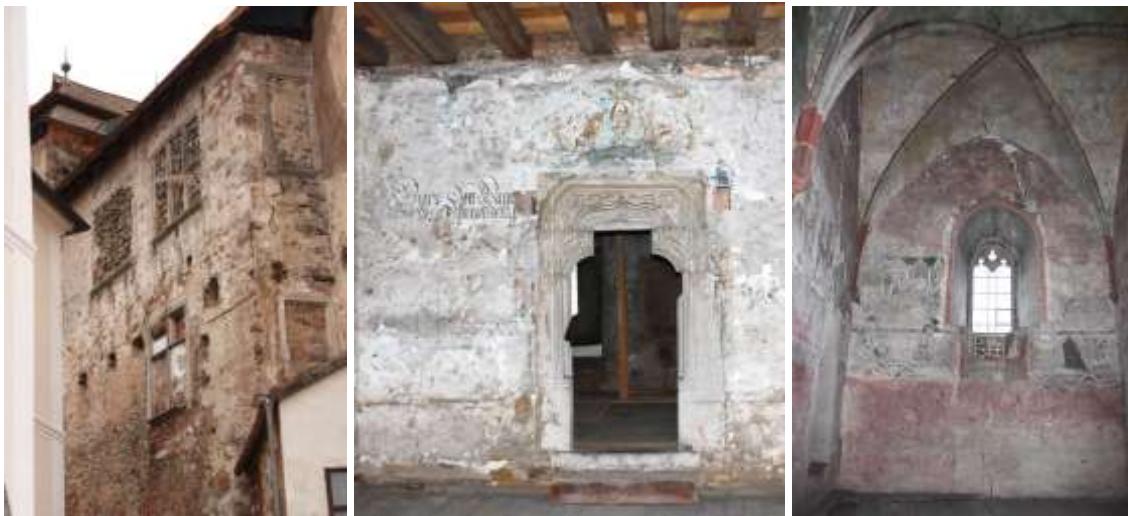
Fig. 1: Bečov Castle – authenticity of plaster surfaces: a) southern facade, b) the Annunciation Chapel, c) corner room in the donjon) stress the genuine historical appearance of buildings

The surface treatment of buildings, both in the exterior and interior, is an integral part of their appearance and value (Fig.1). Apart from the technical importance of protecting the building and its surface, this treatment has always had an aesthetic function subject to changing trends. In all historical periods, surface coatings have participated in creating the building's appearance adding the final touch to it and improving its surface.

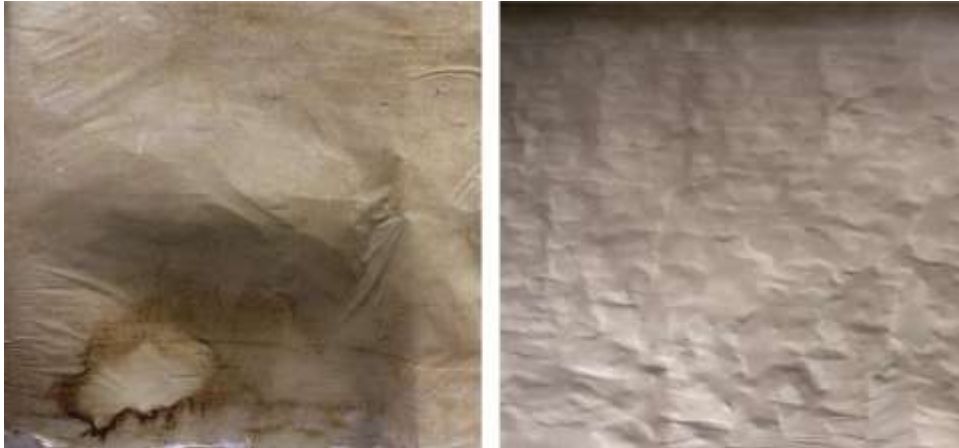
PVB and Paraloid B72 nanotextiles without dopants, the PVB nanotextile with Ag or TiO₂ dopants and the Paraloid B72 nanotextile doped with TiO₂ have light, milky colour. The exception is electrospun Paraloid B72 doped with Ag, which has light, yellow-brown colour and is very brittle (Fig.2).

Fig. 2: a) Paraloid B72 nanotextile doped with TiO₂, b) Paraloid B72 doped with Ag
